**Technical Committee**

**Washington, D.C.  
July 29, 2009**

**When Repairs Go Wrong-  
It is the Consumer who suffers**

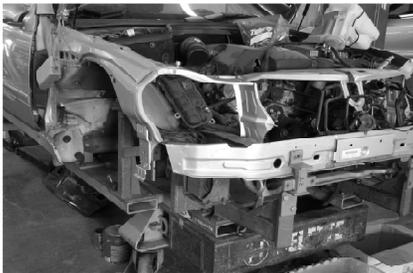
**The vehicle was mounted on a Celette Bench (one of two bench systems approved by MB for its certification program—the other is Car Bench). Body parts and mechanicals were removed for jig access.**

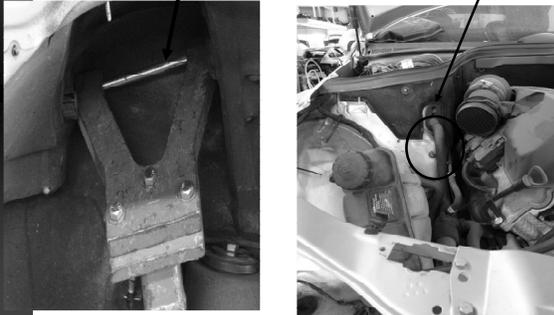
This picture was taken showing the passenger's side upper control arm positioning jib with the locating pin installed.

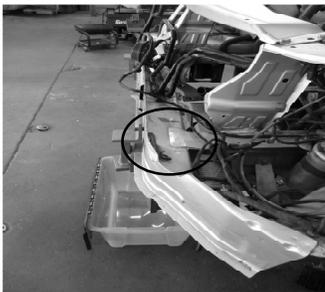
Front bumper reinforcement is still bent after the repairs had been completed.

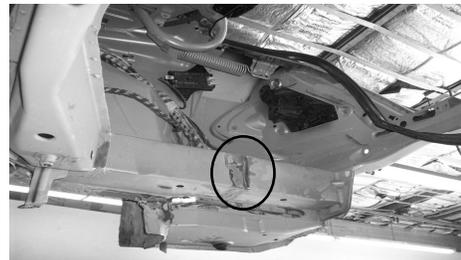
The estimate called for a complete passenger's side rail to be replaced, but the technician sectioned in the rail (MB does not allow sectioning of this rail).

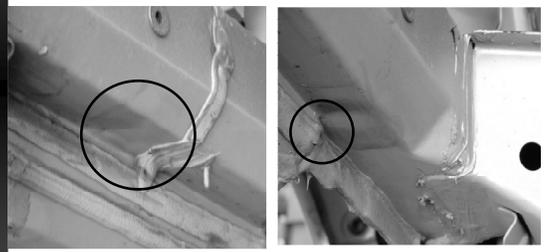
The driver's side rear rail was still bent & the seam sealer had separated from the impact.

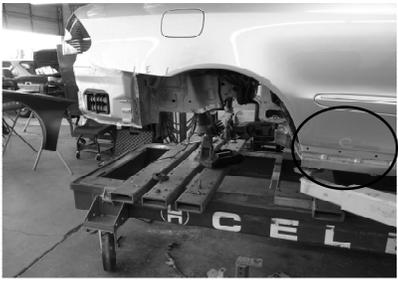
At position C, the factory repair manual calls for rivets and adhesive for attachment of the quarter panel to the rocker. The DRP shop plug welded the quarter panel in this area.

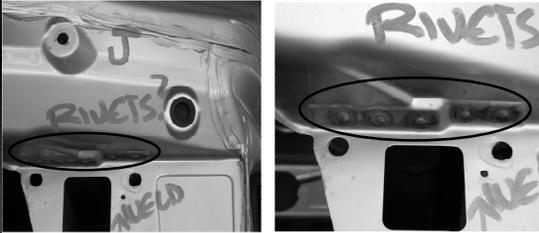
The M/B Factory repair bulletin calls for rivets at this location, but the technician MIG welded the replacement rear body panel. It should also be noted that the panel was not refinished in this area.

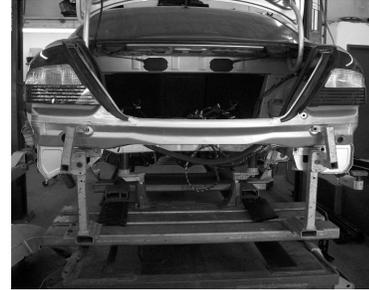
This picture shows the rear rail positioning jigs in the proper length, height & width

Note that the bolt holes are still misaligned after the pull on the driver's side rear rail.

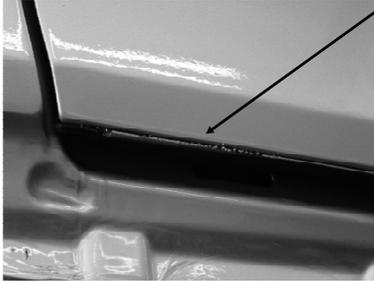
Note the paint overspray on the passenger's side door seal.
