# Estimating Today's Vehicles

Technical Committee  
July 21, 2011  
Salt Lake City, Utah

## A 2010 Toyota Xb with Damage to the Driver's Side

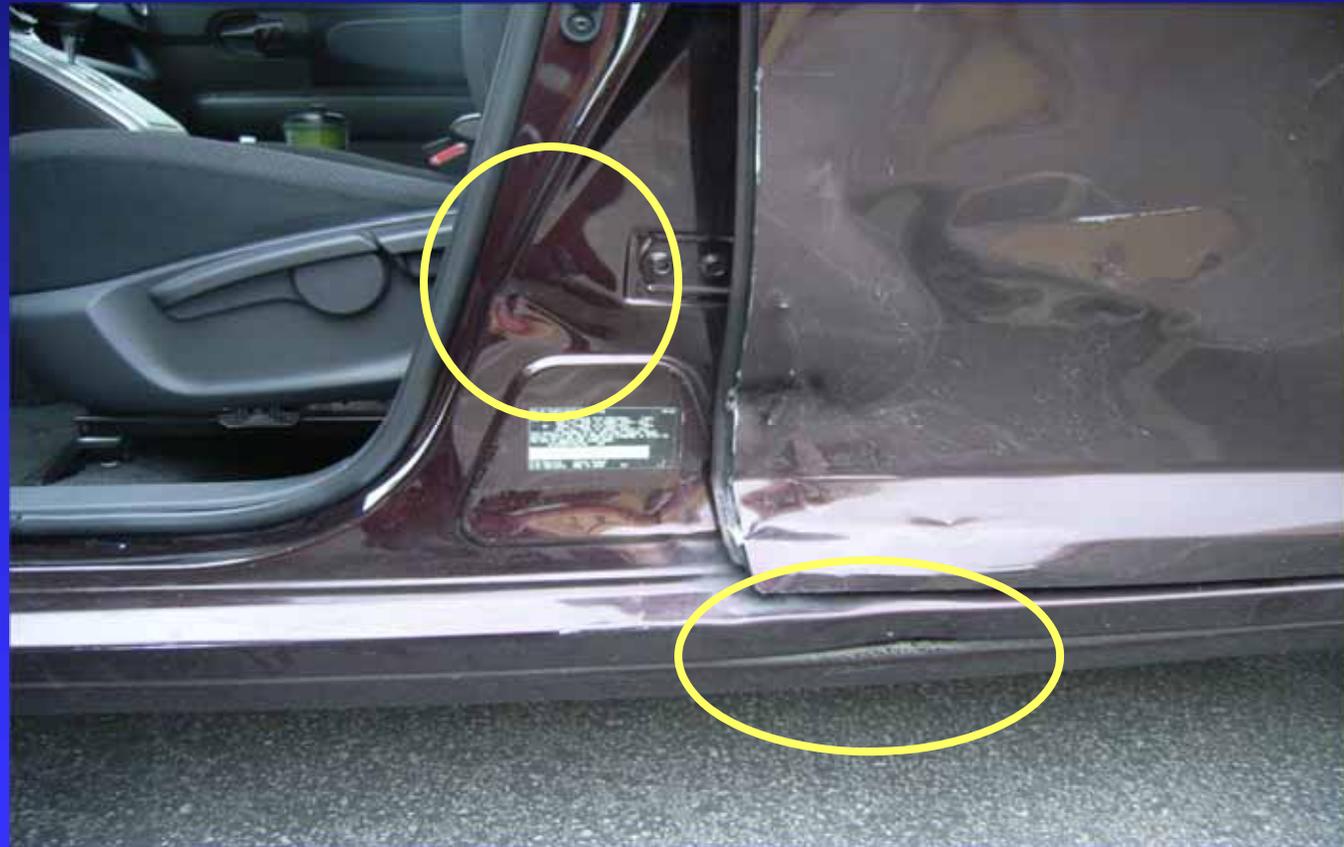
There is damage to the rocker & outer "B" pillar-lower section

- Set up frame machine & measure
- Replace Left FT Door
- Replace Left RR Door
- Pull Rocker to for repair
- Pull Center Post for repair
- Repair Rocker after pull
- Repair Center Post after Pull
- Replace Corrosion Protection
- Replace left quarter panel

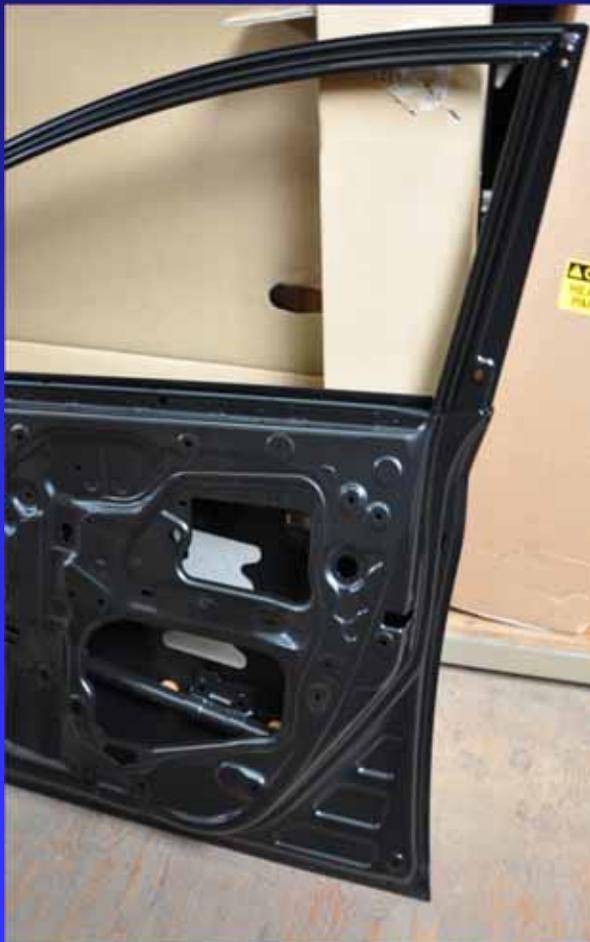
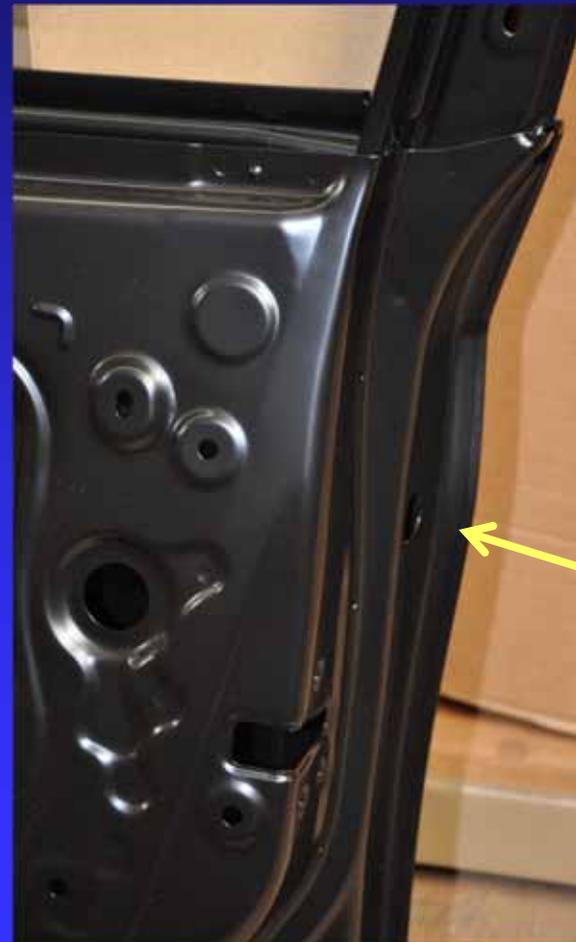
# New Toyota Door Shell Detailing the lack of Seam Sealer on the hem.

Hem w/o  
Seam sealer

To assure factory corrosion prevention measures are replicated during body repairs, always use a like-kind and quality automotive grade sealer on hem-flanges and body seams. During manufacturing specialized materials are used however, aftermarket materials are readily available to match factory quality, application, and purpose. OE replacement body components are not supplied with seam sealer.

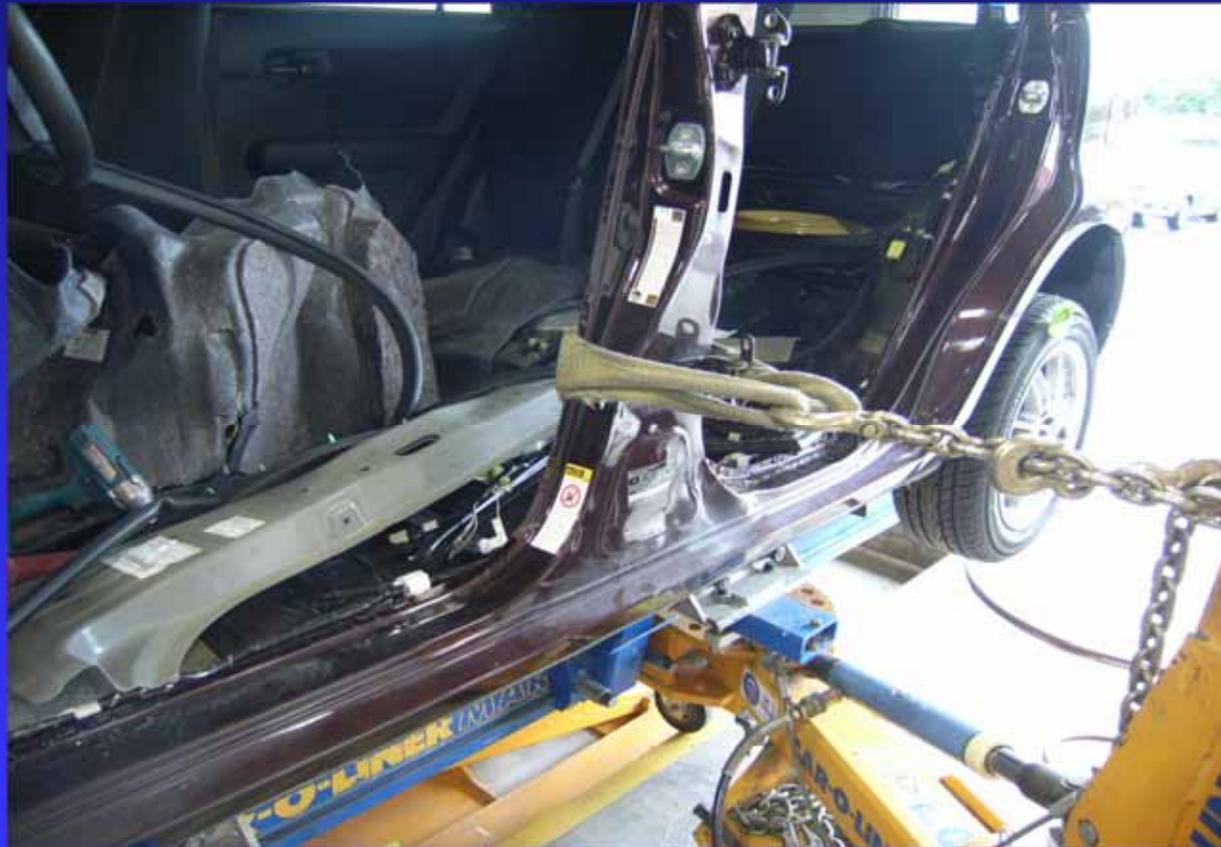
After reviewing the CRIB, pulling for repairs is out of the question. You can pull for replacement only.

- Set up frame machine & measure
- Replace Left FT Door
- Replace Left RR Door
- Pull Rocker for repair
- Pull Center Post for repair
- Repair Rocker after pull
- Repair Center Post after Pull
- Replace Corrosion Protection
- Pull Center Post for Replacement
- Pull Rocker for Replacement
- Replace Center Post & Rocker

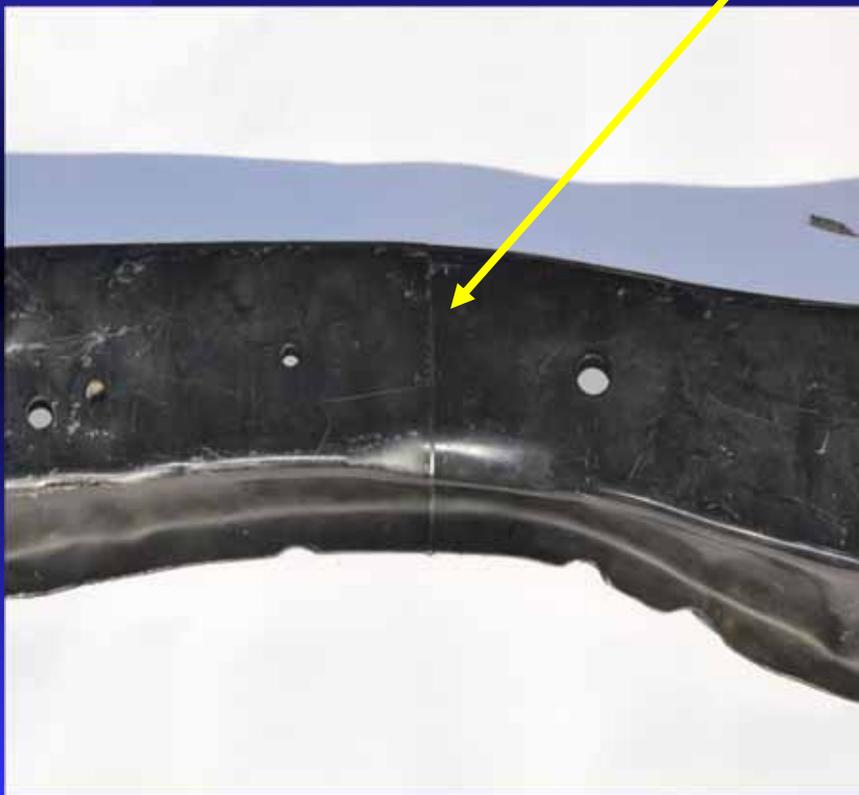
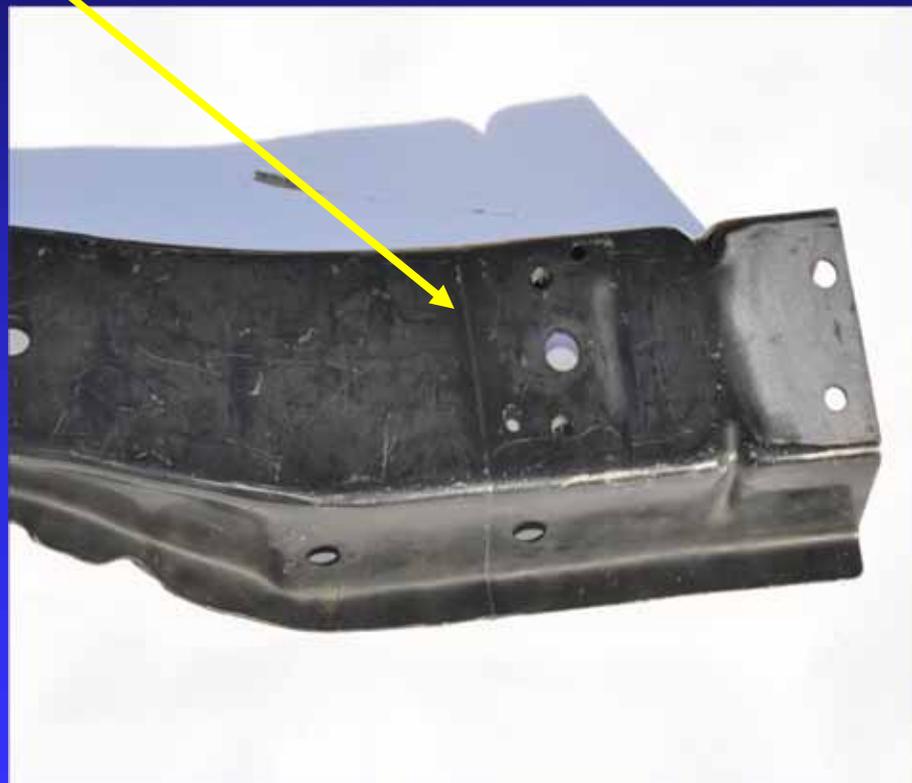
What are these lines?

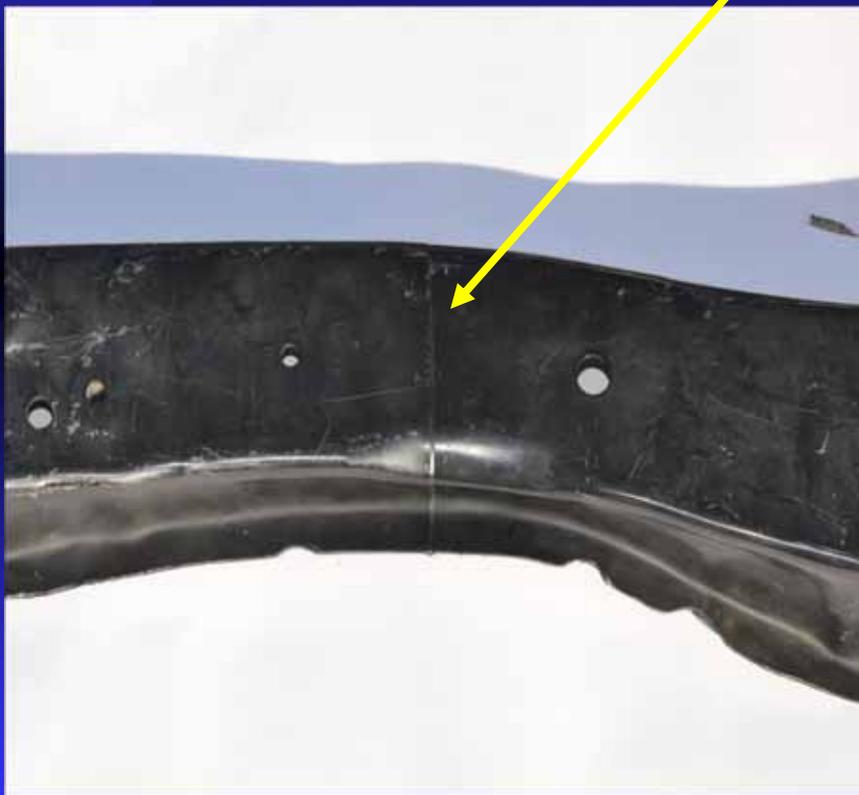
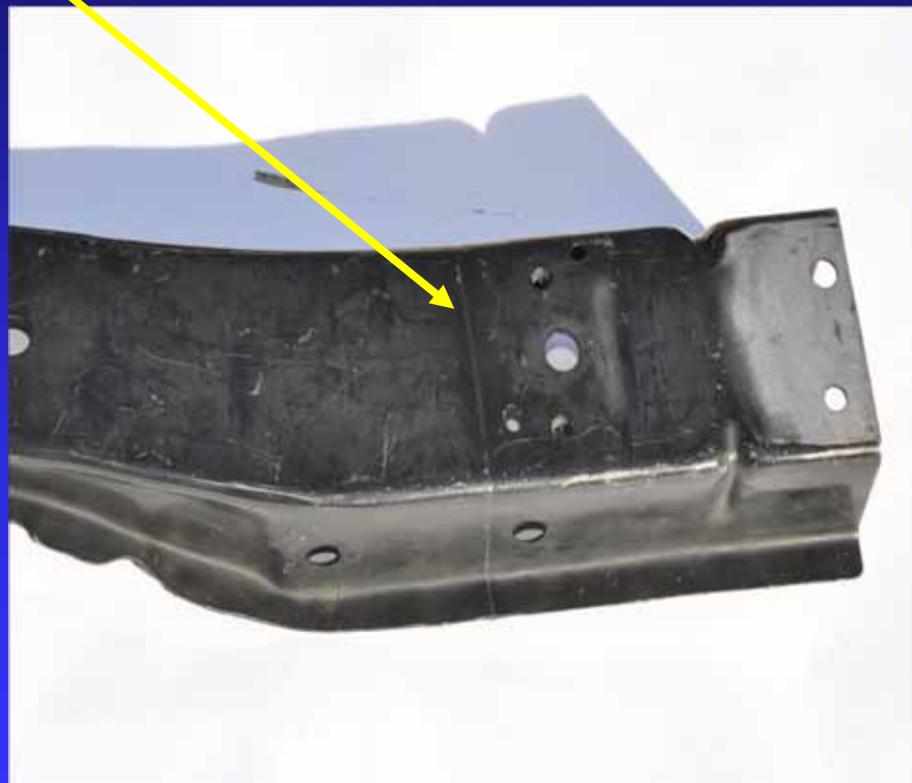
These are laser welds

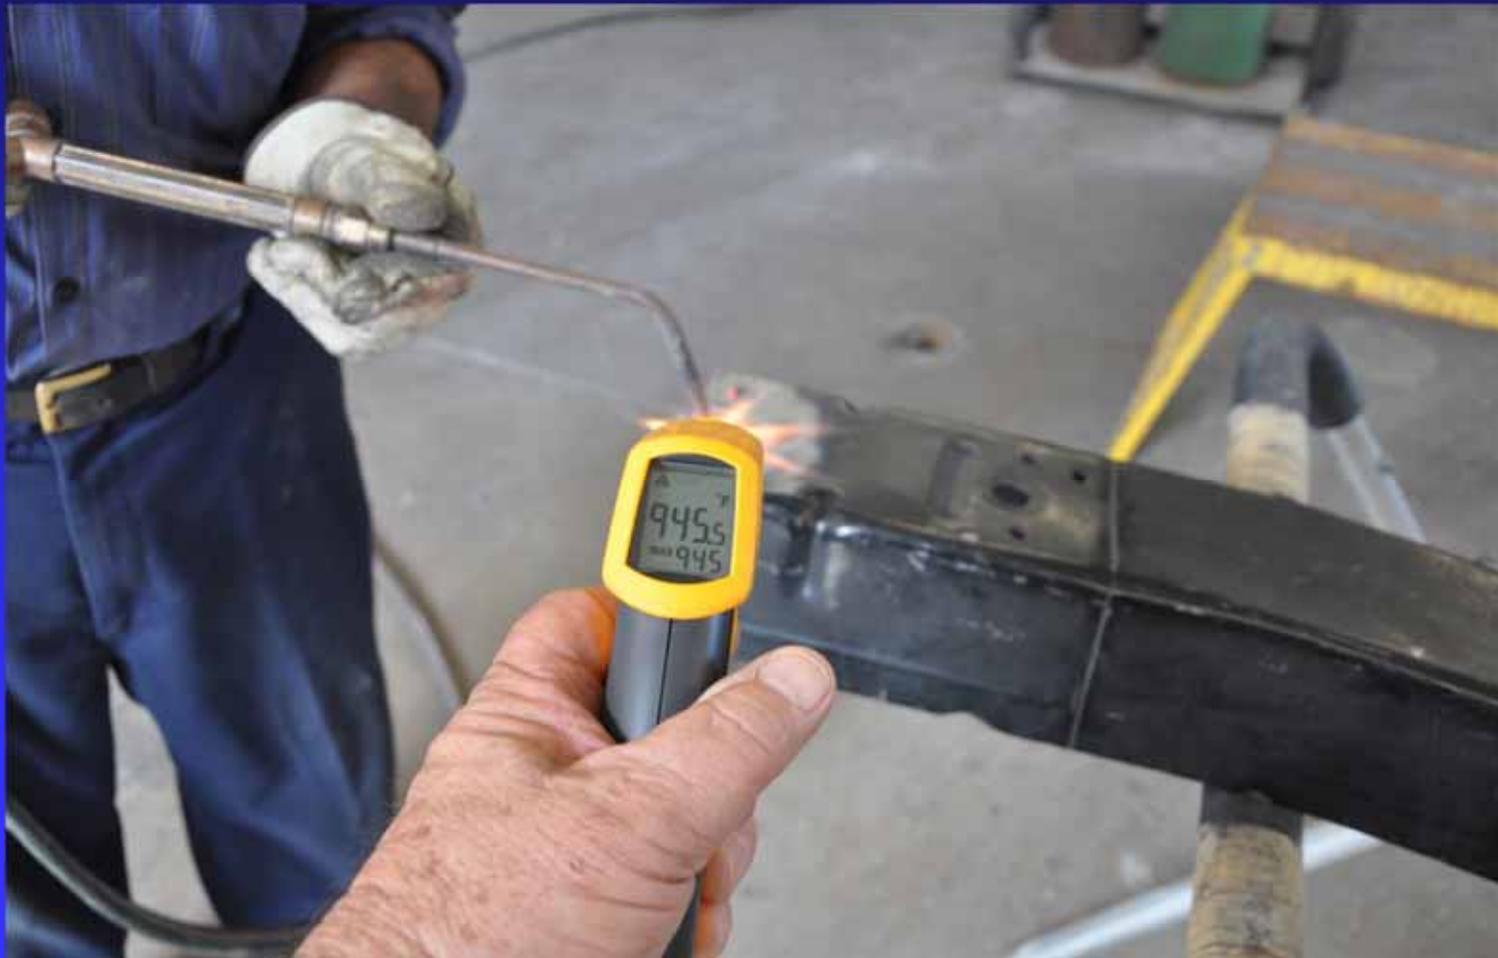
**Next I heated the rail to approximately 1000 degree Fahrenheit.**

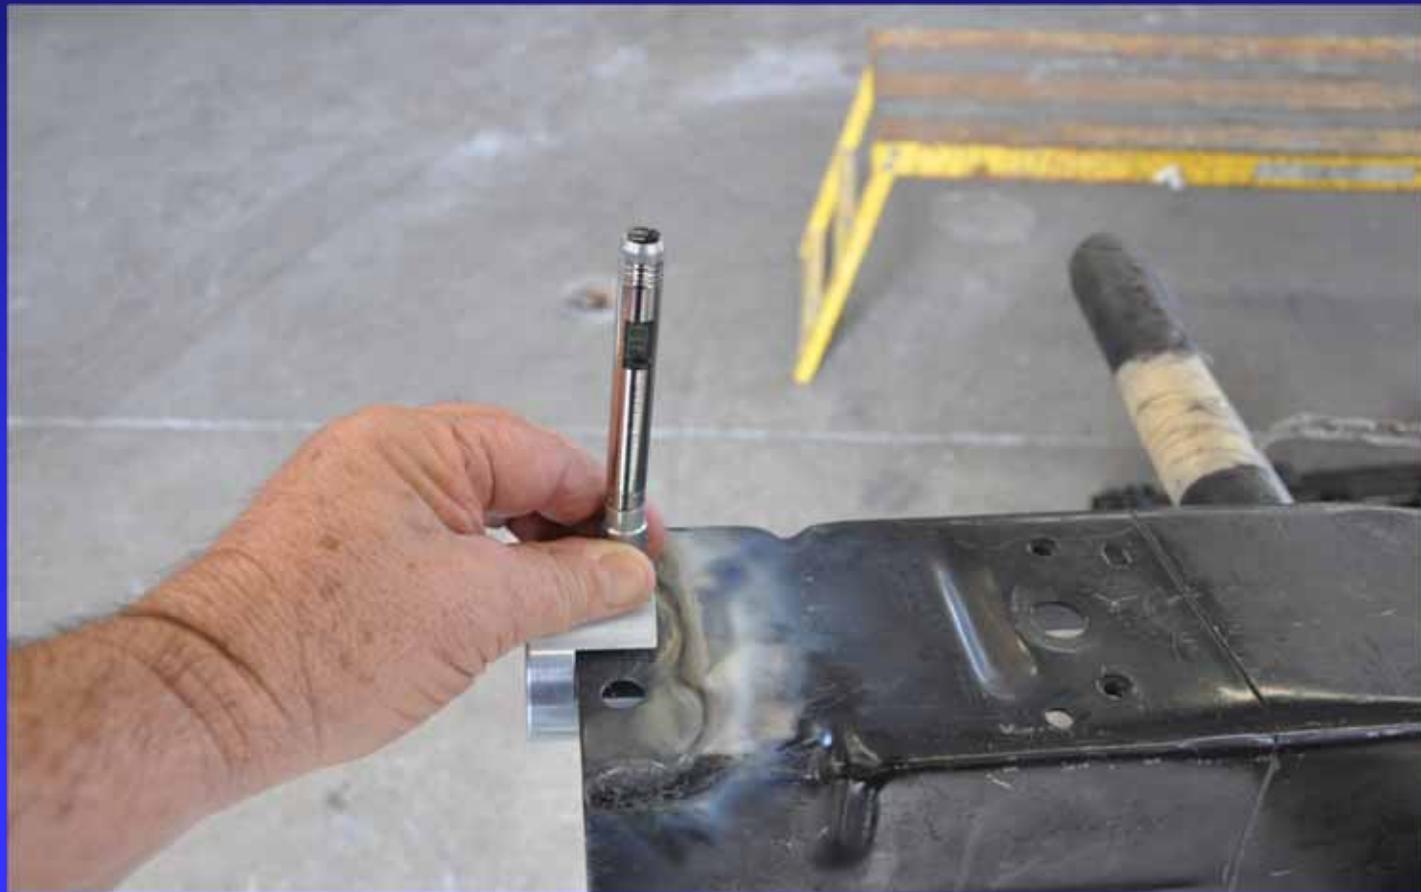
**I retested the strength of the rail after it was heated.**

The results were the heated part of the rail ranged from a low of 230 Mpa's to a high of 320 Mpa's.

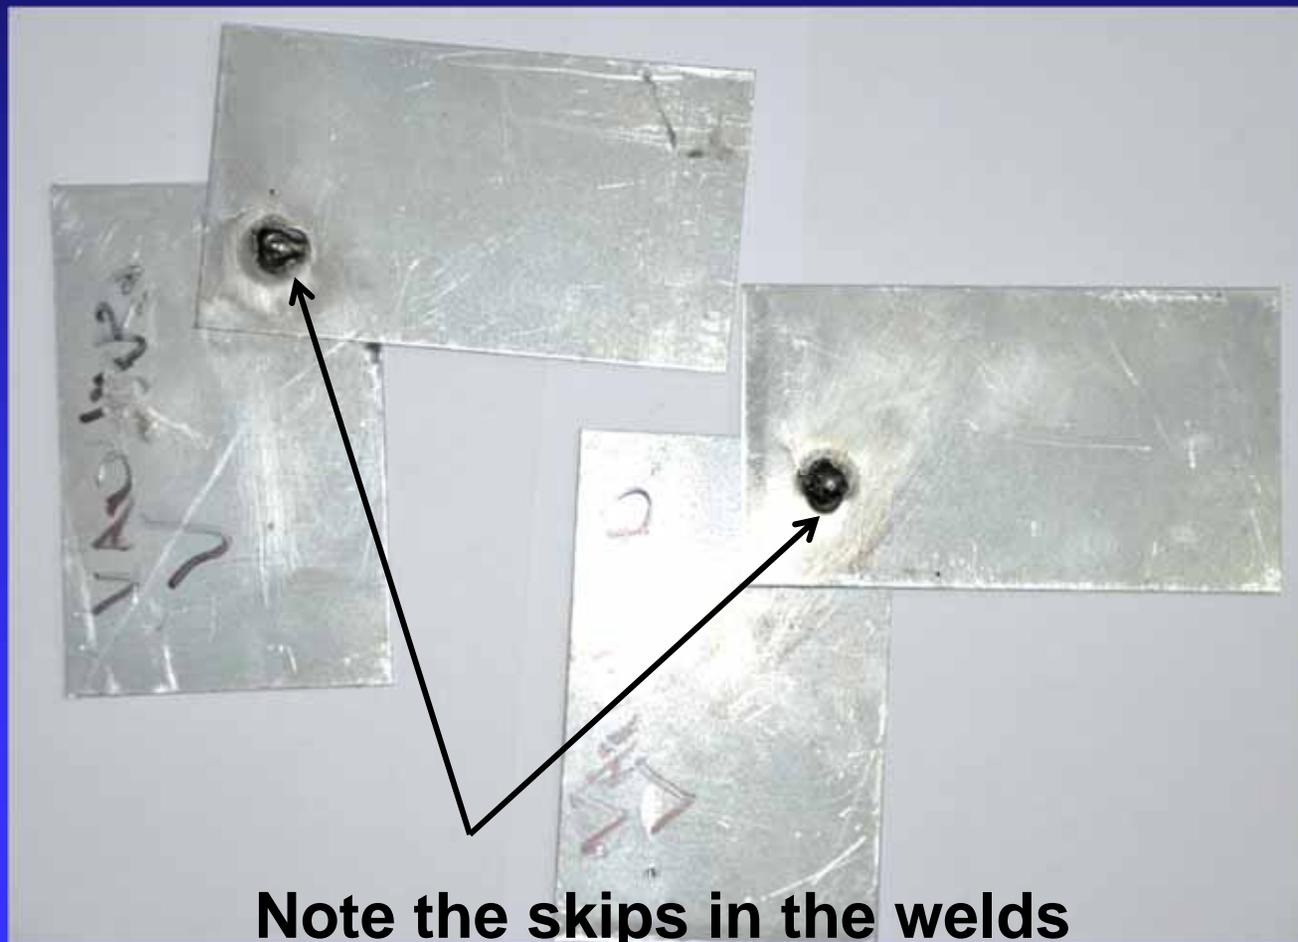
**Note the skips in the welds**

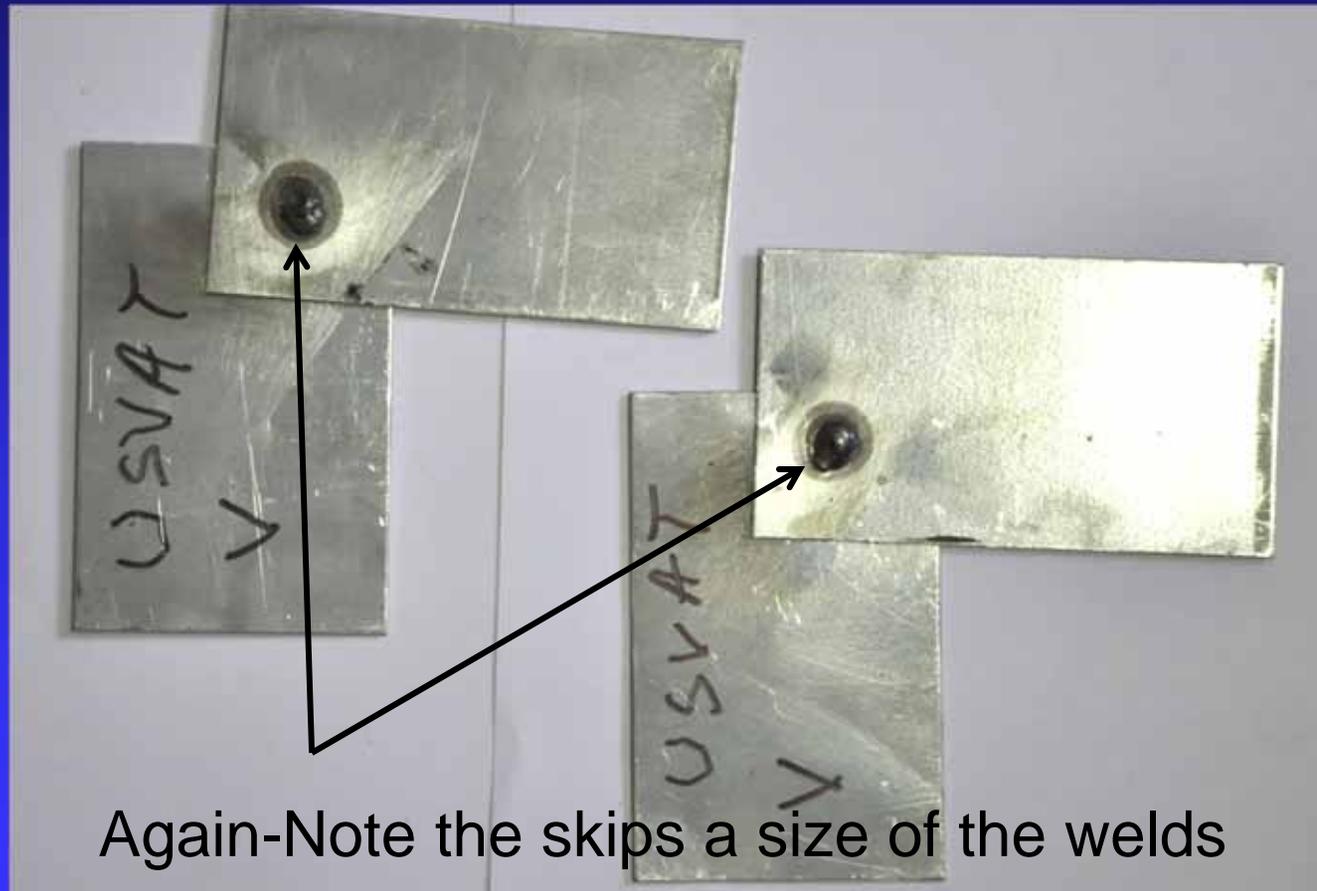
Again-Note the skips a size of the welds

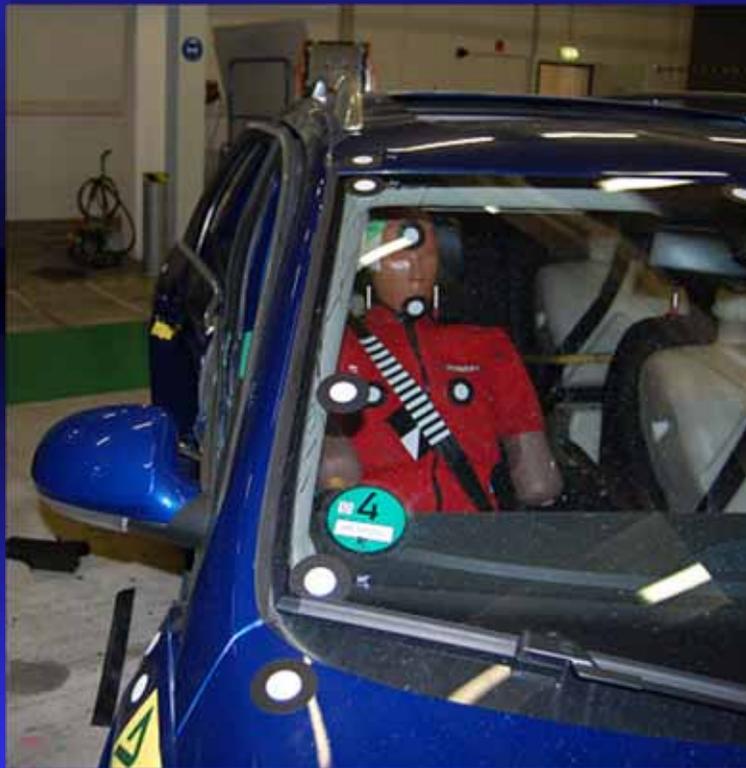
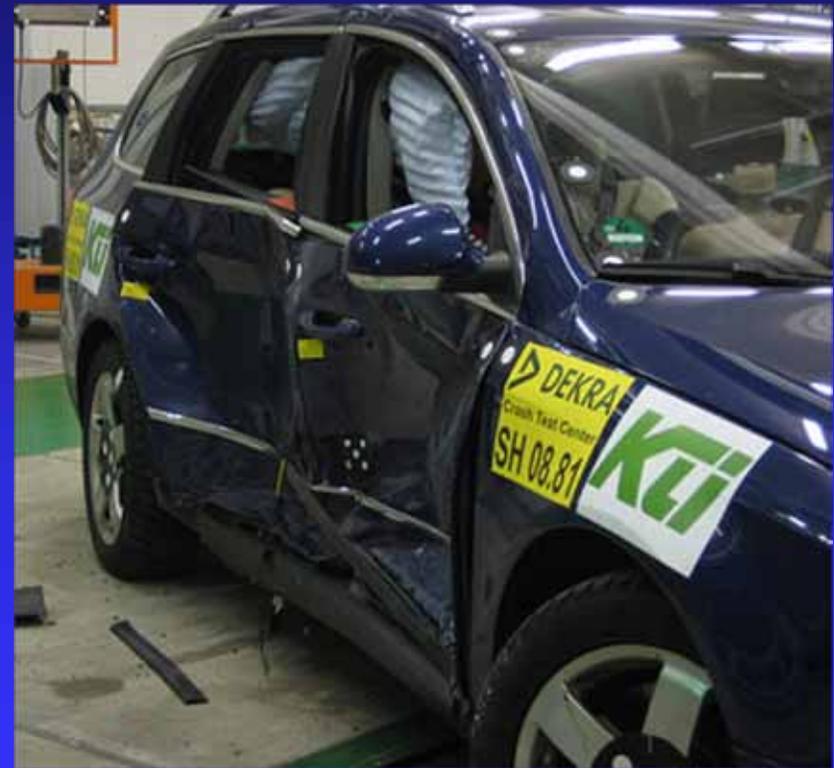
## Vehicle after a 30MPH Crash

**Note: “B” pillar reinforcement & upper door apperature  
Is made ultra high strength steel (1000 MPa)**

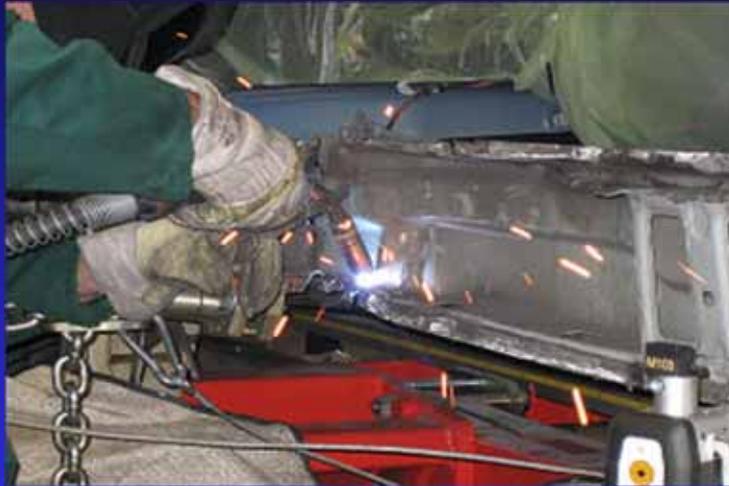
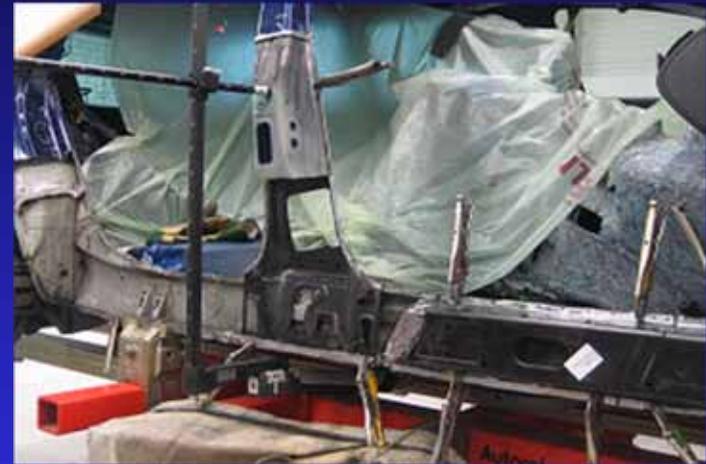
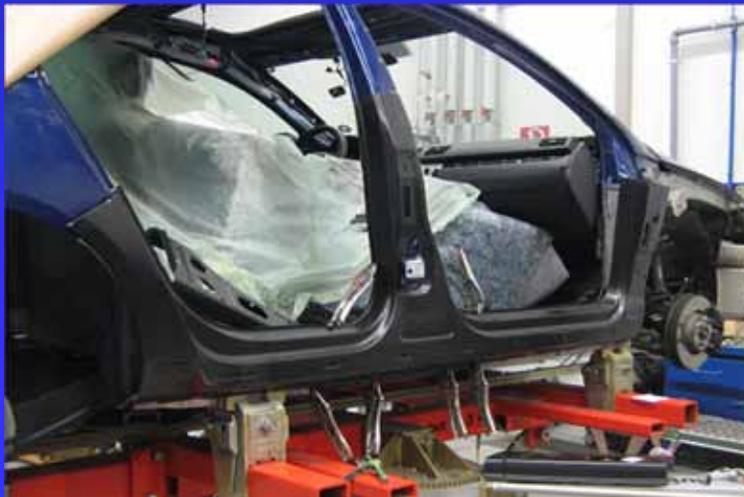
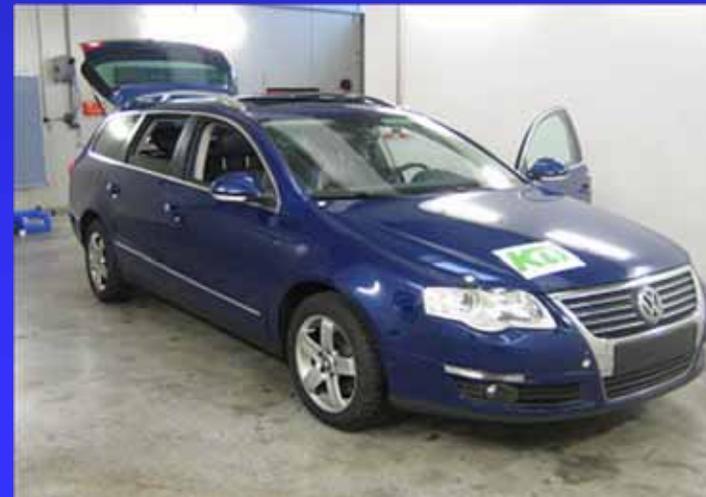
The damaged car was repaired with an older spot welding machine with fixed pressure and 6.4 kA maximum current.

and a variable pressure (maximum 10 bar) to join the high strength steel safely. The deformed inner sill, made from ultra high strength steel, was re-shaped and partially replaced on a bench then re-fitted using a MAG welding process. Figures 6 to 9 show the non professional repair being carried out.

**The vehicle being repaired using older repair methods not approved for this year vehicle.**

Note: The "Professional" repair would include complete renewal of the B-Pillar and other deformed structures with components made from high strength steel. A partial repair of such steels is not acceptable, as the structure and therefore the strength of the material will be severely degraded while welding and reforming.

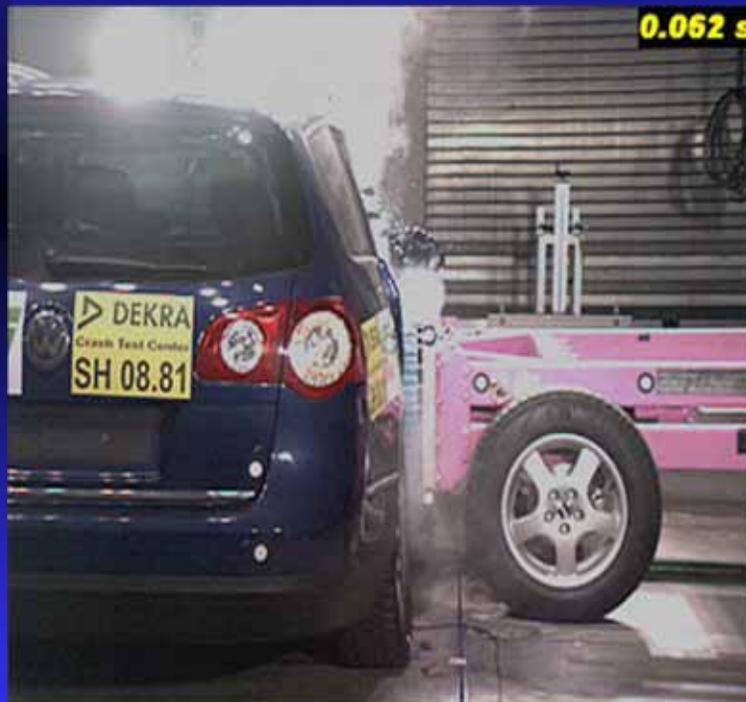
Crash test 1

# Observe the greater of the intrusion in crash test 2.

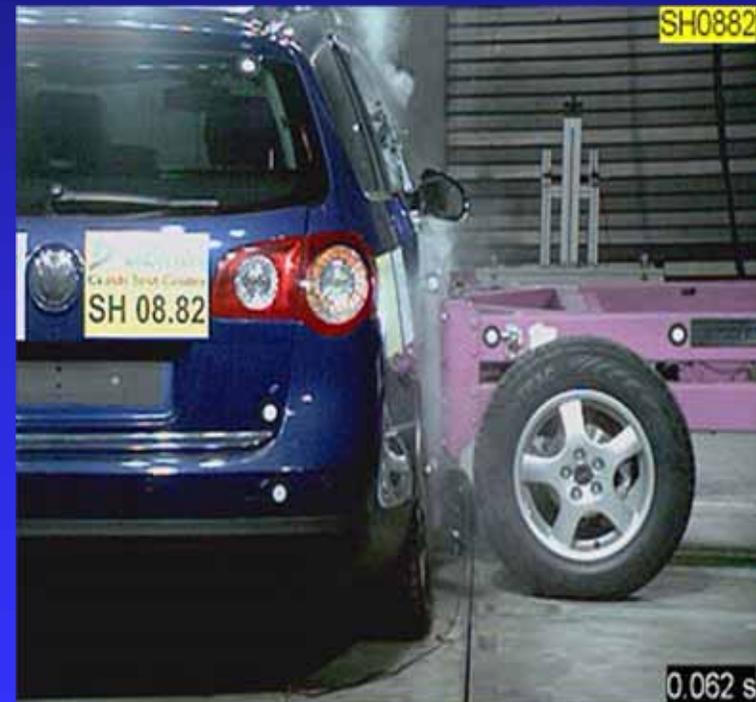
Crash test 2

noticeably higher intrusion into the passenger compartment in comparison with the first crash, especially at the lower part at the connection with the sill (Figures 10 and 11). Note: Later measurement of the car body confirmed there was 60 mm more intrusion after the second test, compared to the first crash. Other differences were noticeable at the cant rail/roof and the transmission tunnel

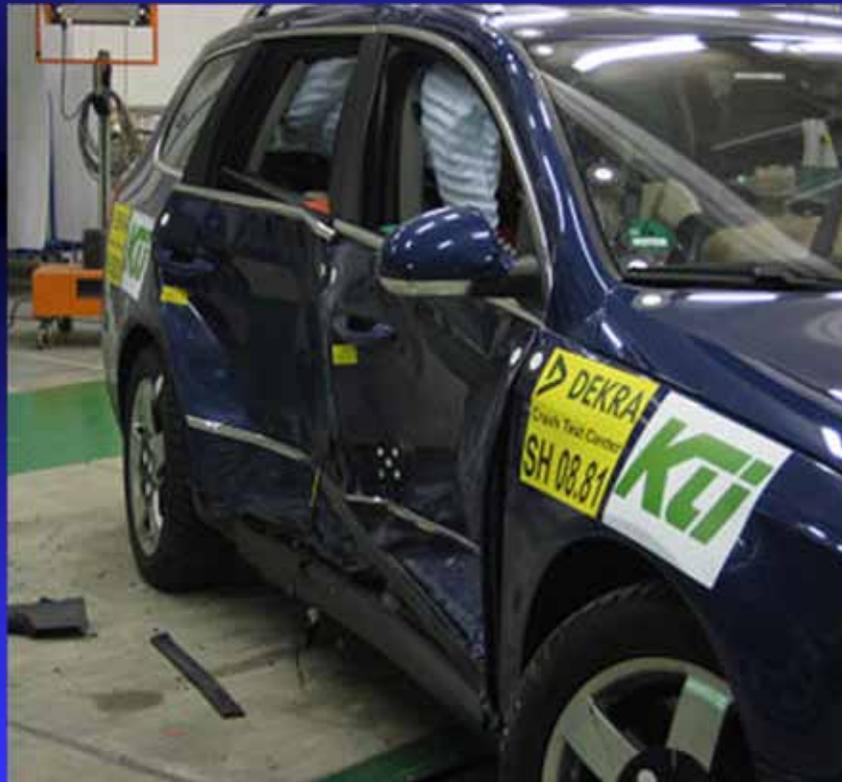
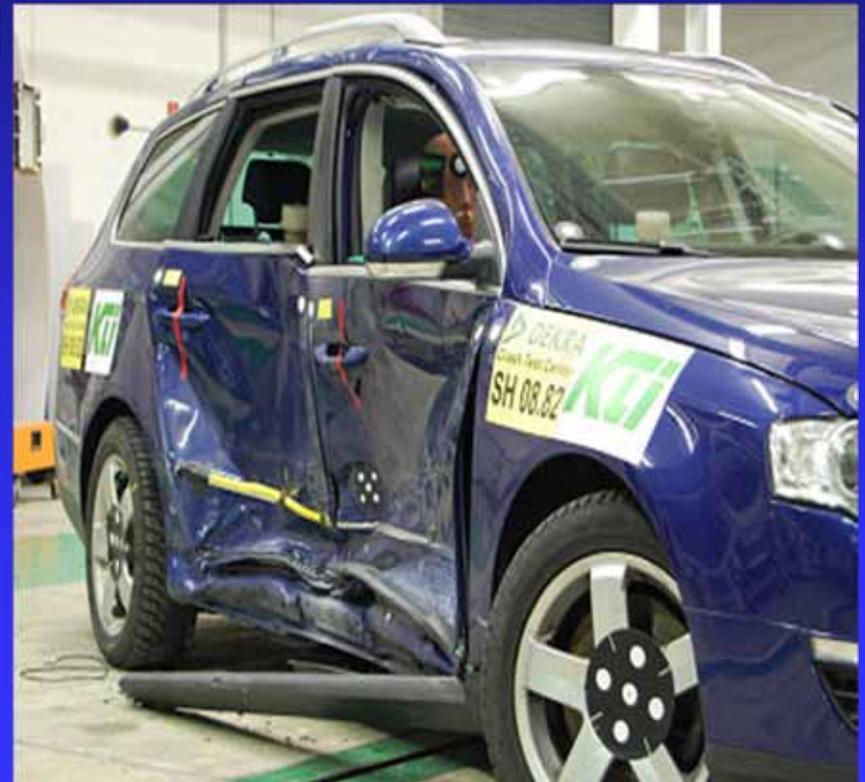
Observe that the side curtain deployed in the crash test 1, but failed in crash test 2.

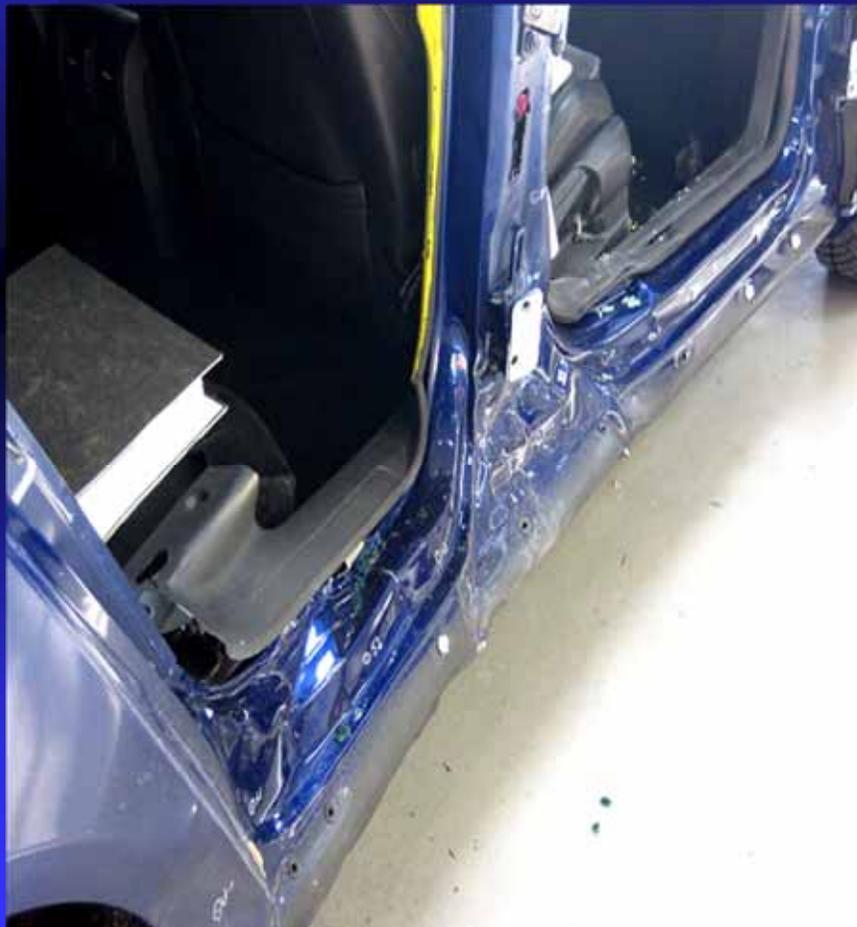
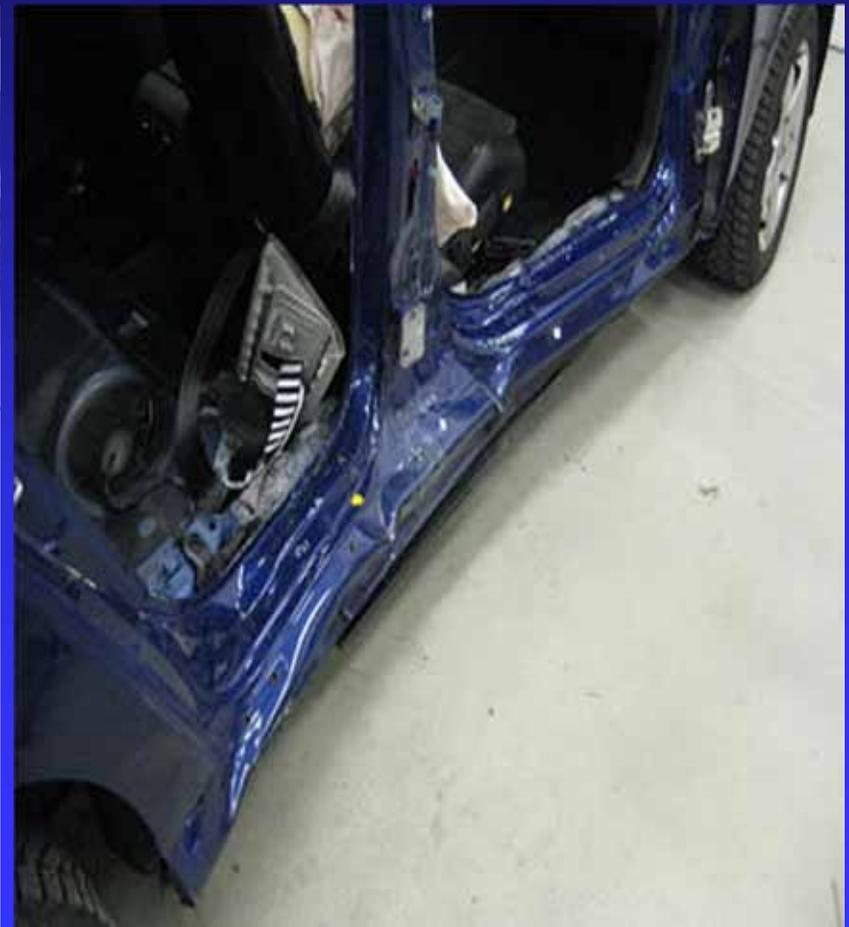
**Observe that the rocker and B pillar has moved further into the vehicle in crash test 2**

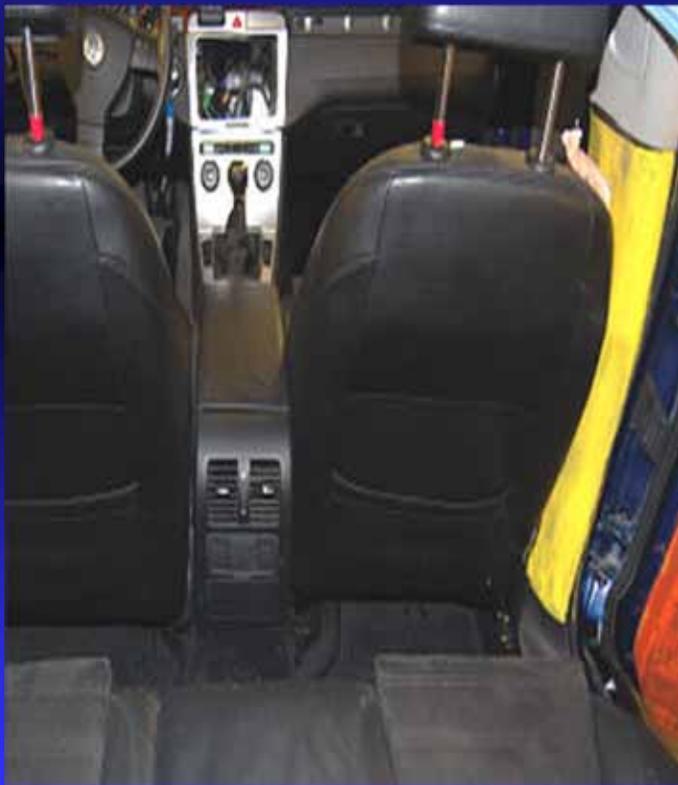
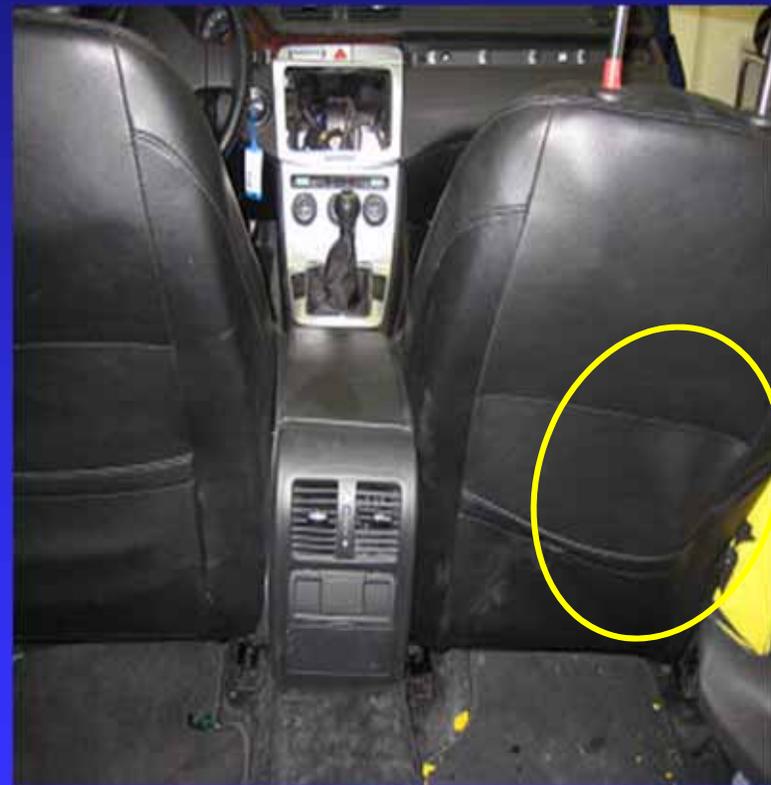
# Observe that damage to the passenger seat in crash test 2

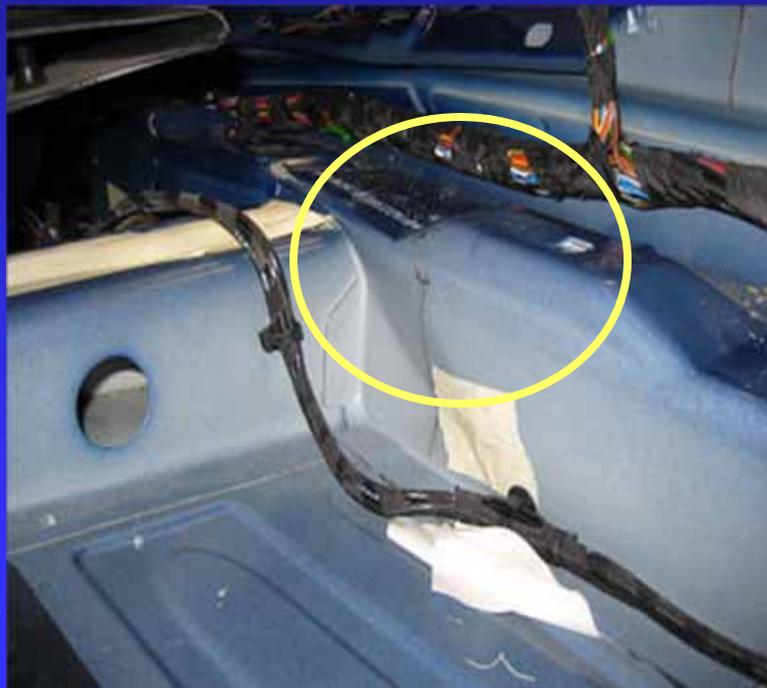
**Crash Test 1**

After removing all the seats and necessary trim the deformation of the transmission tunnel after the second test was clear to see. The cross-member which supported the front seat had pushed into the transmission tunnel, distorting it severely. In comparison, there were no measurable changes at the transmission tunnel during the first crash test.

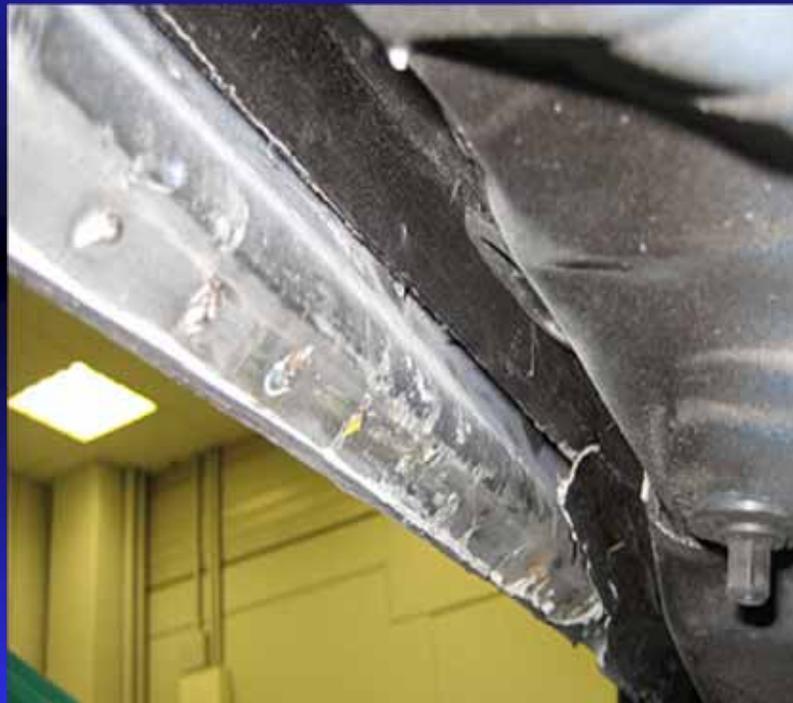
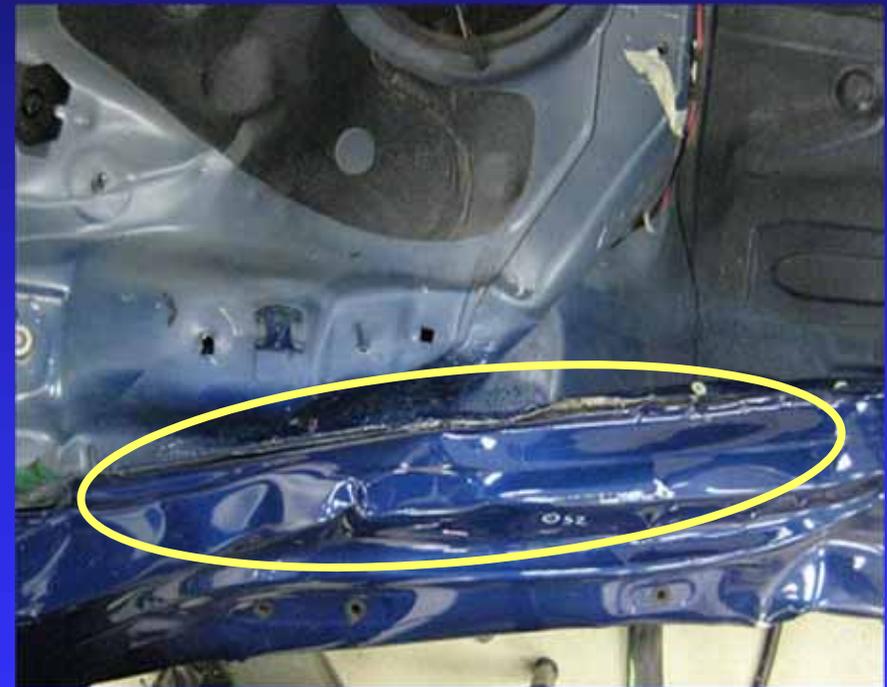
OEM information was not used during the repair after the first crash. These are positions where the inappropriate spot welding machine was used. The disconnection between inner sill and floor panel shows that the spot welds have not withstood the impact and were destroyed. The spot welds need to have a minimum diameter of 4.9 mm at a sheet thickness of 1.5 mm. The optimum would have been 6.7 mm diameter. It is clear that the spot welds were inadequate.

The connection of the B-pillar with the inner sill was joined with MAG welding. The structure of the high-strength steel parts was changed by the welding process and re-shaping. The welded seam was totally broken after the second crash, being unable to withstand the stress and the distortion.

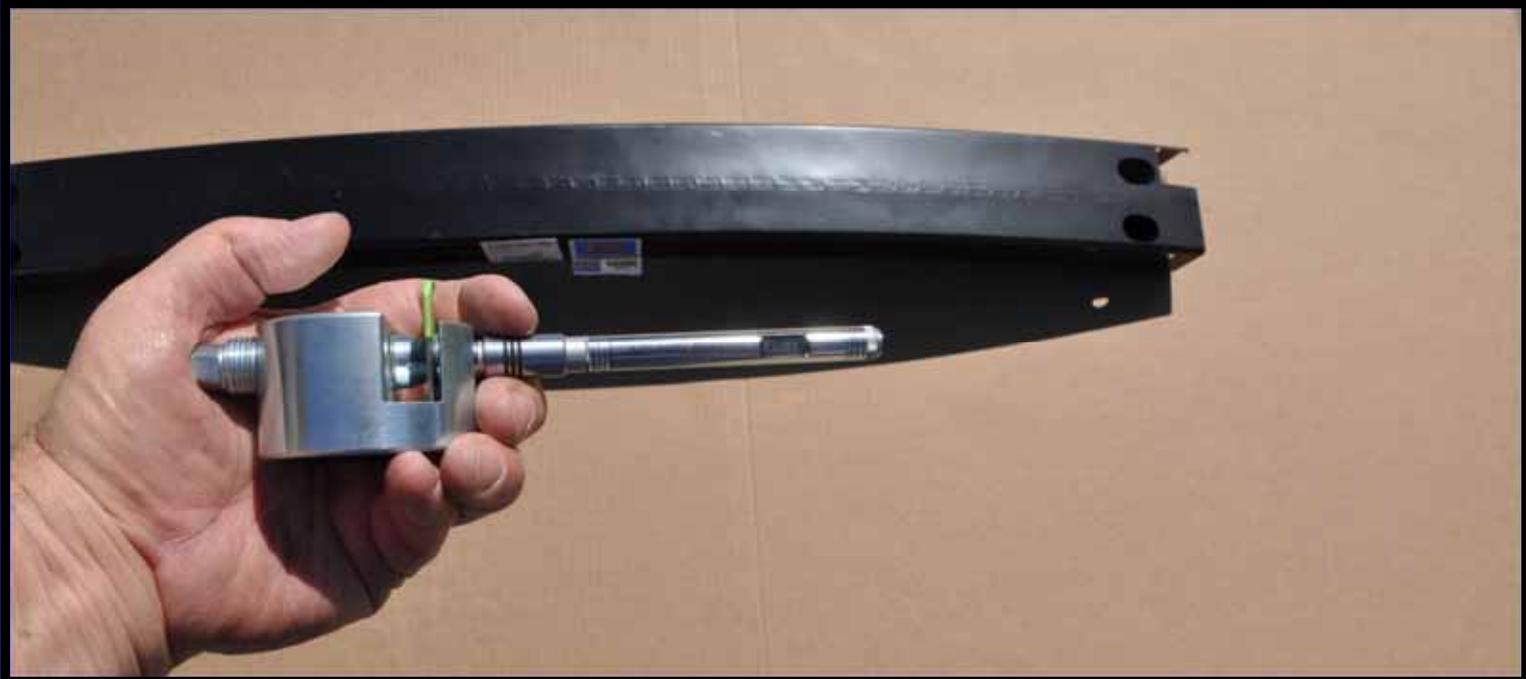
The analyzer reading is 35.1 or UHSS
