# Estimating Today's Vehicles

Technical Committee  
July 21, 2011  
Salt Lake City, Utah

## A 2010 Toyota Xb with Damage to the Driver's Side

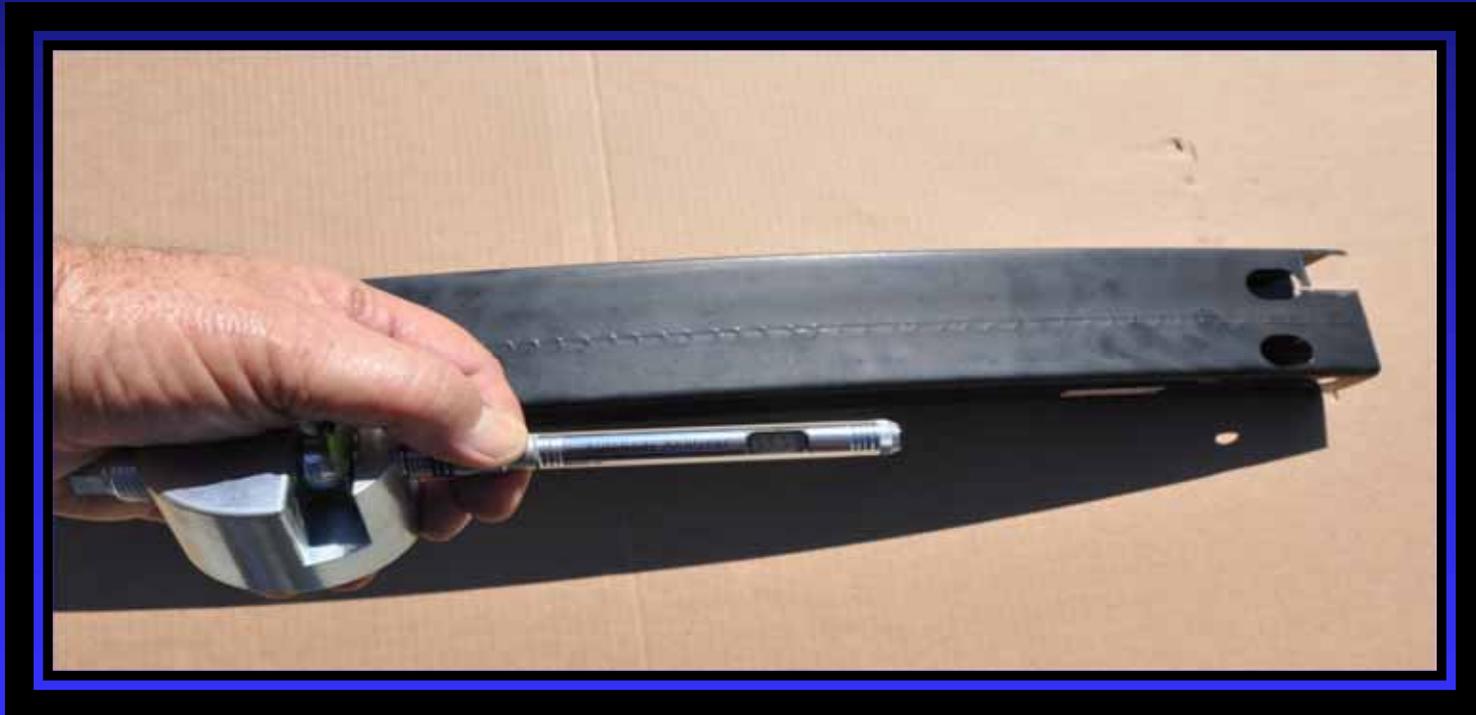
The analyzer reading is 50.1 or UHSS

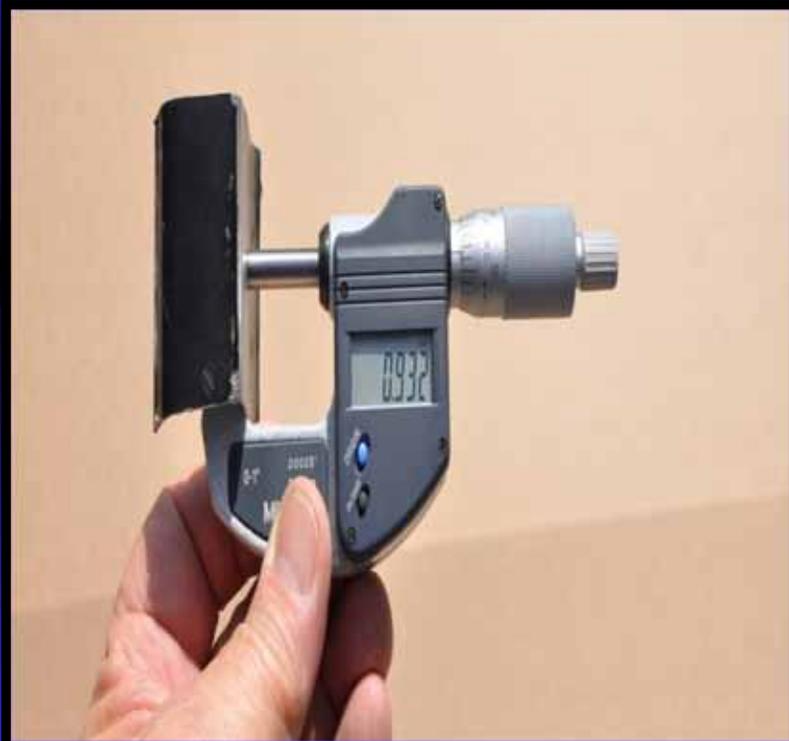
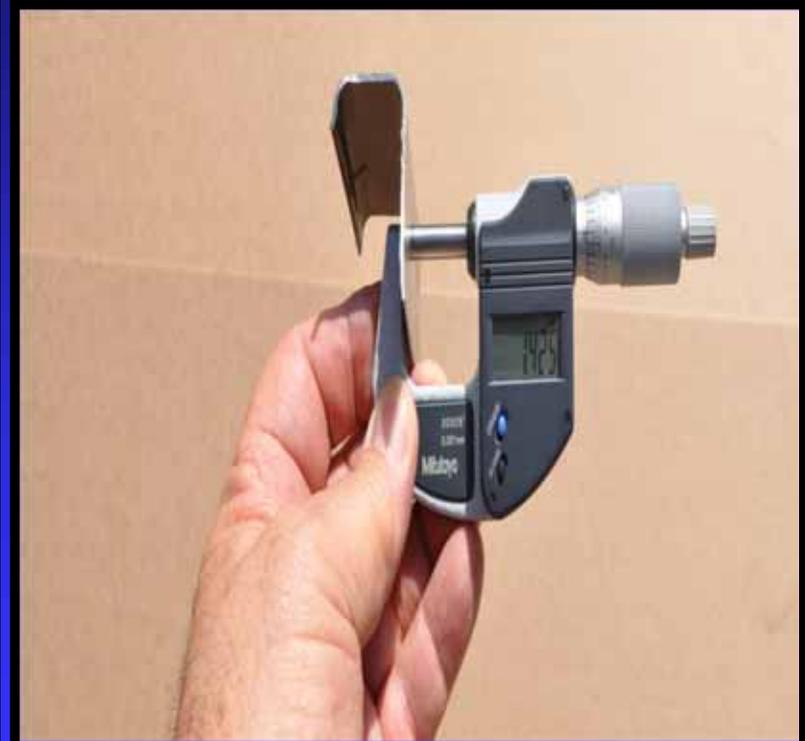
# Testing the metal thickness of Aftermarket & OEM Bumper Reinforcement.

A/M .93mm

OEM 1.42mm

**Question: Like, Kind & Quality?**

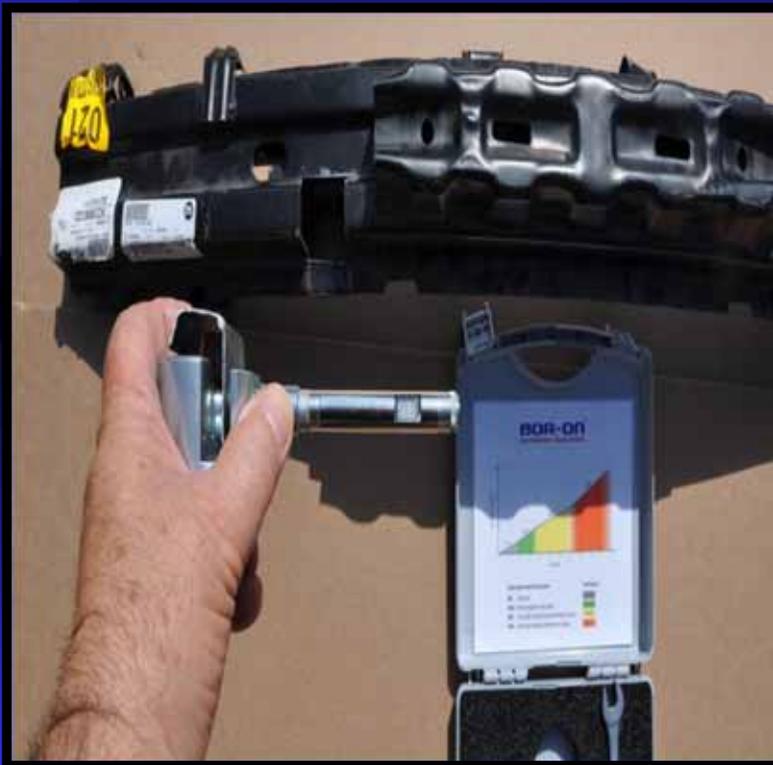
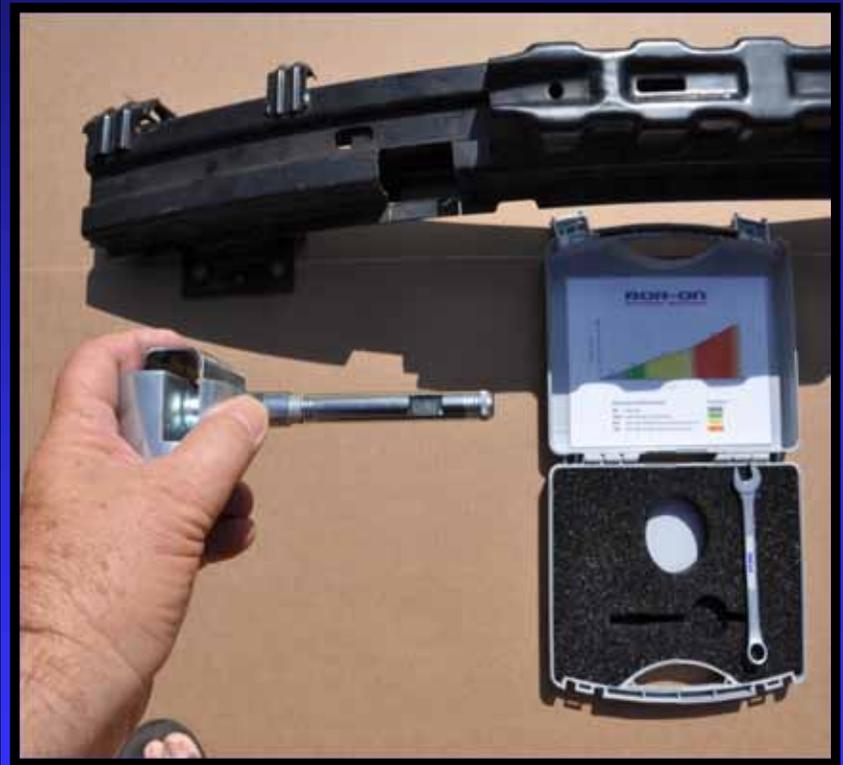
# Testing the hardness of the A/M & OEM Bumper Reinforcements

A/M 27.7

OEM 40.7

Again, I ask the Question: Like, Kind & Quality?
