Estimating Today's Vehicles

Technical Committee
July 21, 2011
Salt Lake City, Utah

A 2010 Toyota Xb with Damage to the Driver's Side

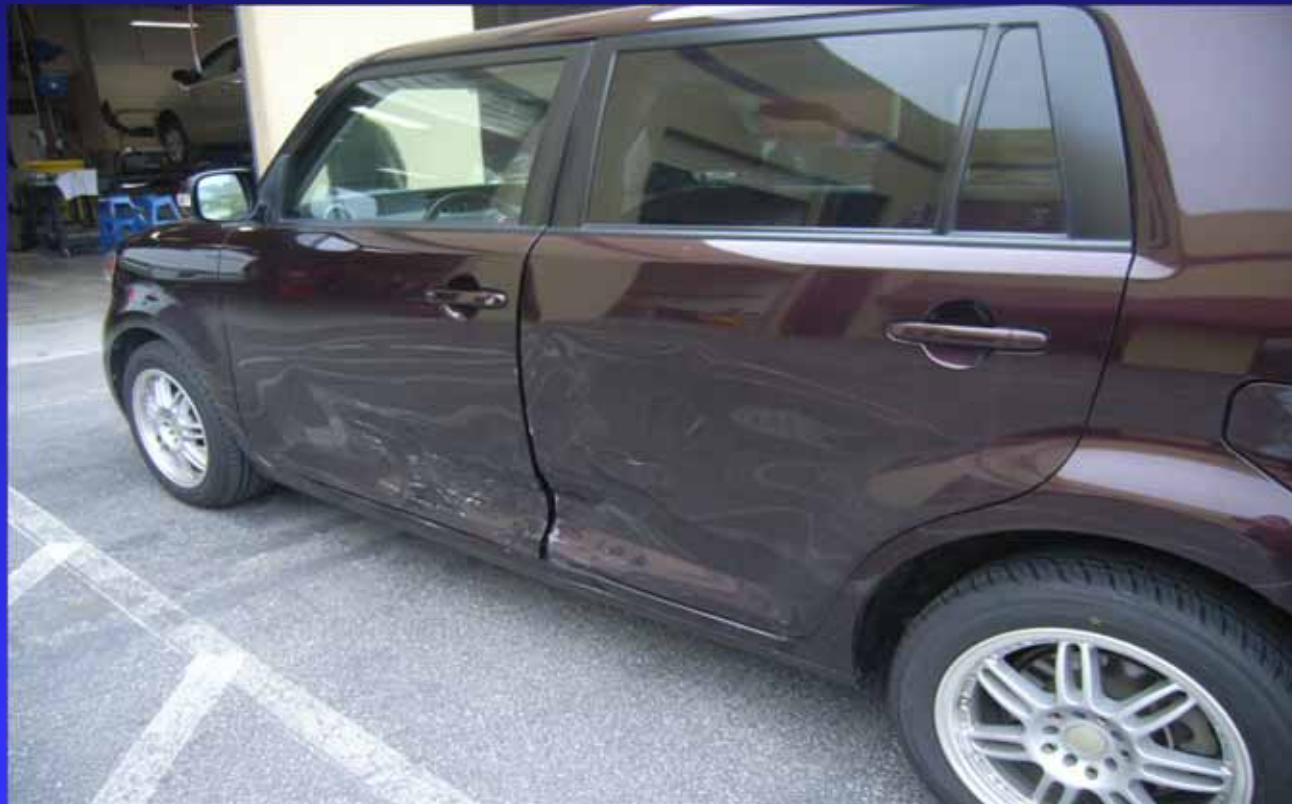
There is damage to the rocker & outer "B" pillar-lower section

- Set up frame machine & measure
- Replace Left FT Door
- Replace Left RR Door
- Pull Rocker to for repair
- Pull Center Post for repair
- Repair Rocker after pull
- Repair Center Post after Pull
- Replace Corrosion Protection
- Replace left quarter panel

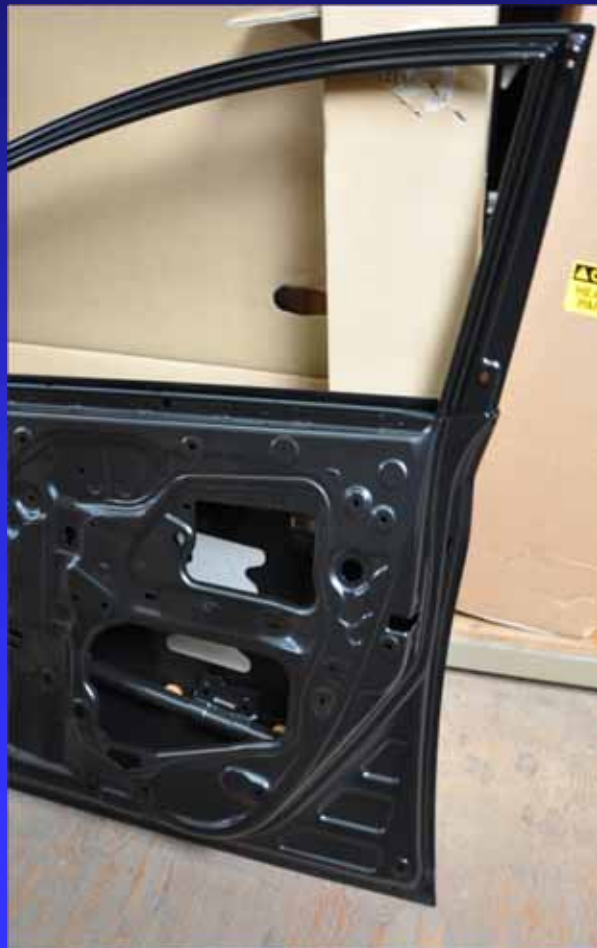
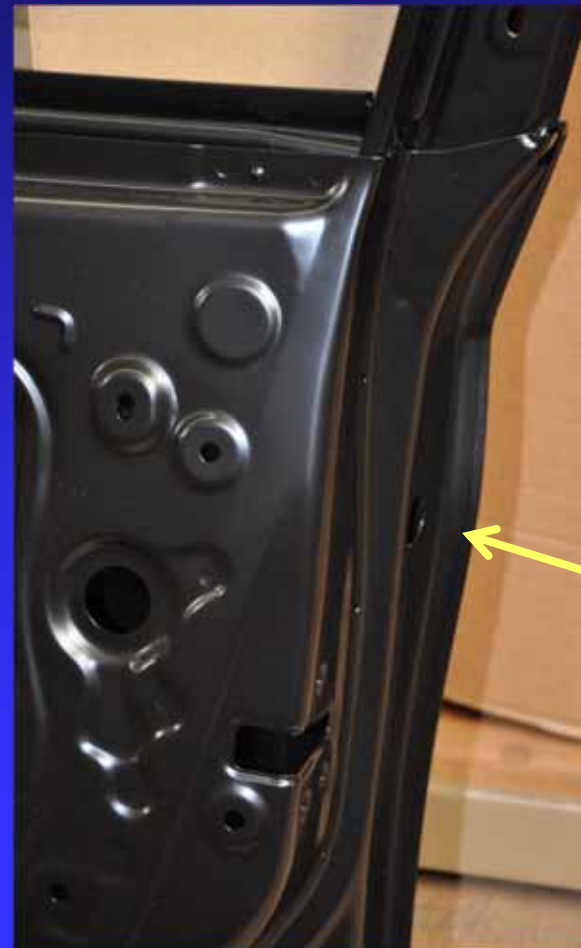
New Toyota Door Shell Detailing the lack of Seam Sealer on the hem.

Hem w/o
Seam sealer

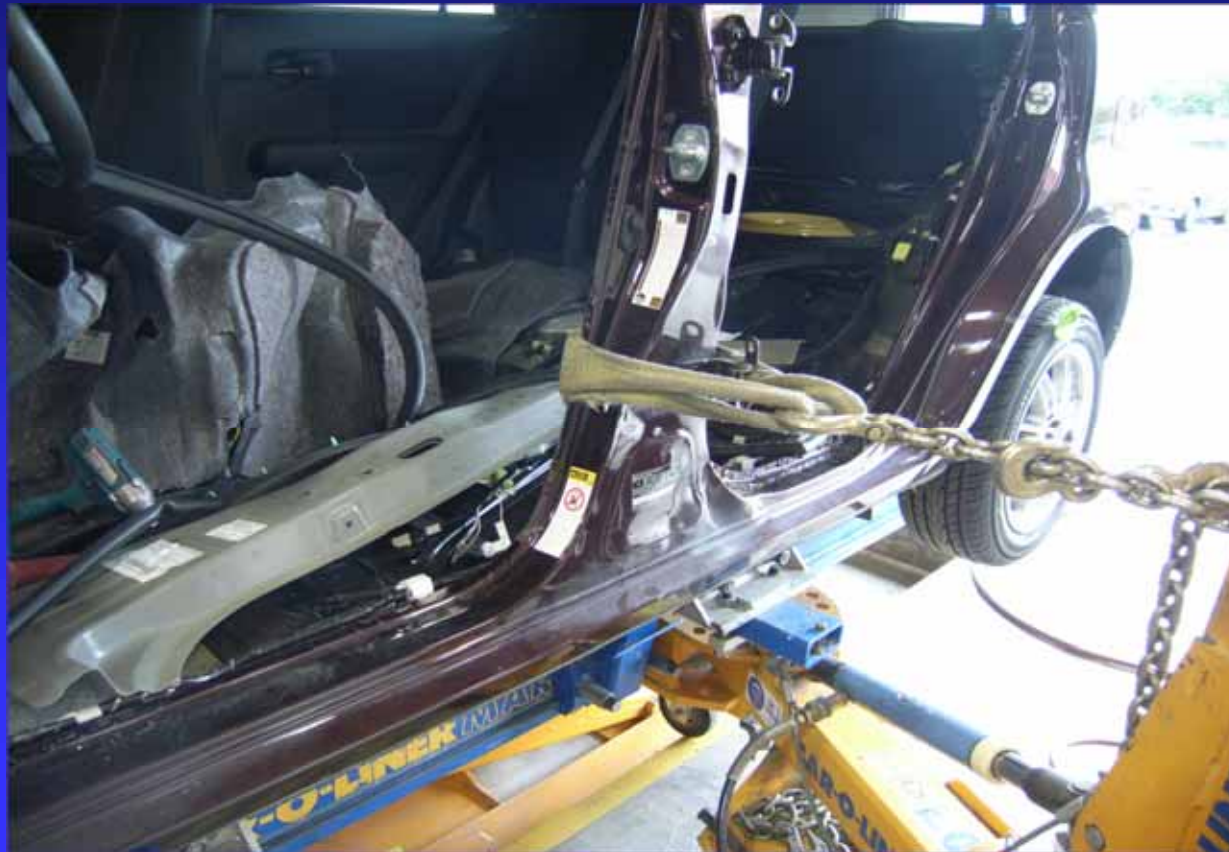
After reviewing the CRIB, pulling for repairs is out of the question. You can pull for replacement only.

- Set up frame machine & measure
- Replace Left FT Door
- Replace Left RR Door
- Pull Rocker for repair
- Pull Center Post for repair
- Repair Rocker after pull
- Repair Center Post after Pull
- Replace Corrosion Protection
- Pull Center Post for Replacement
- Pull Rocker for Replacement
- Replace Center Post & Rocker

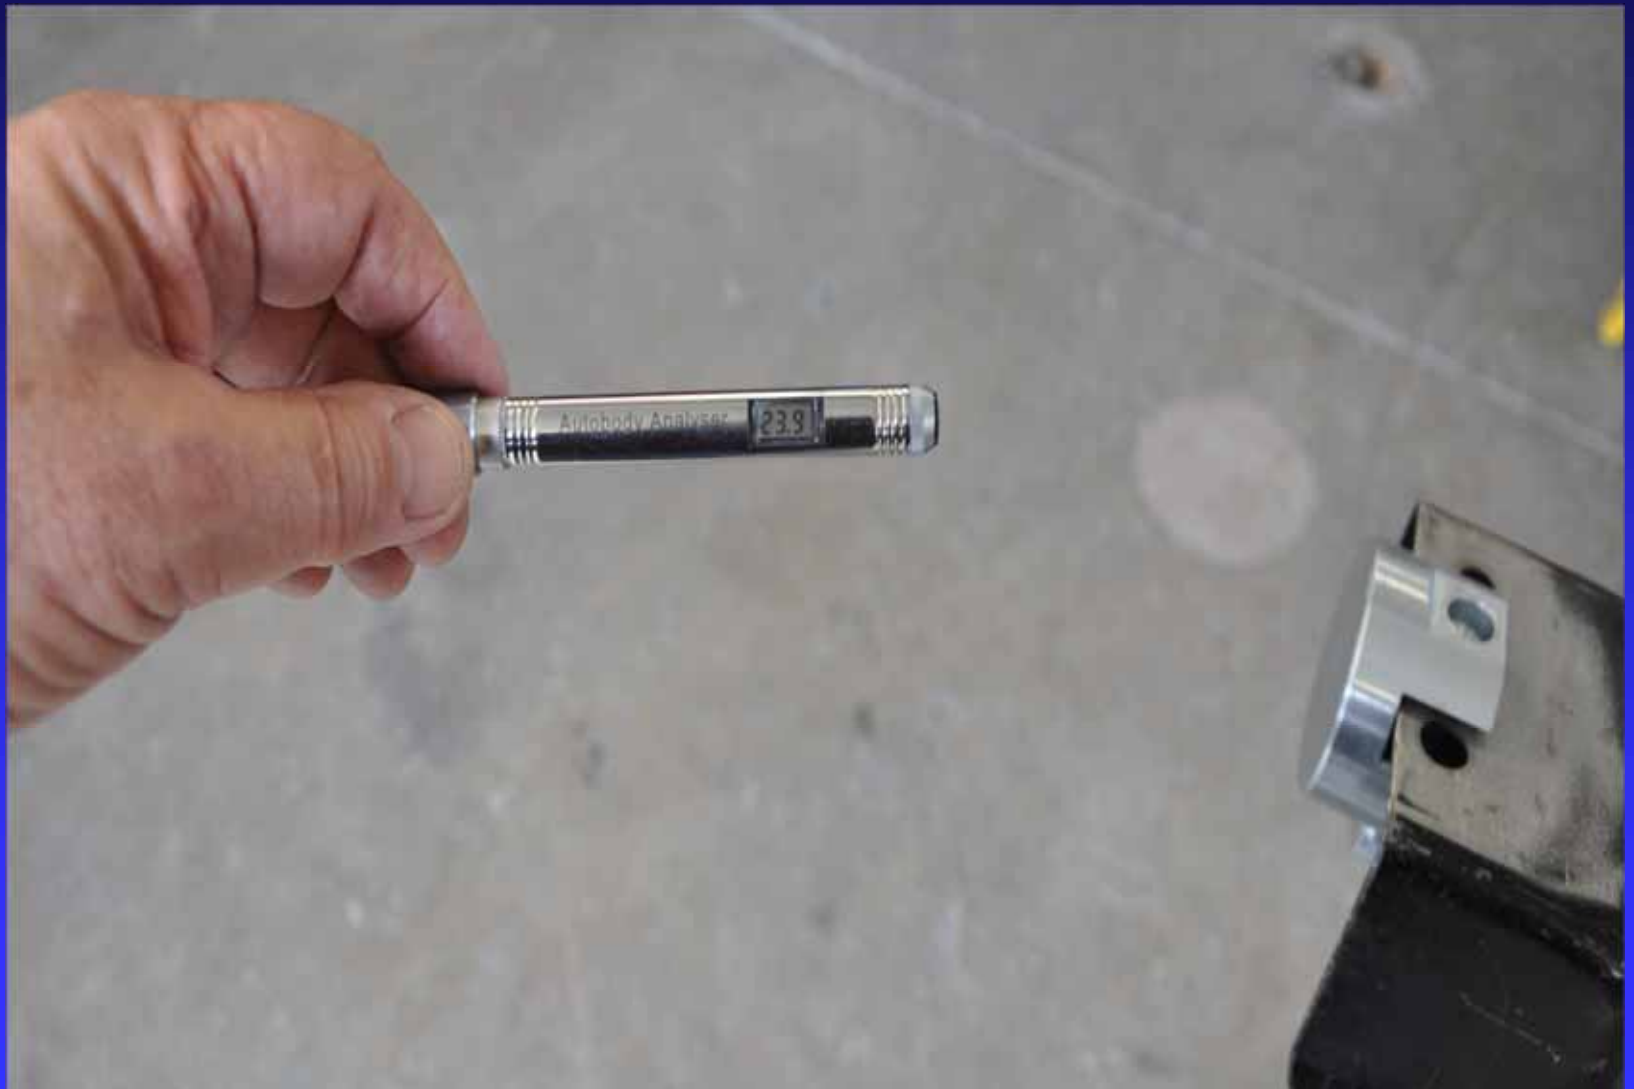
The strength of the front Toyota Camry rail is 450 MPas

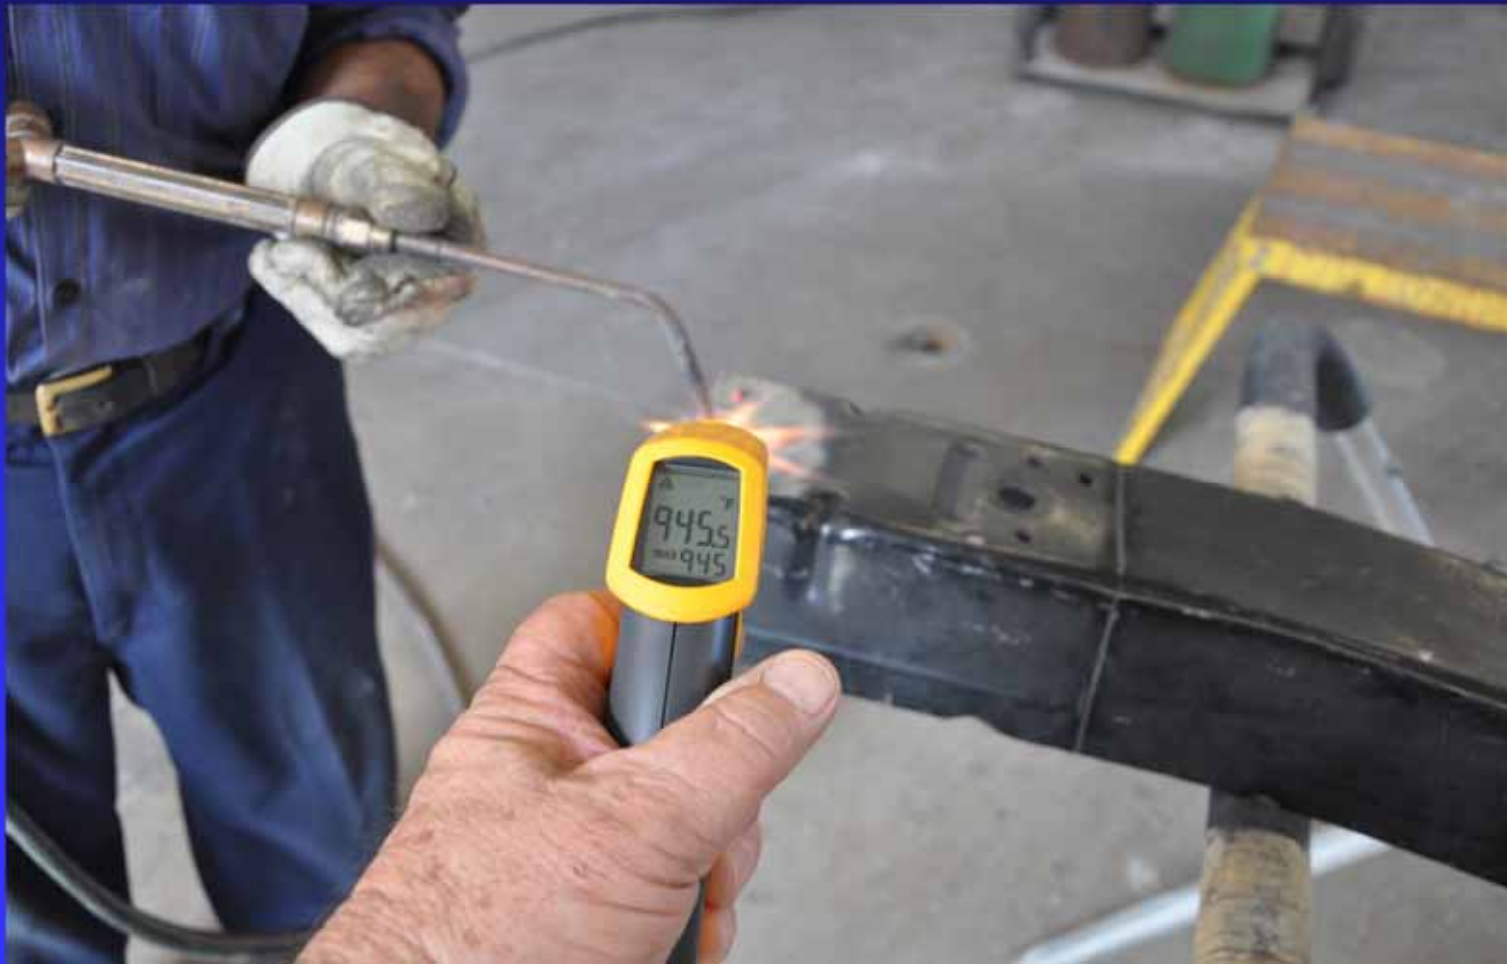
Next I heated the rail to approximately 1000 degree Fahrenheit.

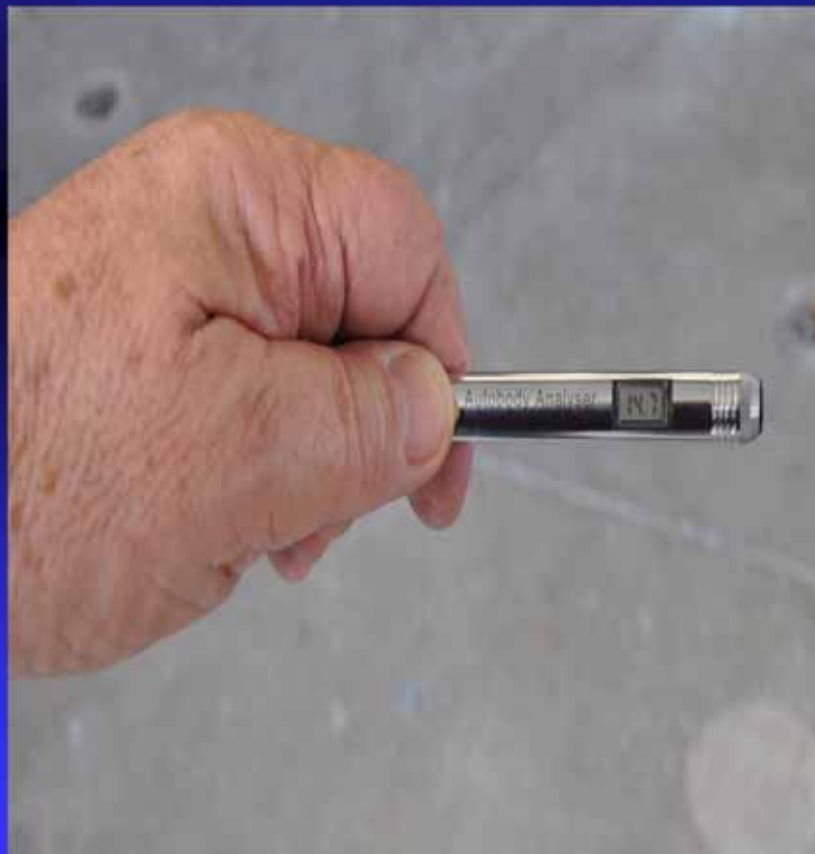
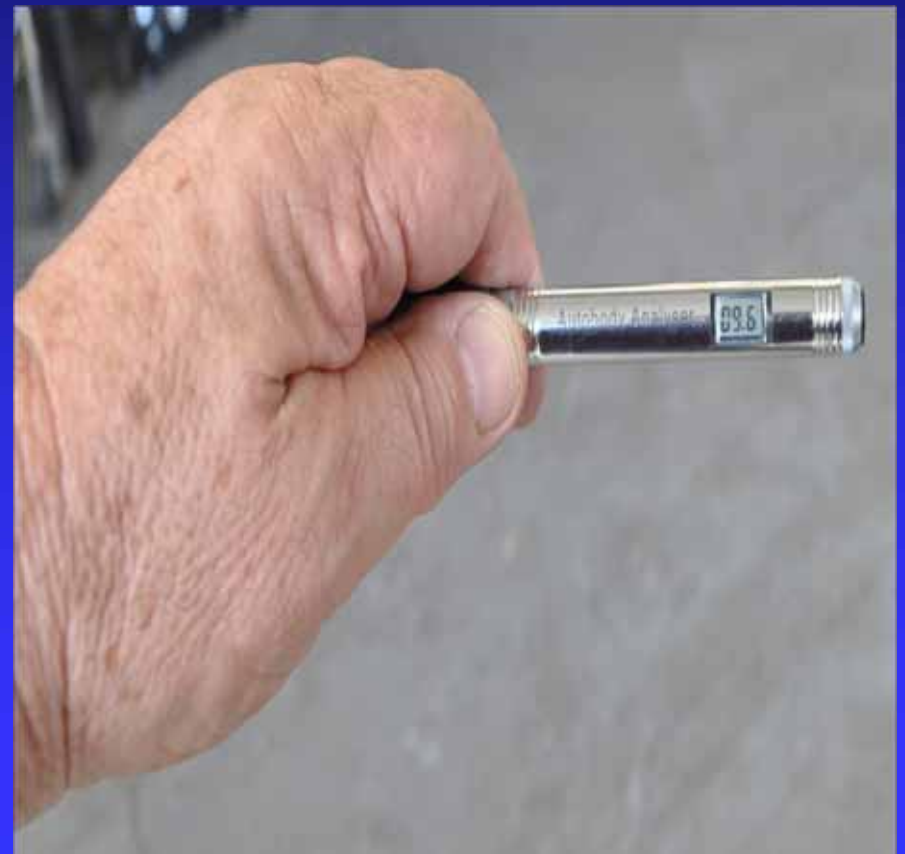
I retested the strength of the rail after it was heated.

The results were the heated part of the rail ranged from a low of 230 Mpa's to a high of 320 Mpa's.

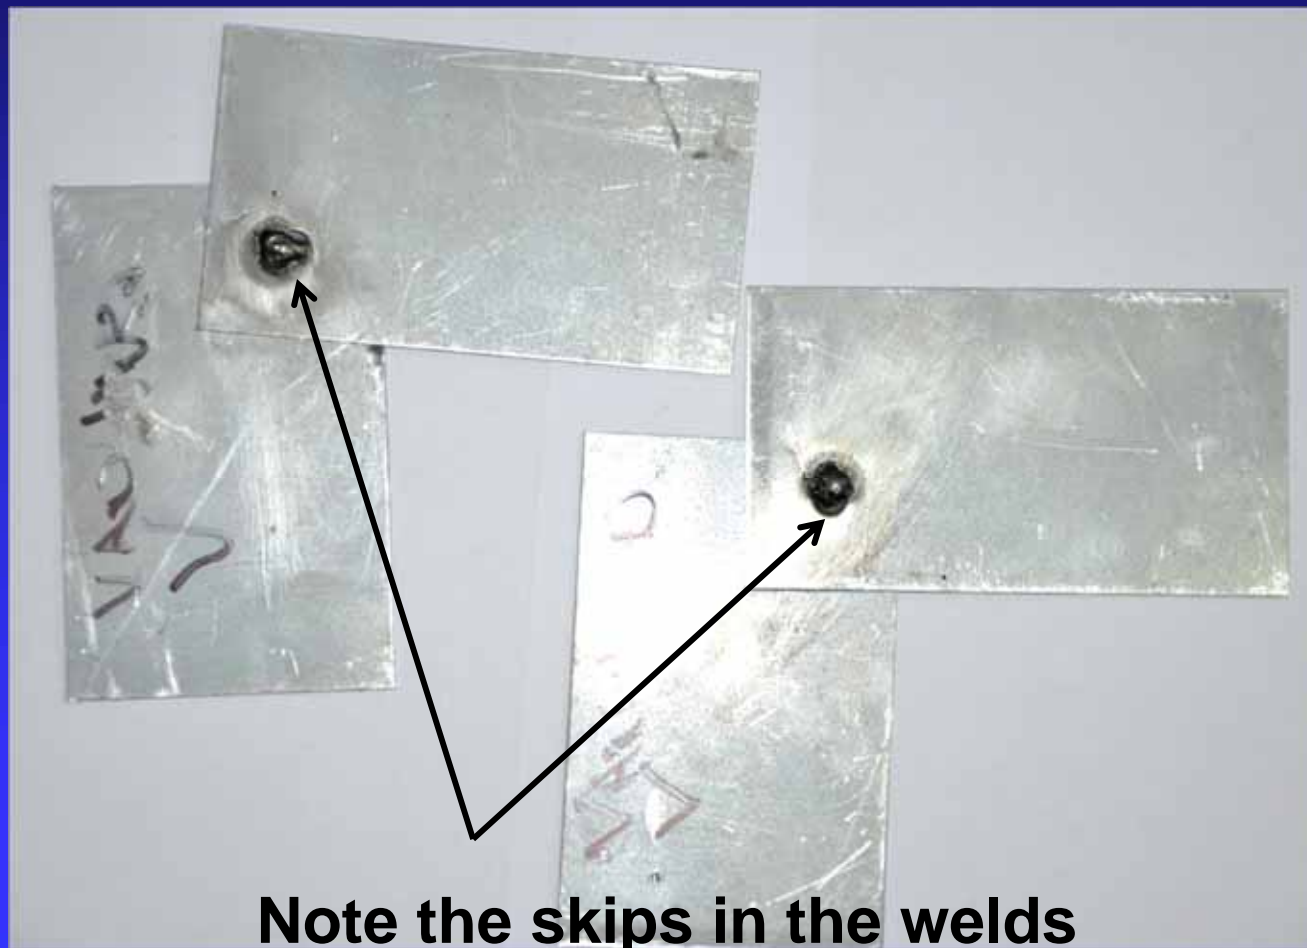
Plug Welds prior to taking the I-CAR Mig Qualification Tests

Note the skips in the welds

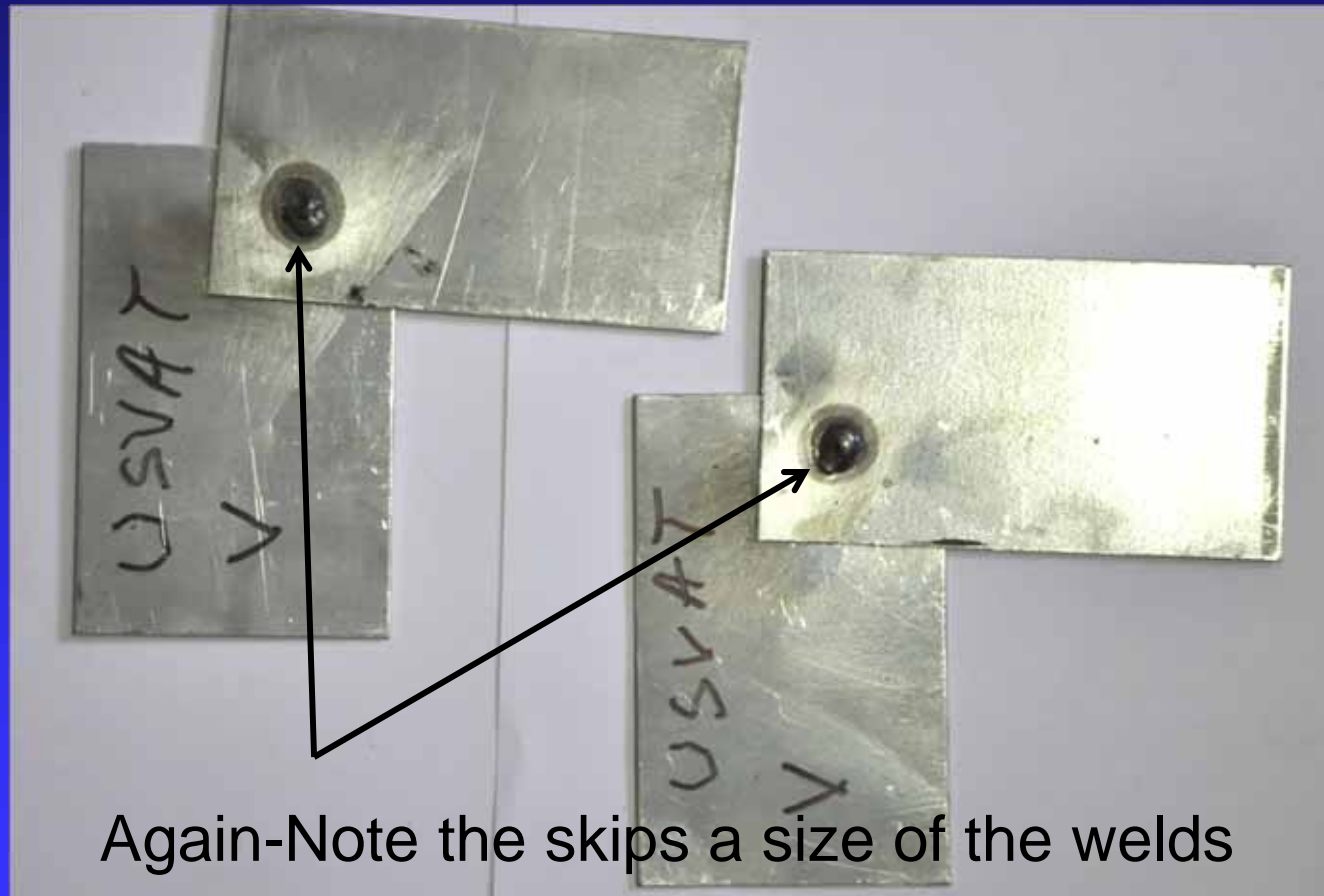
Plug Welds prior to taking the I-CAR Mig Qualification Tests

Again-Note the skips a size of the welds

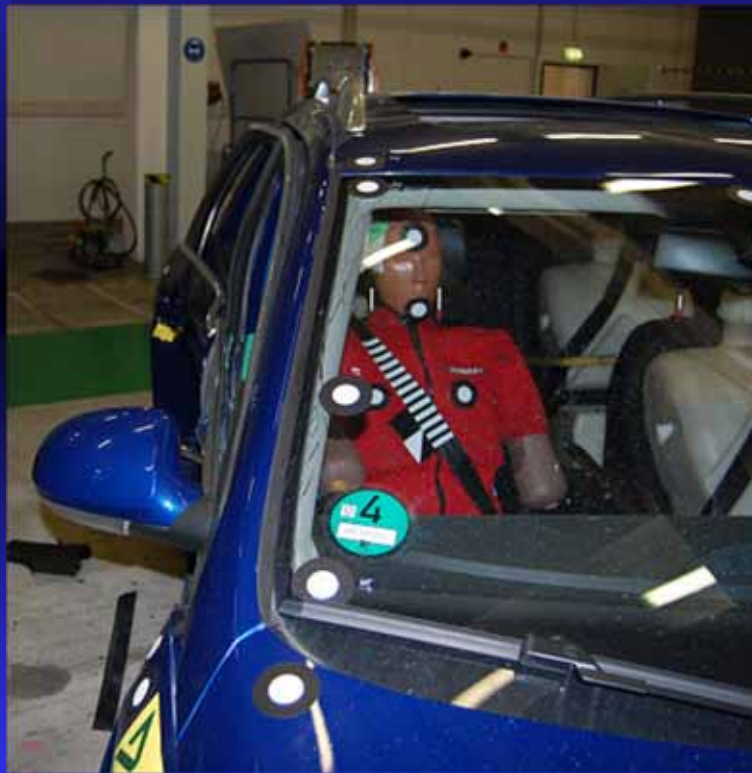
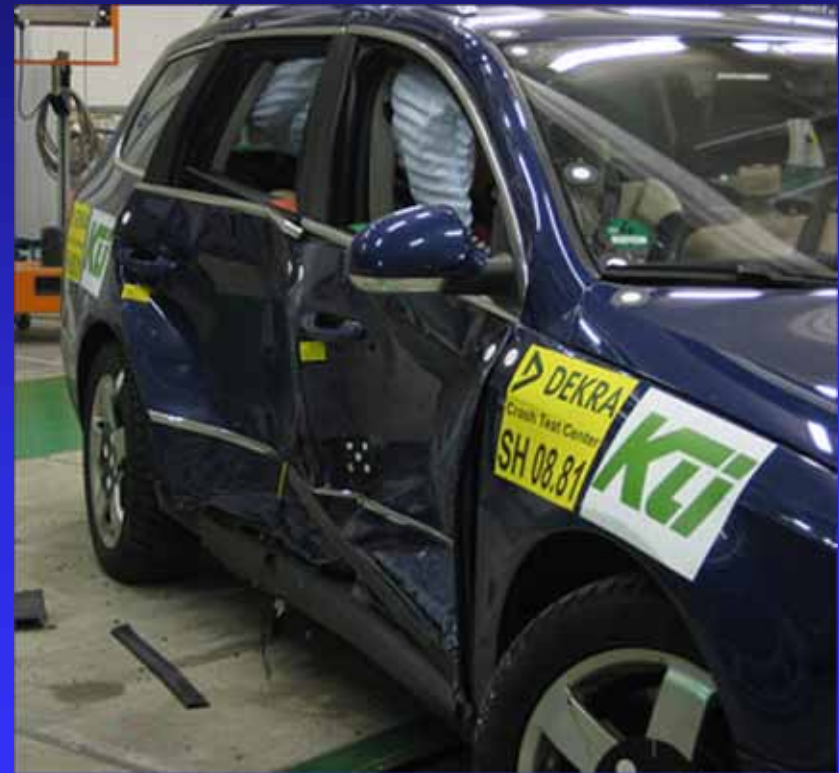
Vehicle after a 30MPH Crash

**Note: “B” pillar reinforcement & upper door apperture
Is made ultra high strength steel (1000 MPa)**

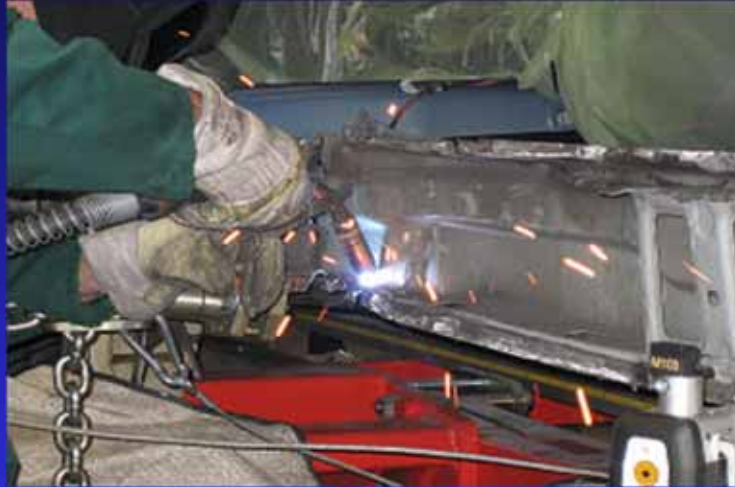
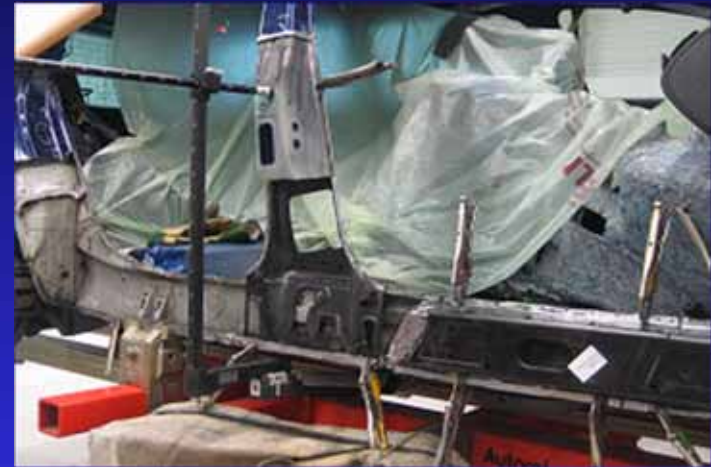
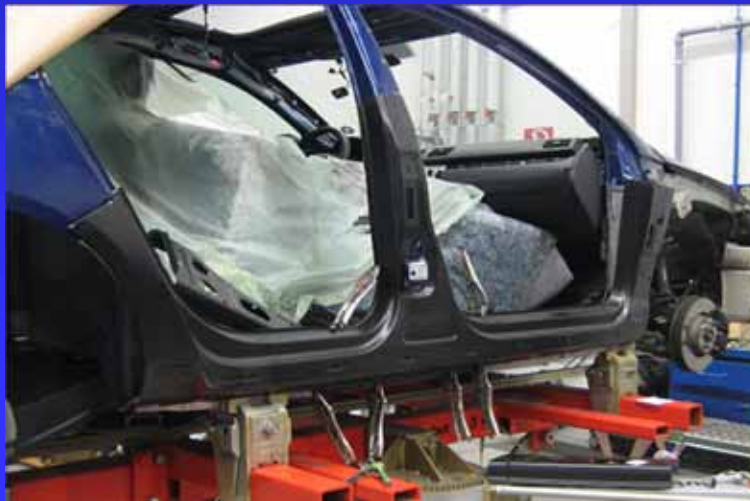
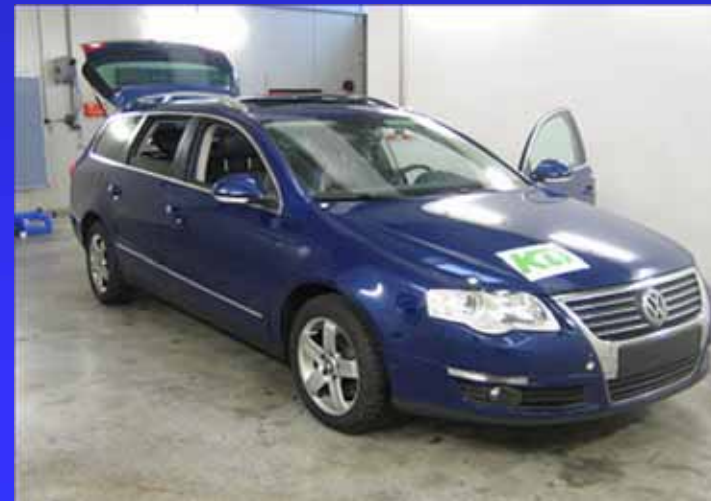
The damaged car was repaired with an older spot welding machine with fixed pressure and 6.4 kA maximum current.

and a variable pressure (maximum 10 bar) to join the high strength steel safely. The deformed inner sill, made from ultra high strength steel, was re-shaped and partially replaced on a bench then re-fitted using a MAG welding process. Figures 6 to 9 show the non professional repair being carried out.

The vehicle being repaired using older repair methods not approved for this year vehicle.

Note: The "Professional" repair would include complete renewal of the B-Pillar and other deformed structures with components made from high strength steel. A partial repair of such steels is not acceptable, as the structure and therefore the strength of the material will be severely degraded while welding and reforming.

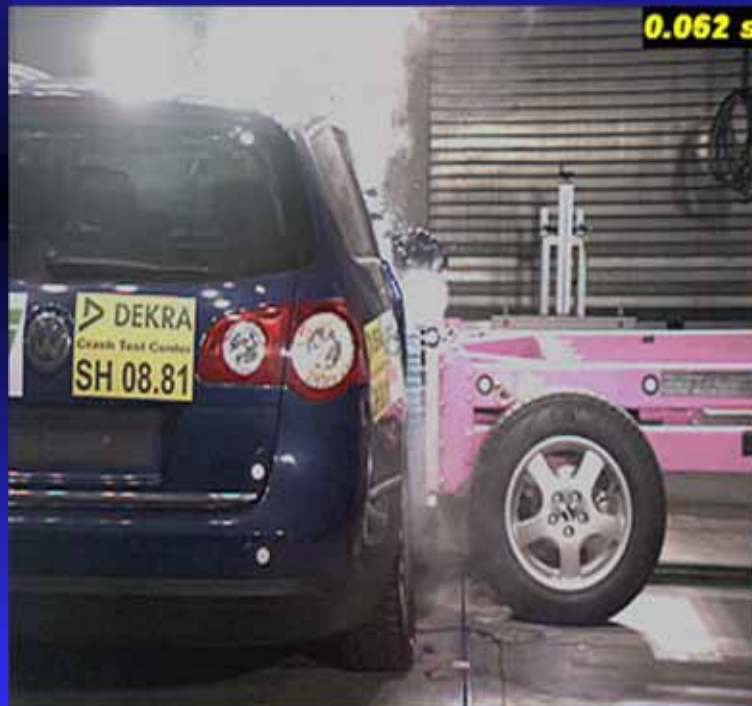
Crash test 1

Observe the greater of the intrusion in crash test 2.

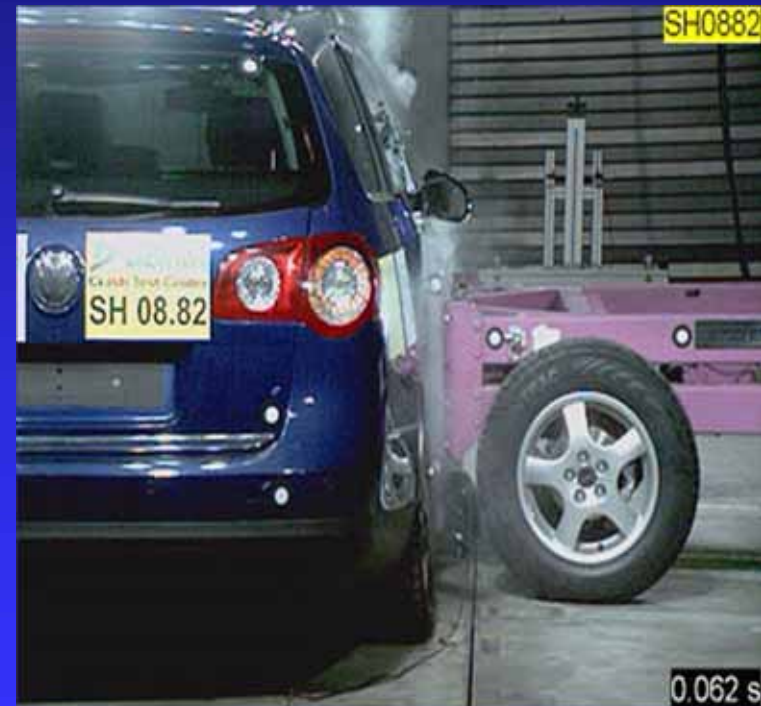
Crash test 2

noticeably higher intrusion into the passenger compartment in comparison with the first crash, especially at the lower part at the connection with the sill (Figures 10 and 11). Note: Later measurement of the car body confirmed there was 60 mm more intrusion after the second test, compared to the first crash. Other differences were noticeable at the cant rail/roof and the transmission tunnel

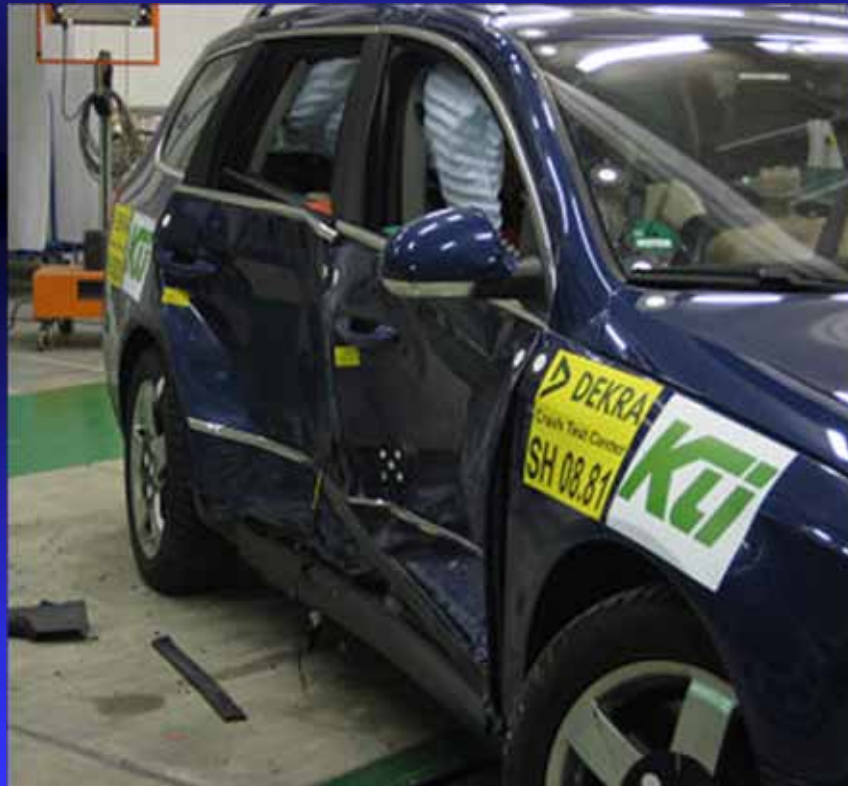
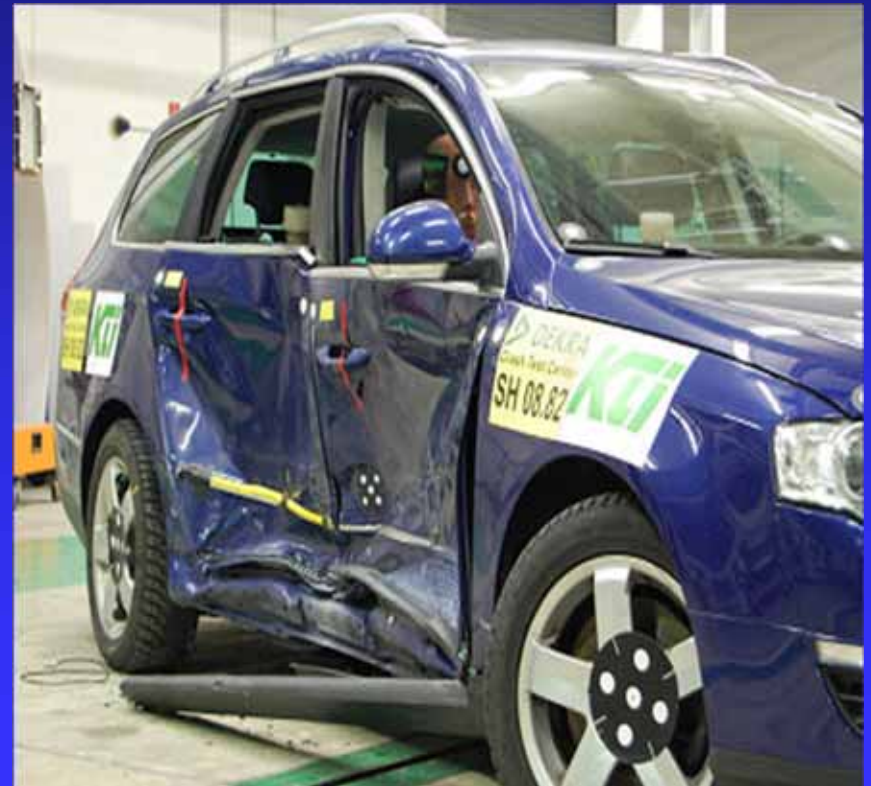
The pyrotechnic protection/restraint systems (Front and rear passenger side airbags and the front passenger belt pre-tensioner) were correctly the passenger side curtain airbag failed to operate.

Observe that the side curtain deployed in the crash test 1, but failed in crash test 2.

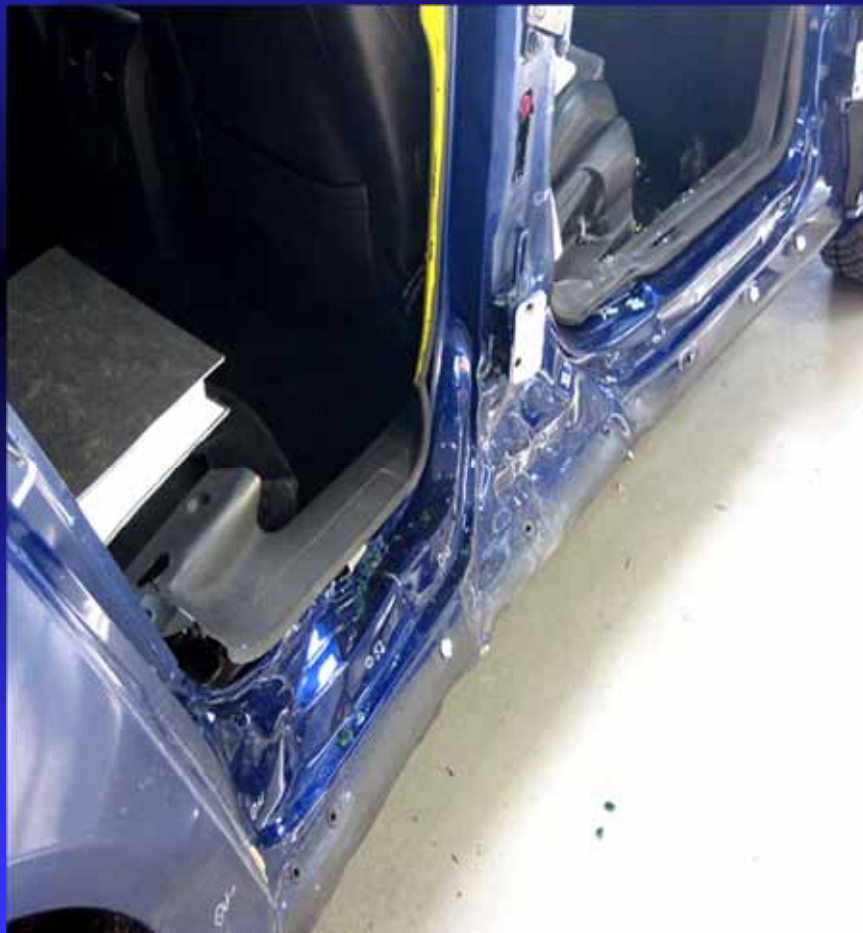
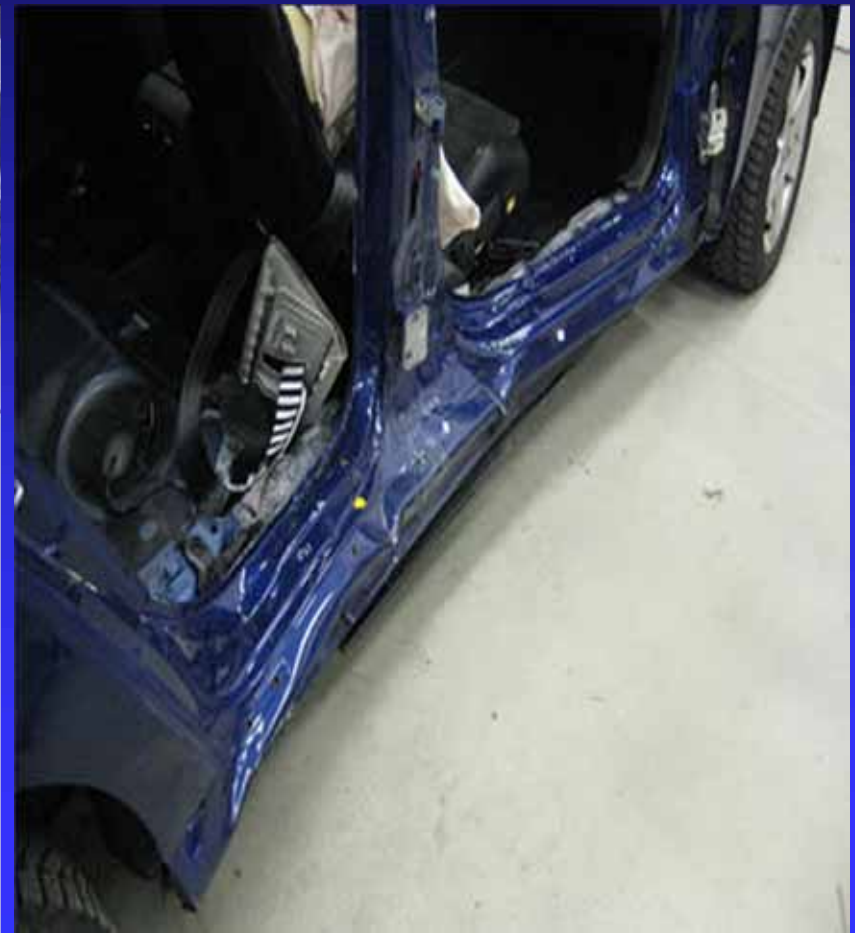
Observe that the rocker and B pillar has moved further into the vehicle in crash test 2

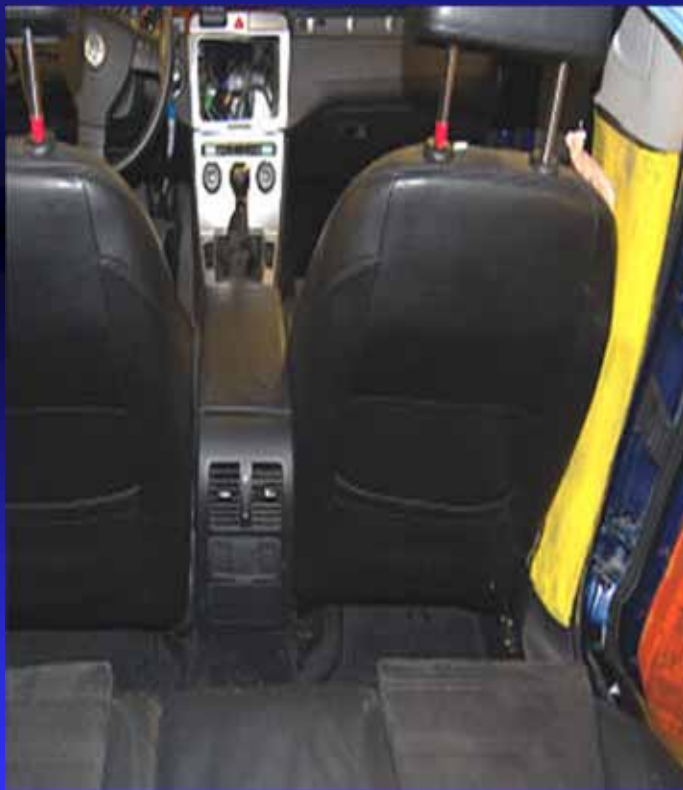
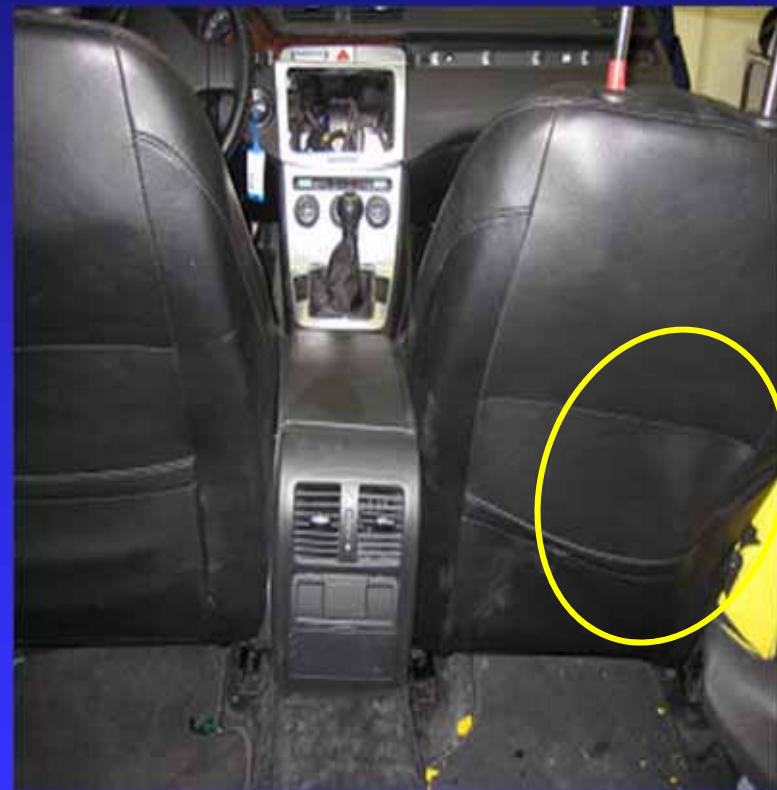
Observe that damage to the passenger seat in crash test 2

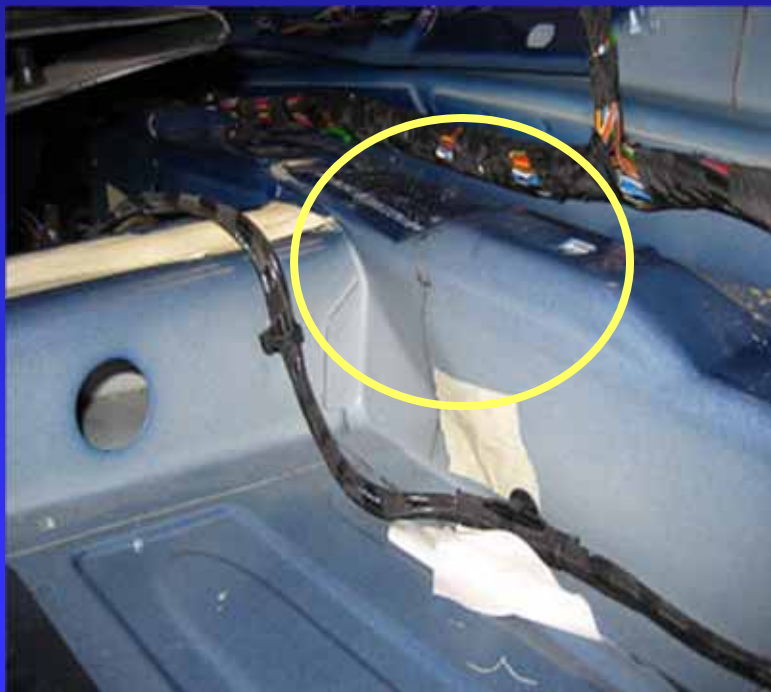
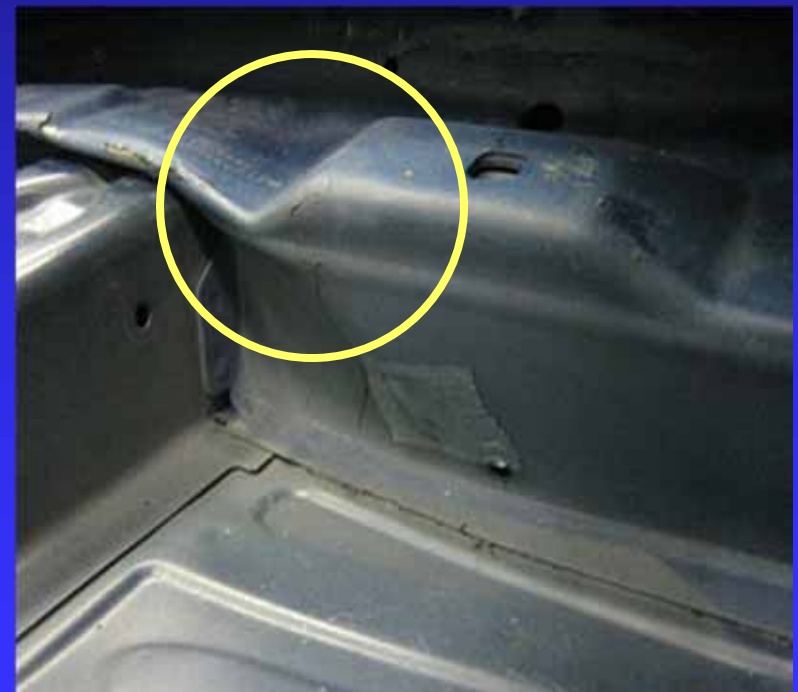
After removing all the seats and necessary trim the deformation of the transmission tunnel after the second test was clear to see. The cross-member which supported the front seat had pushed into the transmission tunnel, distorting it severely. In comparison, there were no measurable changes at the transmission tunnel during the first crash test.

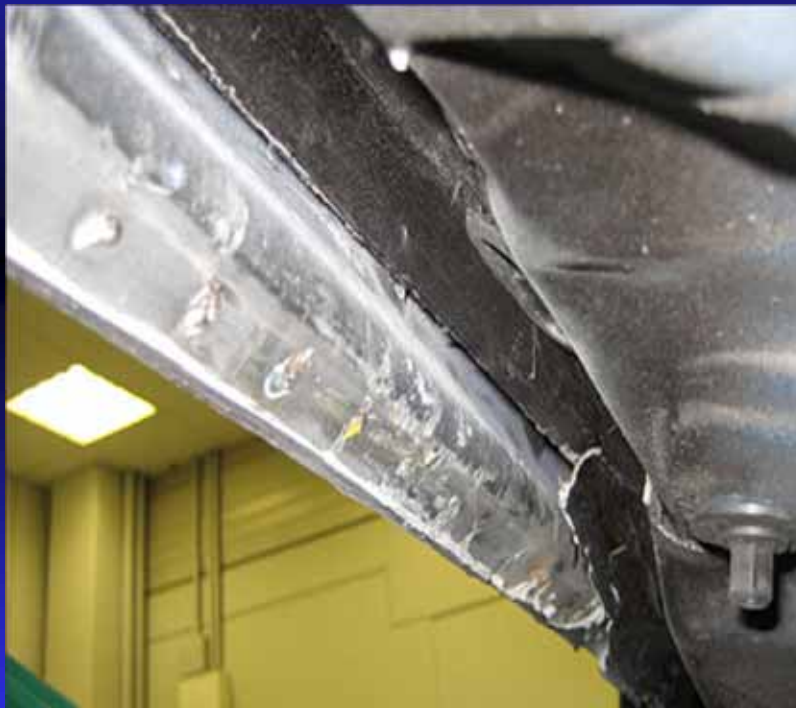
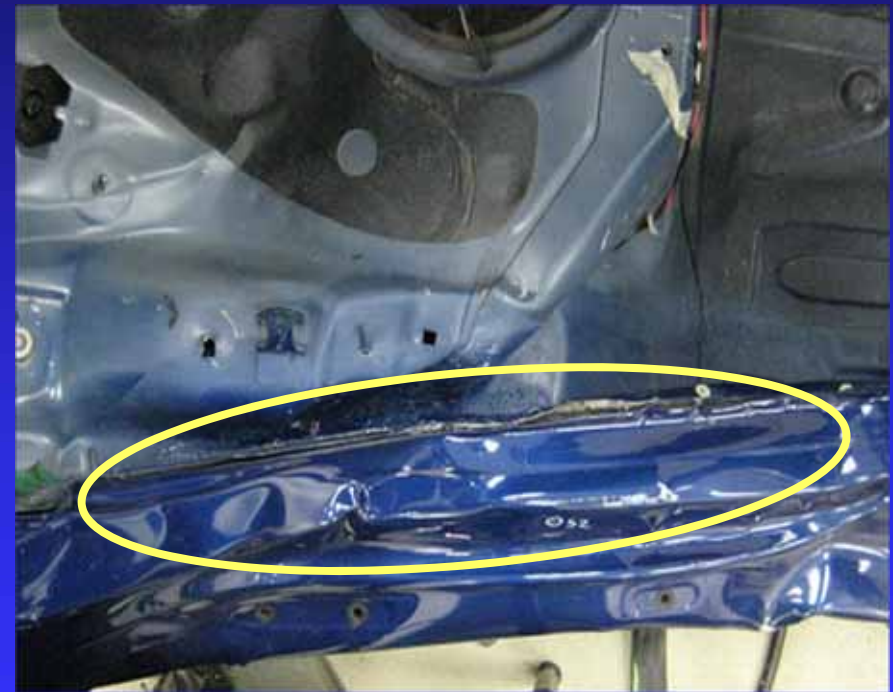
OEM information was not used during the repair after the first crash. These are positions where the inappropriate spot welding machine was used. The disconnection between inner sill and floor panel shows that the spot welds have not withstood the impact and were destroyed. The spot welds need to have a minimum diameter of 4.9 mm at a sheet thickness of 1.5 mm. The optimum would have been 6.7 mm diameter. It is clear that the spot welds were inadequate.

The connection of the B-pillar with the inner sill was joined with MAG welding. The structure of the high-strength steel parts was changed by the welding process and re-shaping. The welded seam was totally broken after the second crash, being unable to withstand the stress and the distortion.

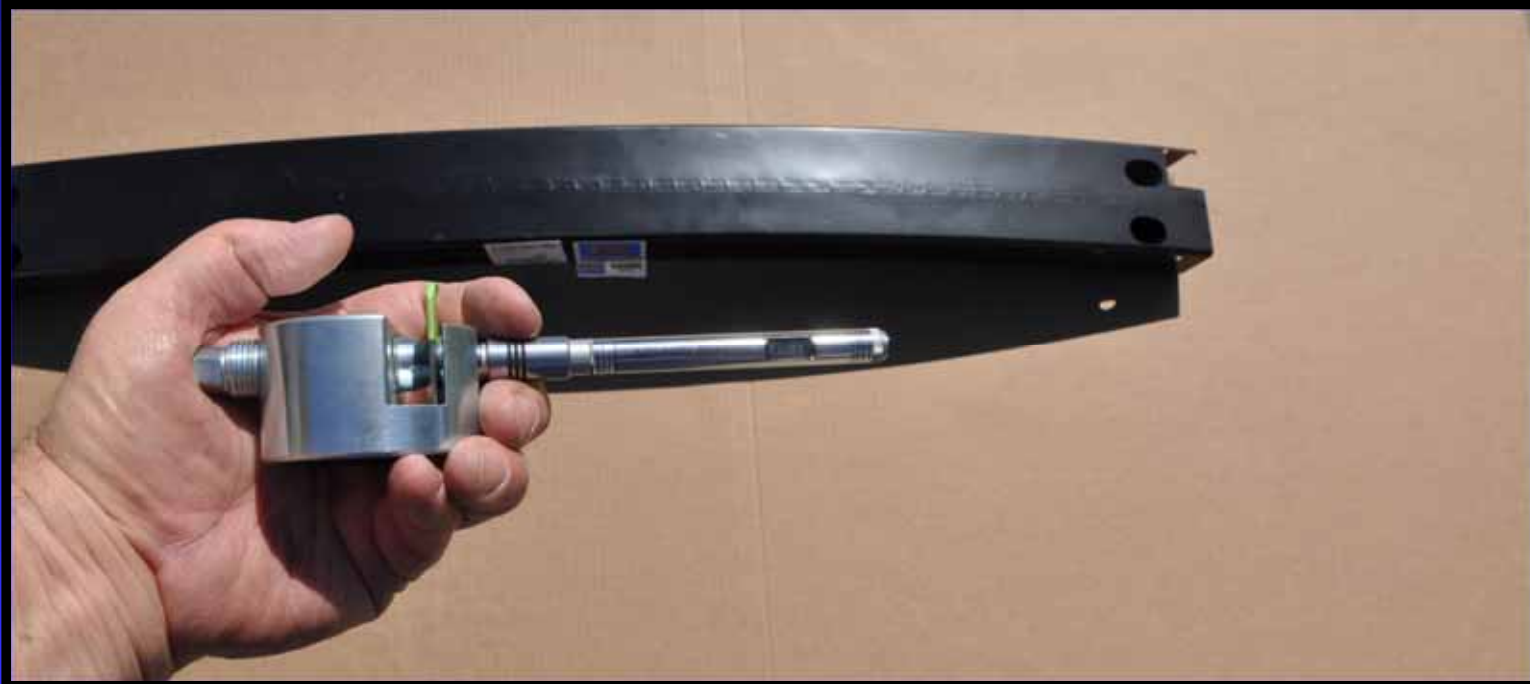
Metal Analysis test on Diamond Standard Bumper Reinforcement

The analyzer reading is 35.1 or UHSS
