Estimating Today's Vehicles

Technical Committee
July 21, 2011
Salt Lake City, Utah

A 2010 Toyota Xb with Damage to the Driver's Side

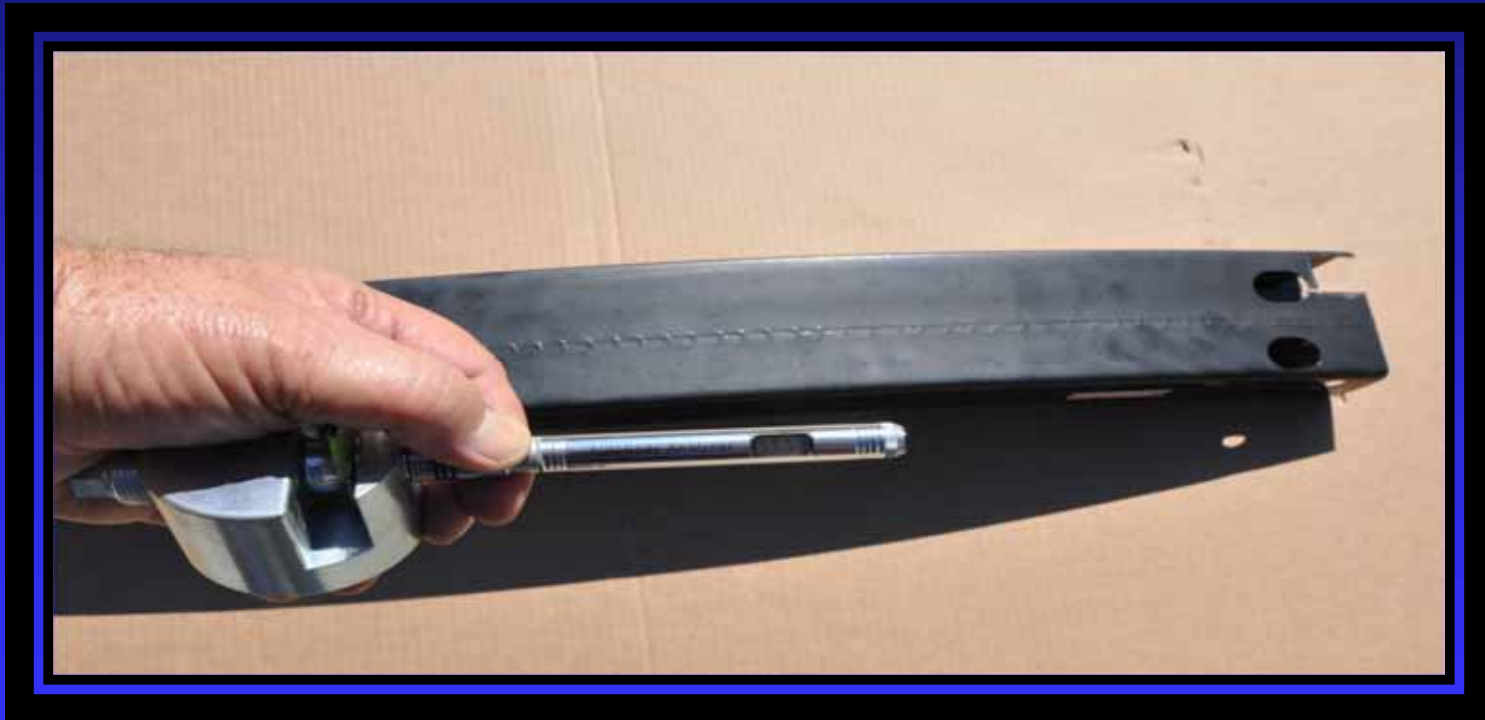
Metal Analysis test on a OEM Front Bumper Reinforcement

The analyzer reading is 50.1 or UHSS

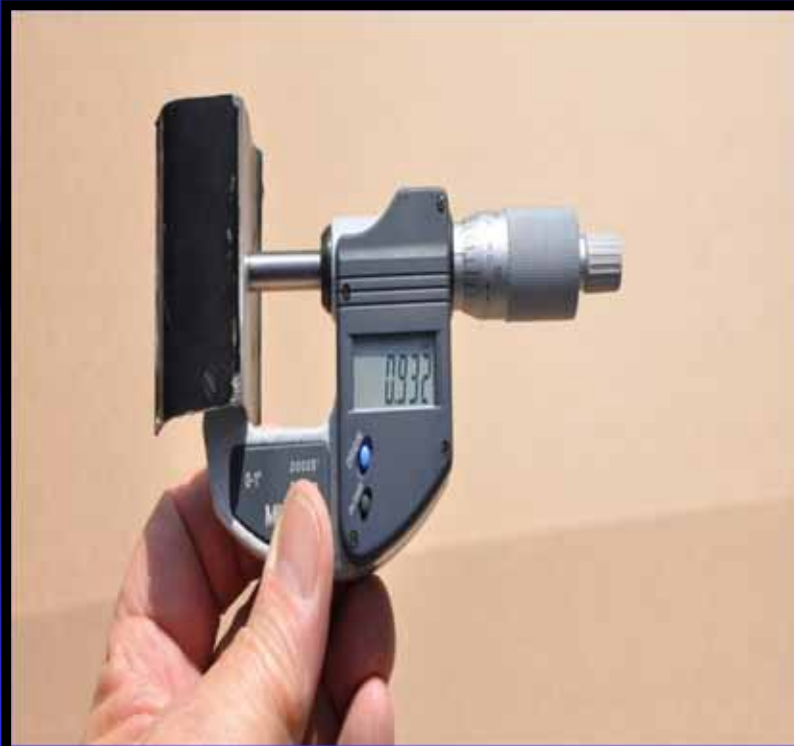
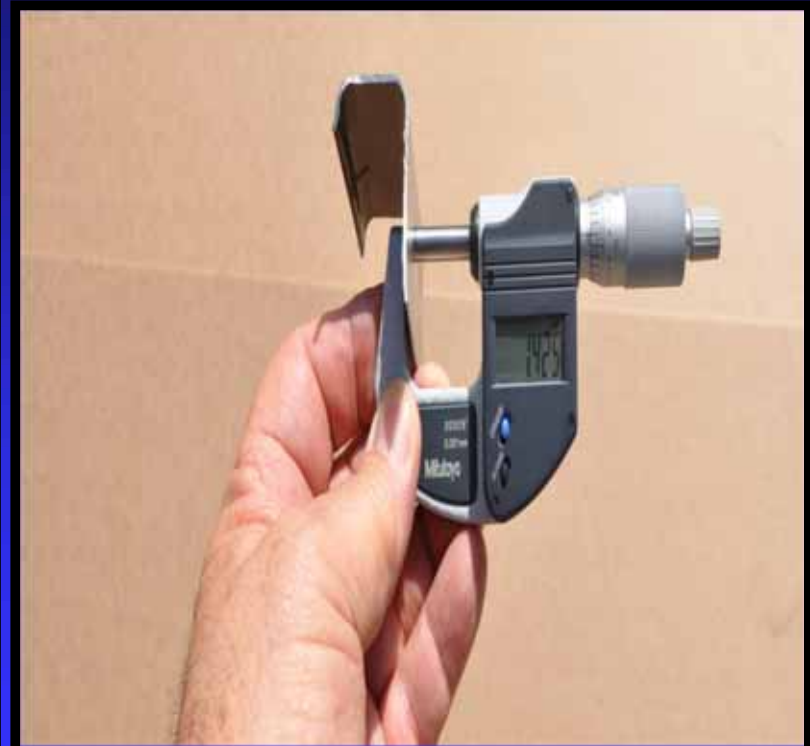
Testing the metal thickness of Aftermarket & OEM Bumper Reinforcement.

A/M .93mm

OEM 1.42mm

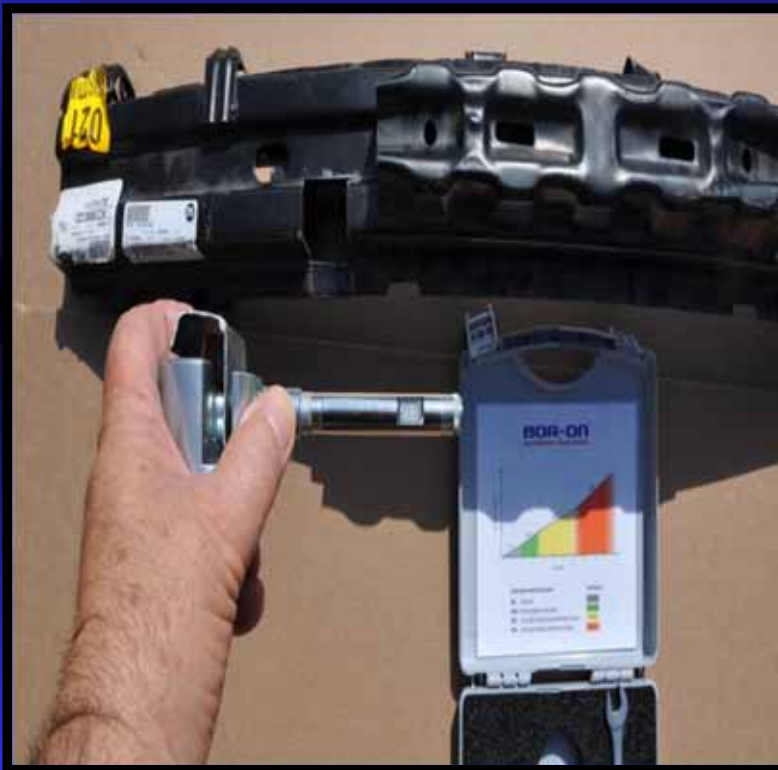
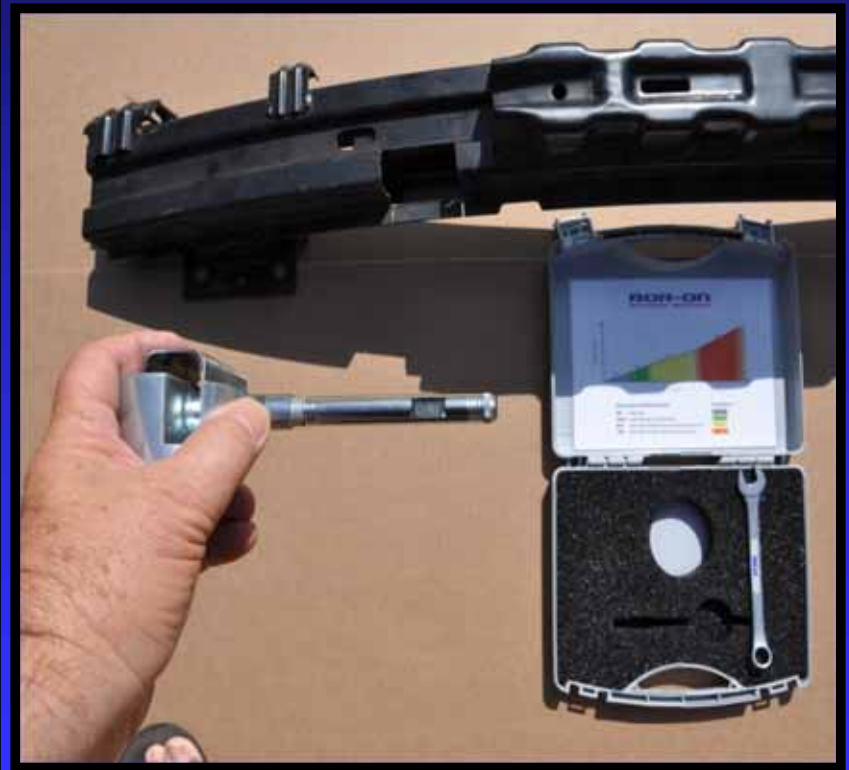
Testing the hardness of the A/M & OEM Bumper Reinforcements

A/M 27.7

OEM 40.7
