**When
Quality
Counts**

**Not all Aftermarket Parts
are Created Equal**

Parts Covered CAPA 501: Bumper Parts Standard

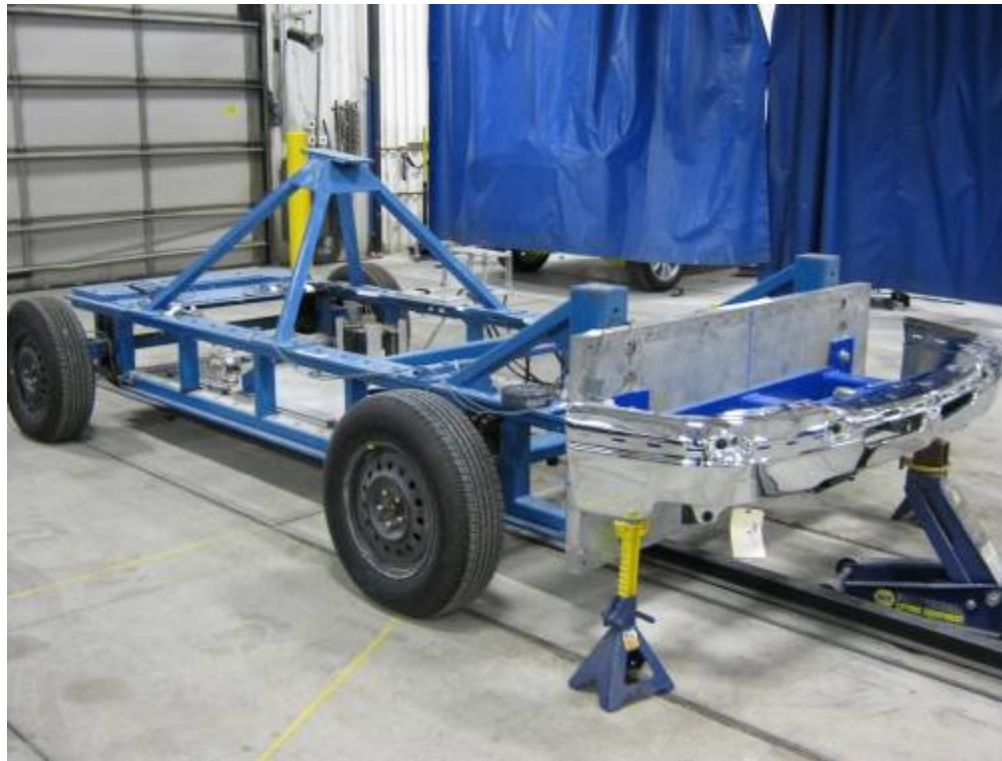
CAPA 501: Bumper Parts Standard: What Does the Standard Test?

- Full Part Stress Test: Dynamic

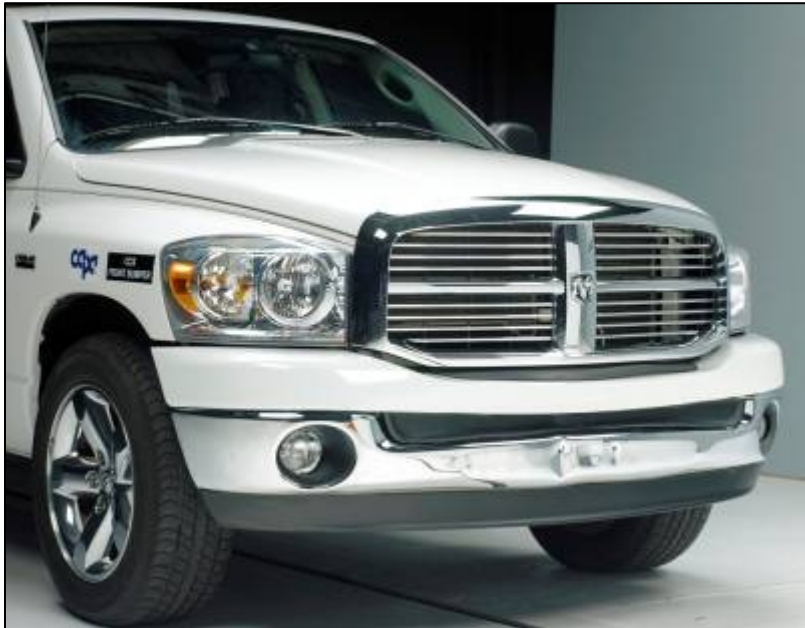
Car Company Brand Service Bumper

IIHS Low Speed Crash Testing: Front Bumper 2008 Dodge Ram 1500

Result: Identical Repair.

\$1,120 in damage

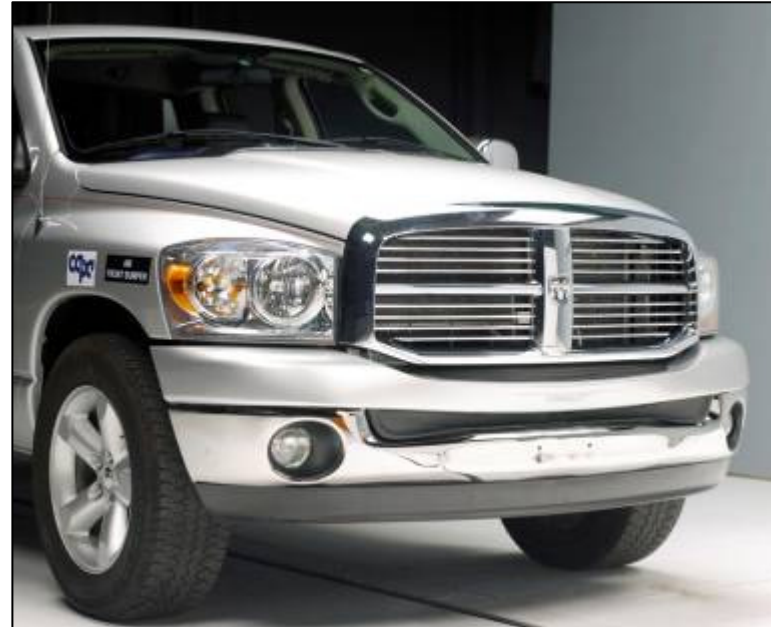
Aftermarket Bumper

\$1,120 in damage

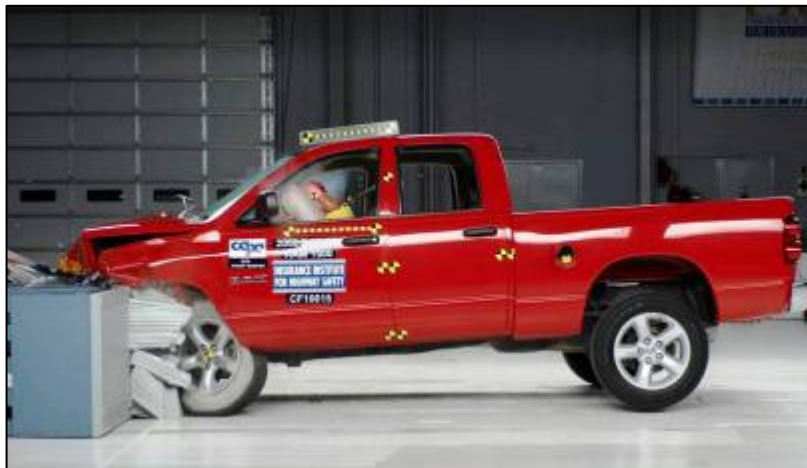
Car Company Brand Service Bumper

IIHS High Speed Crash Testing: Front Bumper 2008 Dodge Ram 1500

IIHS: The injury and intrusion measures for both tests were nearly identical; with both vehicles earning an overall IIHS rating of “Good.”

Test CF10015
IIHS Rating: Good

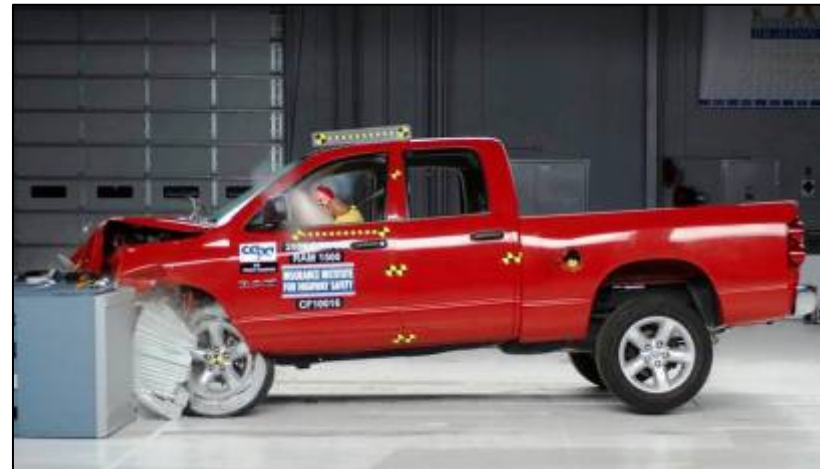
Aftermarket Bumper

Test CF10016
IIHS Rating: Good

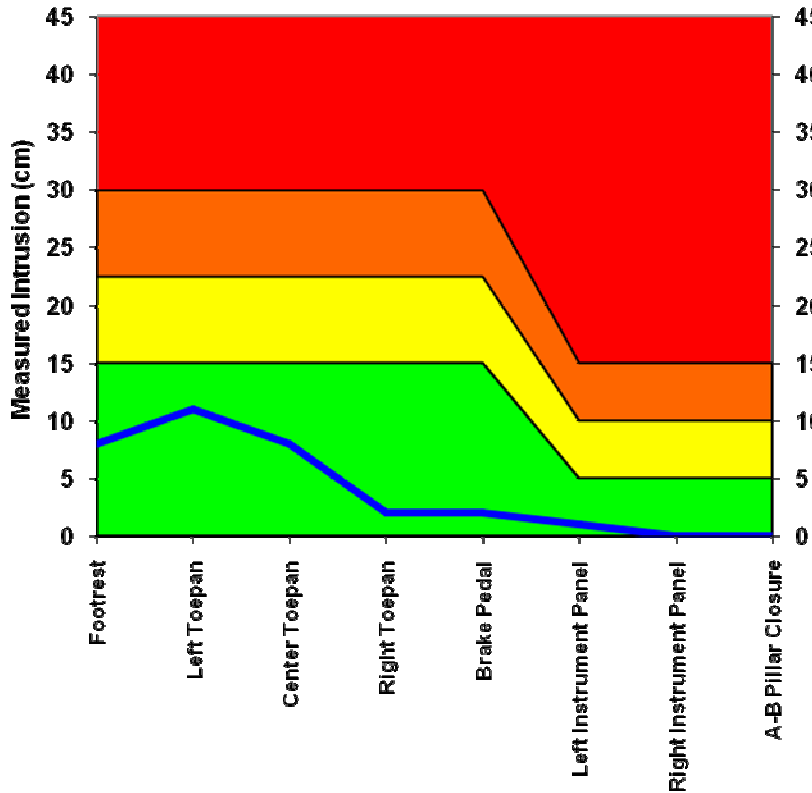
IIHS Frontal Offset High-Speed Test Results Intrusion Measures

CF10015 2008 Dodge Ram 1500 w/Mfg Bumper

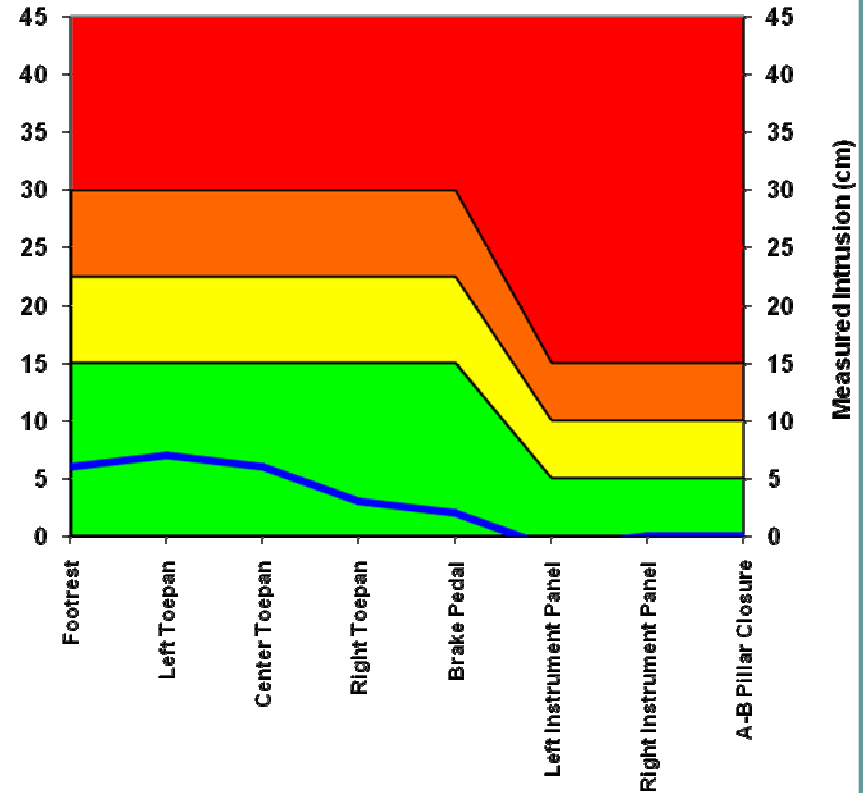
CF10016 2008 Dodge Ram w/AM Bumper

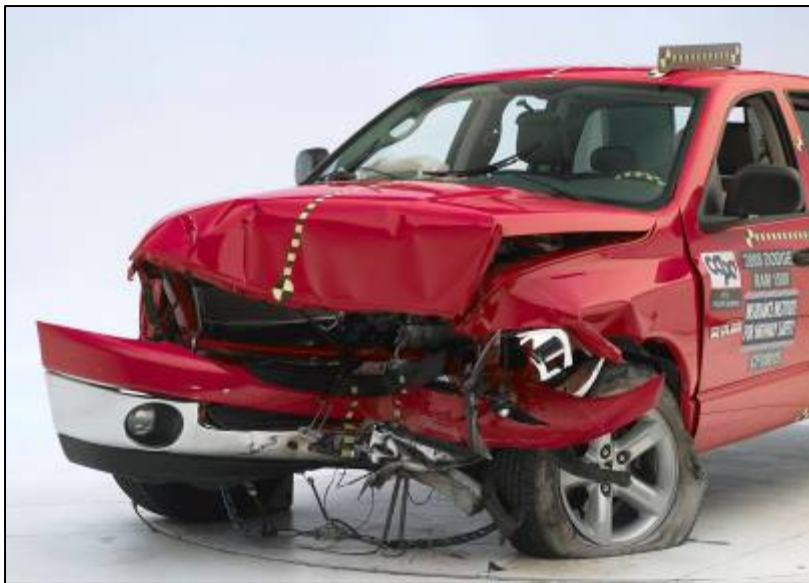
Car Company Service Bumper

IIHS High Speed Crash Test Results :

- Post-crash
