Friction Costs

SEMA-Las Vegas
October, 2012

Vehicle Repair
Knowledge

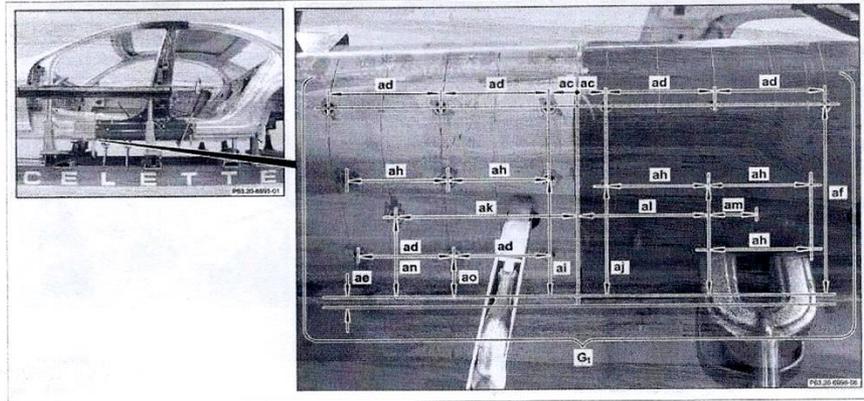
PG3 20-6999-09

Dimensions:

ac 20 mm
ad 60 mm
ae 5 mm
af 155 mm
ah 60 mm
ai 102 mm
aj 103 mm
ak 102 mm

al 80 mm
am 30 mm
an 72 mm
ao 41 mm

13 Scribe rivet holes at bottom on outer longitudinal member (2) (area G).

14 Center punch rivet holes at bottom on outer longitudinal member (2) using BTR Usibor center punch, dia. 8 x80 mm (area G).

15 Drill rivet holes at bottom on outer longitudinal member (2) with BTR Usibor drill bit, dia. 6.7 mm (area G).

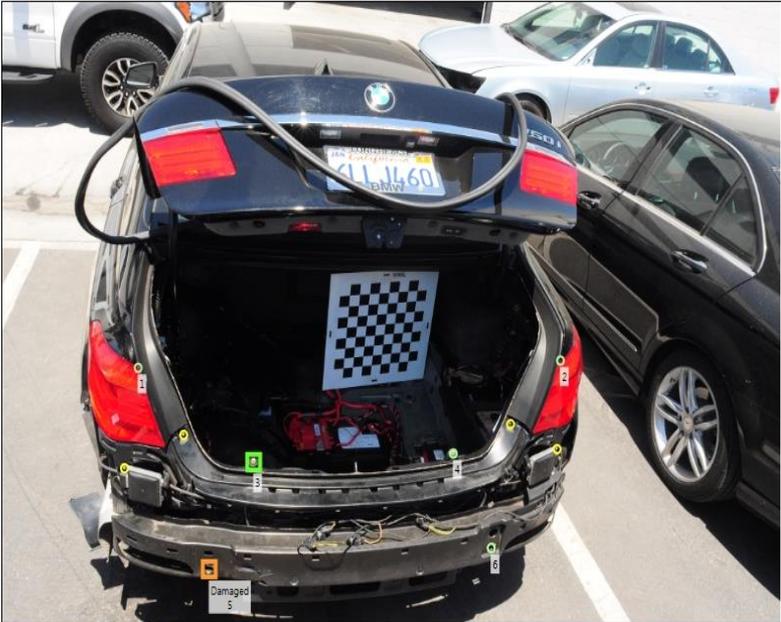
XYZ Comparative Rear Repair Analysis

A 2011 BMW 7 Series was towed to a BMW referred body shop with damage to the left rear wheel. The door to quarter gap and quarter panel to deck gap showed no visible movement. The collision center wanted to put the vehicle on a bench(their expertise in BMWs dictated mounting the car onto the bench) to measure the vehicle, but the insurance company said no due to the fact that they could not see any panel movement.

XYZ Comparative Measurements

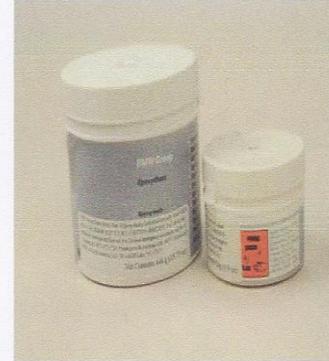
Metal filler is used to fill the seam that was cut during a quarter panel replacement. It is important to follow all the guidelines in "Information on Metal Filler" found in ISTA. There you will find information on storage temperature, shelf life, surface pre-treatment, mixing ratio, application, and hardening time.

NOTE: Curing is temperature sensitive. Follow all the steps to achieve properly cured metal filler.

A second application of Metal Filler is not permitted. (Insufficient adhesion)

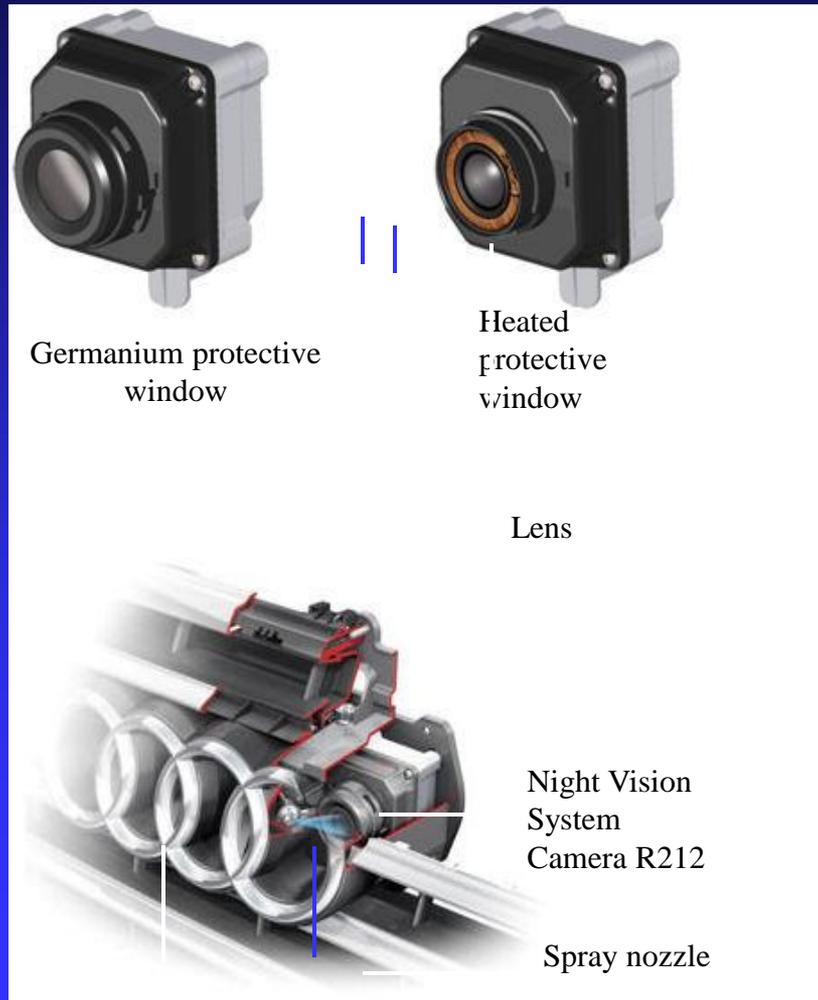
Night Vision System Camera R212

- ▶ Infrared thermal imaging camera.
- ▶ 320 X 240 pixel resolution.
- ▶ 30 frames per second.
- ▶ Stores last calibration results.
- ▶ Germanium protective window.
- ▶ Window heated at temps < 43°F (6°C.)
- ▶ Cleaned by washer jet.
- ▶ Protective window and seal replaceable.

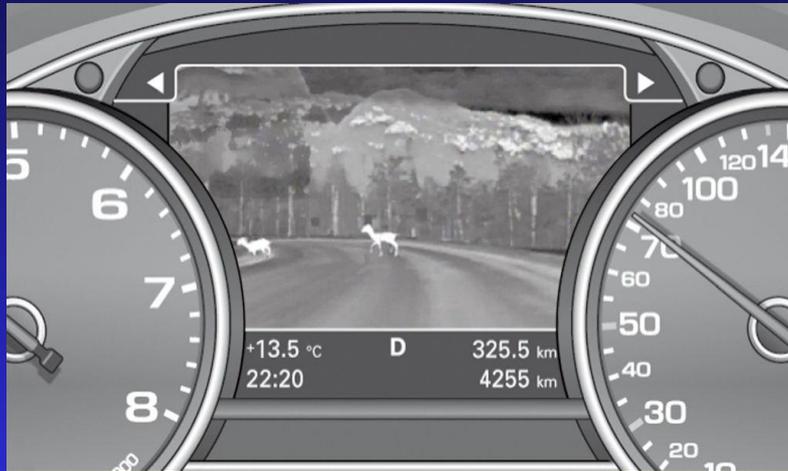
- ▶ Larger animals are identified because of their body heat.
- ▶ Smaller animals are not identified.

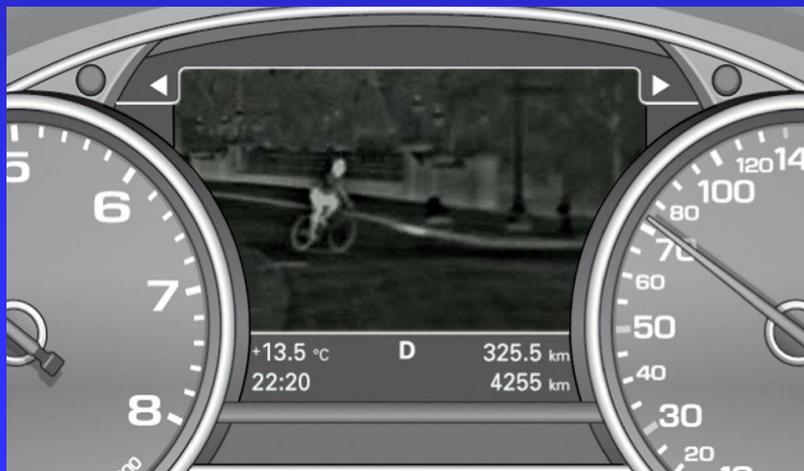
- ▶ Cyclists are clearly visible but at times are not fully highlighted.
- ▶ Motorcyclists are not highlighted by system.

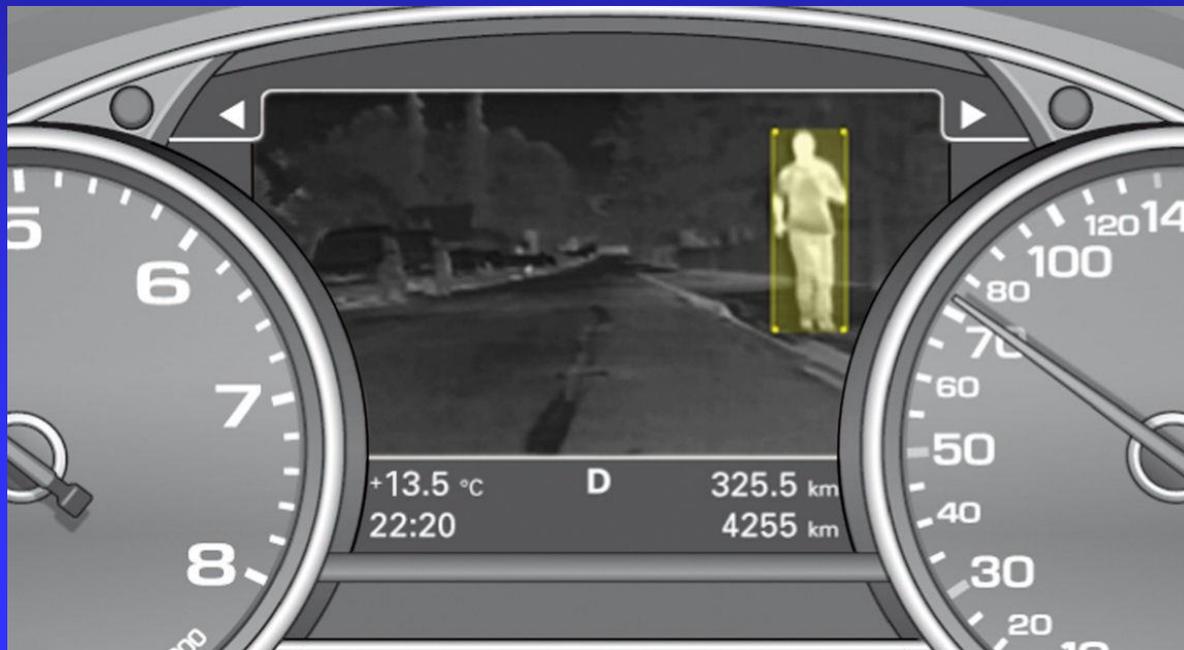
Highlighting detected pedestrians

- ▶ Identification done through infrared camera technology.
- ▶ Classification of persons based on a list of categories.
- ▶ Detected persons highlighted by a yellow rectangle with brackets.
- ▶ No classification of persons who are partially concealed.
- ▶ Classification of persons only within a distance of approximately 50 ft to 295 ft (15m to 90m) of camera.

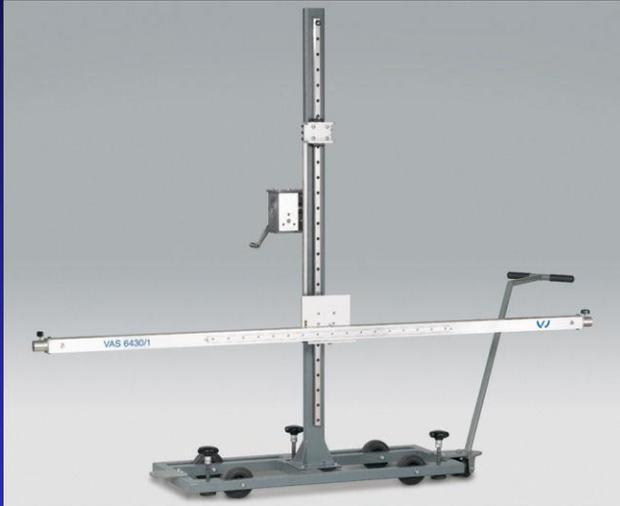
- ▶ VAS Scan Tool.
- ▶ VAS 6141.
- ▶ VAS 6430 or VAS 6430/1.
- ▶ Calibration plate VAS 6430/6.
- ▶ Laser measuring device VAS 6350/3.

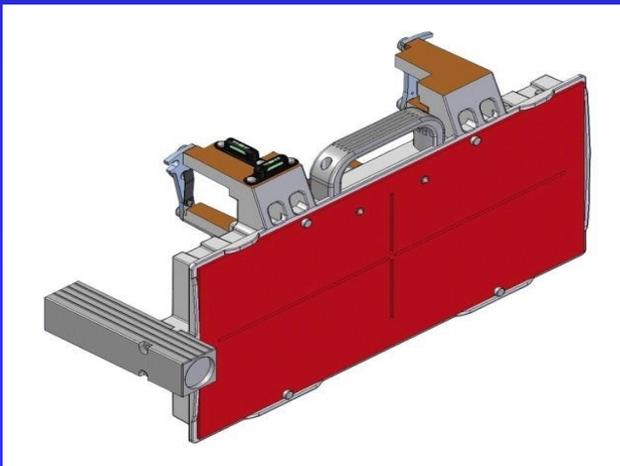
VAS 6430/6

- ▶ Replacement of camera.
- ▶ Replacement of camera housing mounting bracket.
- ▶ Replacement/removal of front bumper.
- ▶ DTC: No or incorrect Basic Setting in control module.
- ▶ After vehicle alignment.

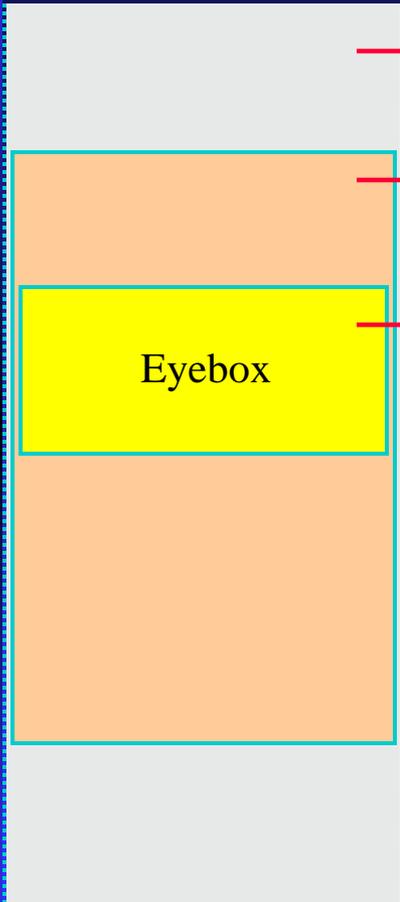
Heads-up Customer: accessible vertical calibration

- ▶ The adjustment range of the eyebox can be aligned vertically on the windshield by the customer.
- ▶ Adjustment range of the eyebox determined by the service vertical calibration.
- ▶ Visible area in which the driver sees the head-up display untruncated.

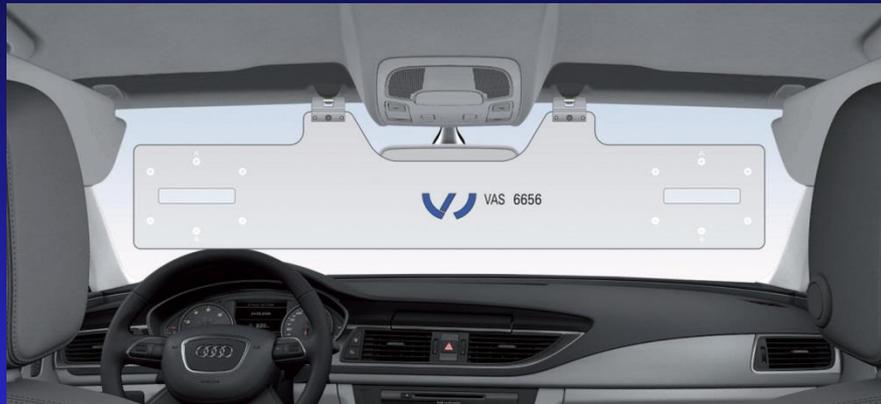
Heads-Up: Service calibration with the VAS Scan Tool

Two-step calibration:

- ▶ Height adjustment.
- ▶ Distortion correction.

- ▶ VAS Scan Tool.
- ▶ VAS 6656.

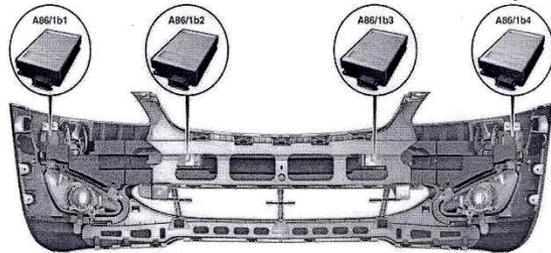
Location of radar sensors in front bumper, shown on model 221
A86/1b1 Left outer radar sensor
A86/1b2 Left inner radar sensor
A86/1b3 Right inner radar sensor
A86/1b4 Right outer radar sensor

When performing filling and painting work on the bumpers, it is important to make sure that the maximum coat thickness is not exceeded at the short range radar sensors. This can lead to malfunctions as the sensors detect the excessive coat thickness as an obstacle. The limit value for the coat thickness at the sensors is two coats of paint. If the short range radar does not function correctly after painting, either the paint must be removed or the bumper must be replaced.

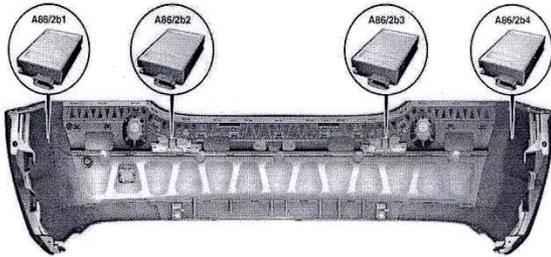
Location of radar sensors in rear bumper, shown on model 221
A86/2b1 Left outer radar sensor
A86/2b2 Left inner radar sensor
A86/2b3 Right inner radar sensor
A86/2b4 Right outer radar sensor

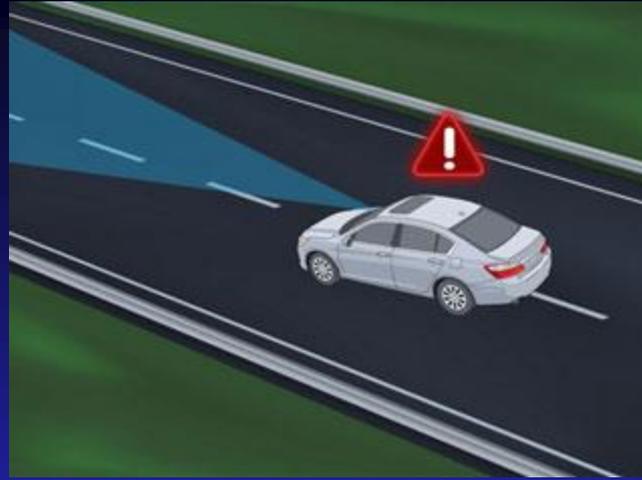
Lane Departure Warning (LDW)

A small camera mounted at the top of the front windshield tracks lane markings on the road, and it can detect when the driver is making an un-indicated lane departure[1]. Visual alerts will light up on the driver's instrument panel and the system also can provide an audible warning.

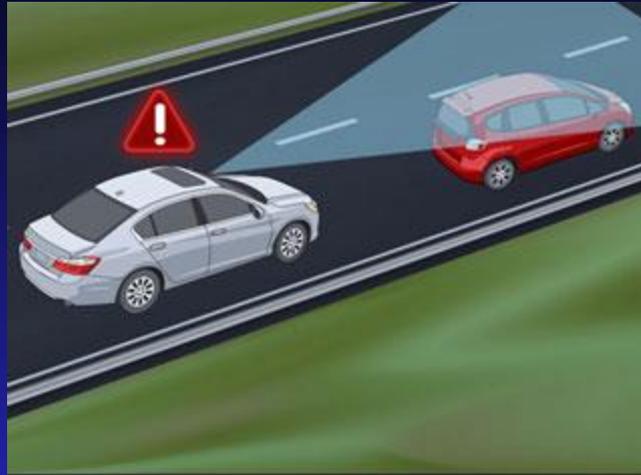
Forward Collision Warning (FCW)

A small camera mounted at the top of the front windshield or, in the case of the Touring model, a radar system mounted in the front grille can detect the presence of vehicles in front of you.

When the FCW system calculates that you are at risk of a collision, it immediately activates visual and/or audible alerts

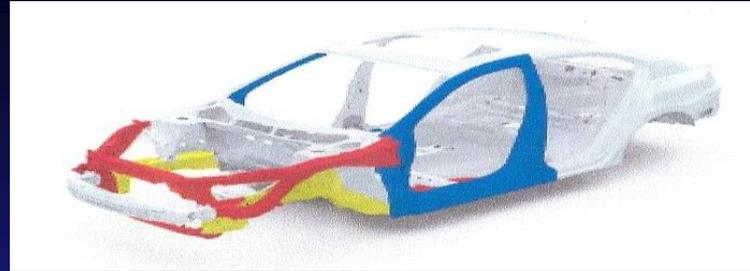
The newly redesigned 2013 Accord body uses 55.8-percent high-tensile steel, more than in any previous Accord. And 17.2-percent of the steel is grade 780, 980 and 1,500 MPa, extremely high grades that have never before been used in any Accord, and in fact, very few other cars, according to Jason Bartanen, of I-CAR

"This is one of the first cars to use such high strength steel (1500 MPa) in its body structure," says Bartanen. "Most applications only use it only for bumper beams. But the new Accord uses ultra-high strength steel in its A pillar and B pillar reinforcements as well as its rocker reinforcements. Honda is requiring MIG brazing only in these areas.
