COLLISION INDUSTRY
CONFERENCE

Technical Committee

Why OEM Data for Vehicle Repair

Toby Chess and Kye Yeung
SEMA-Las Vegas, NV
October 2017

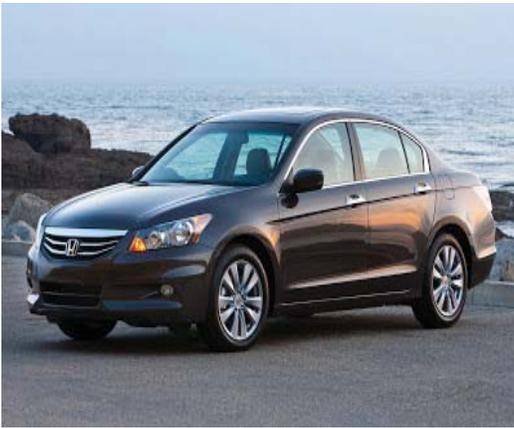
2012 Honda Accord

Question: What is the major difference between two Honda Accords?

Answer: The "A" Pillar reinforcement, "B" pillar reinforcement and Rocker panel reinforcement are constructed of one of the highest strength steels seen in passenger cars. They have an 1500 MPa steel rating.

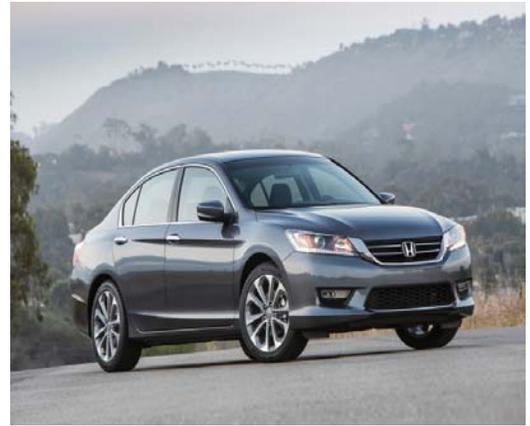
2013 Honda Accord has ultra strength steel in the A pillar, “B” pillar and Rocker reinforcement

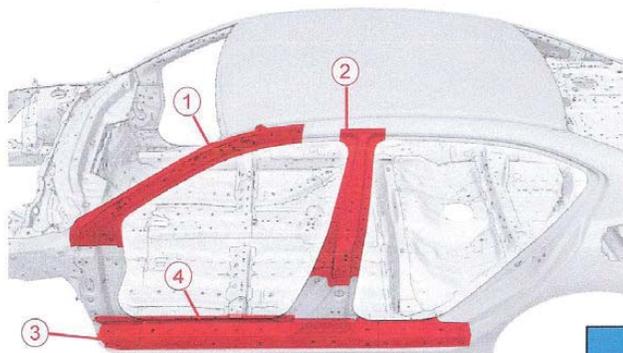
1,500 MPa (HOT STAMP) STEEL LOCATIONS

1,500 MPa steel is stronger than ordinary steel, so it can help protect vehicle occupants while reducing overall vehicle weight to improve fuel efficiency.

The numbered parts in the diagrams below are constructed of 1,500 MPa steel:

4-Door Models	
1	Front Inner Upper Pillar
2	Center Pillar Upper Stiffener
3	Side Sill Stiffener
4	Inside Sill Reinforcement

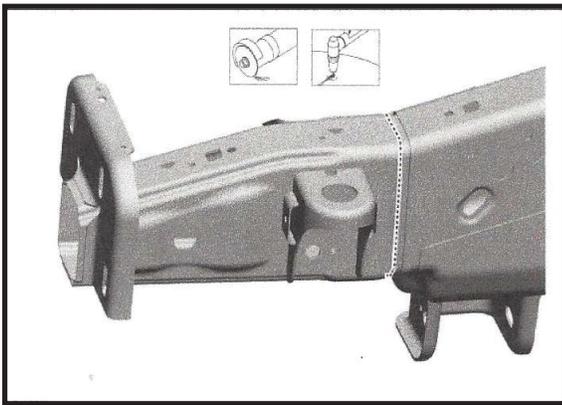
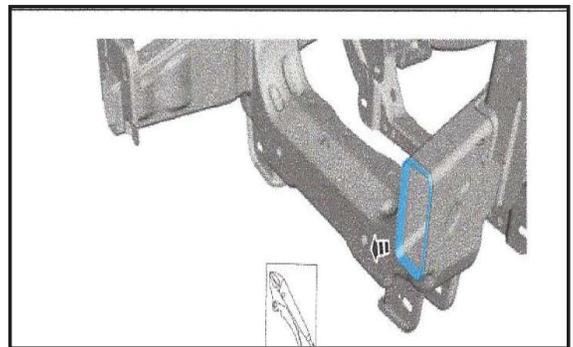
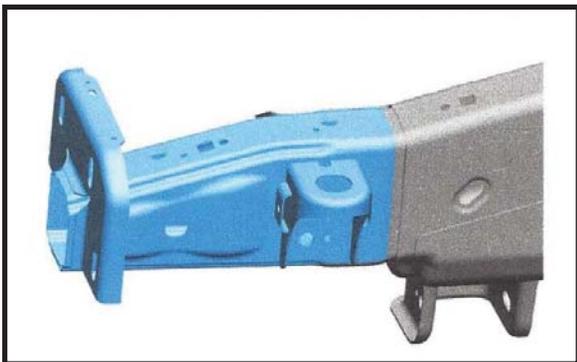
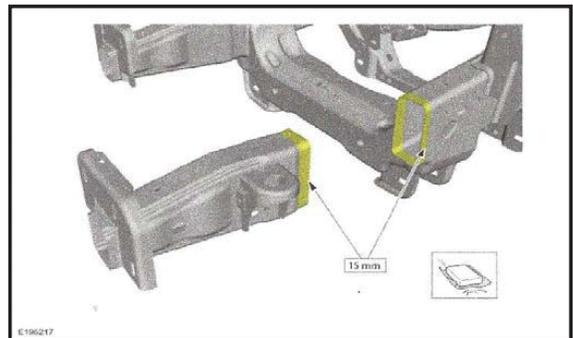
Ford OEM Procedure for replacing front frame rail section on 2013 F150

What Ford OEM Procedures state about the welding wire and equipment to replace the section

Weld the joint completely around the perimeter, if fit and alignment are correct, using a Metal Inert Gas (MIG) welding machine capable of producing a minimum of 200 amps. Use 0.9-1.1 mm (0.035-0.045 in) ER70S-3 or equivalent weld wire that is compatible with mild (Society of Automotive Engineers (SAE) 1010) steel.

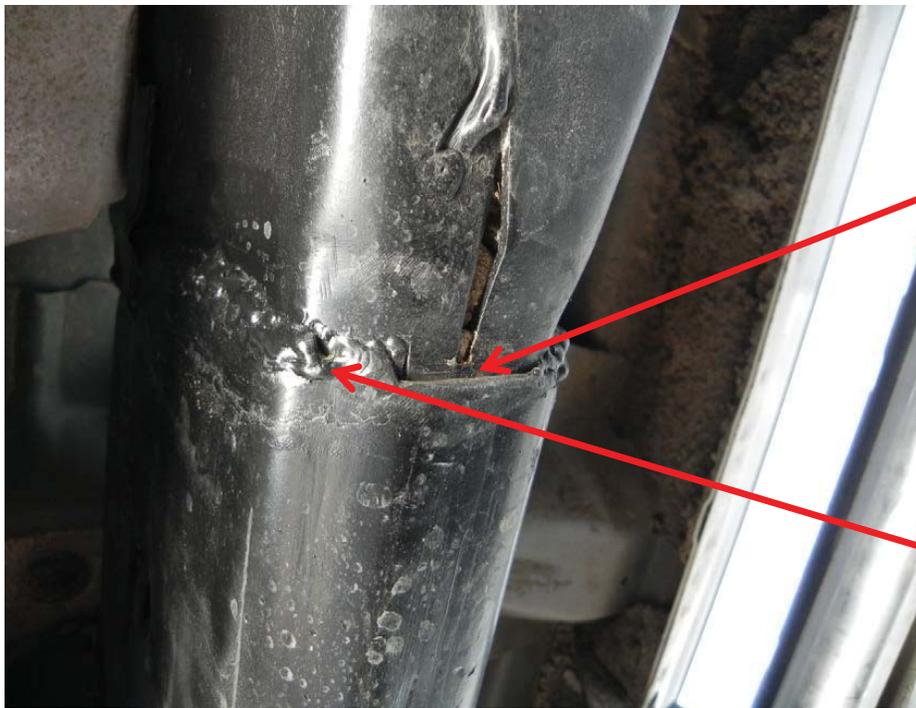
Incomplete Weld

.024 Wire used with
110 Volt welder

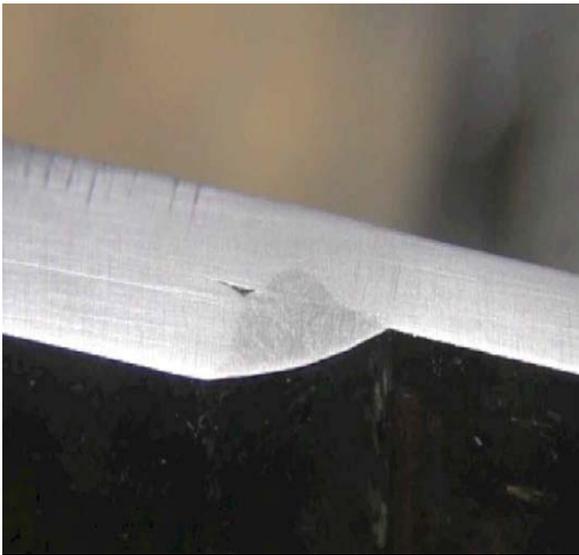
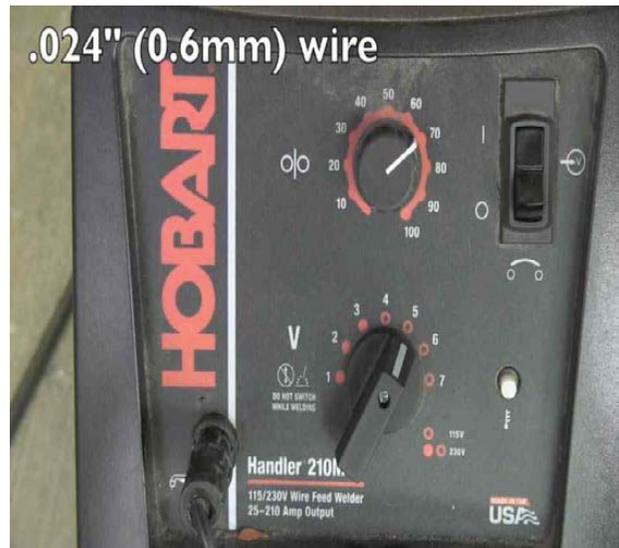
Lack of Penetration welding .024 wire on 1/8 steel.

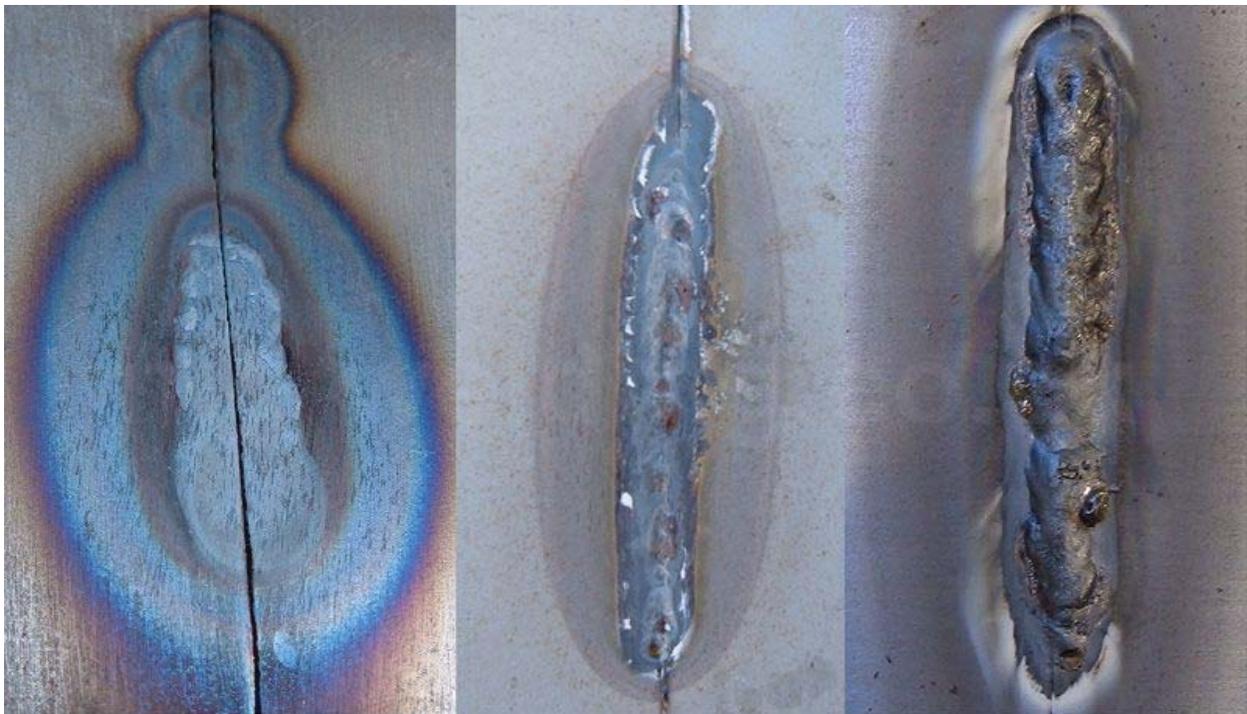
Weld Penetration on the backside of a metal panel.

not enough

OK

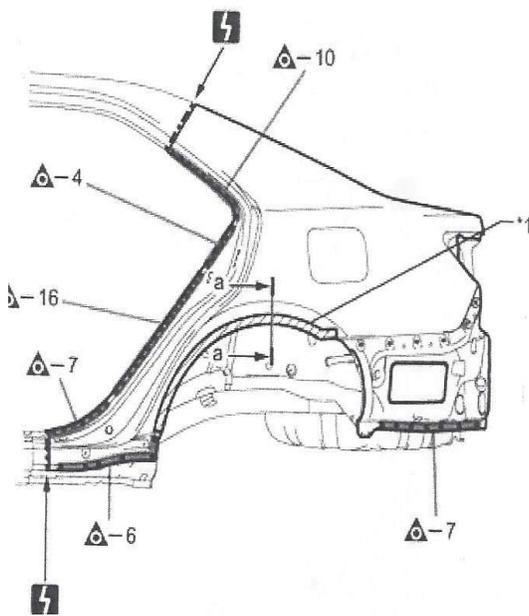
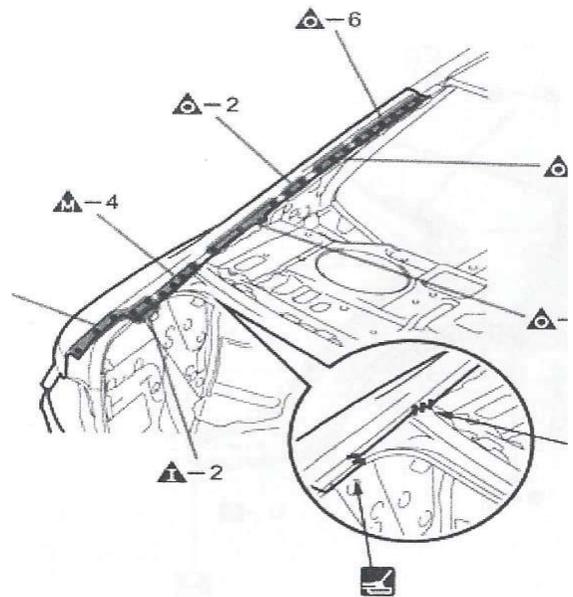
Note: 8 additional CRIBs are also needed to perform the quarter panel replacement

Additional Toyota Procedures need for a Quarter panel Replacement.

- CRIB 177 –Perform a zero calibration after a collision
- CRIB 2021—Glass Sealer
- CRIB 2025—Seam Sealer
- CRIB 2027—Pinch Weld Repair
- CRIB 2028 –Anti Chip Primer
- CRIB 2029 Repair Procedures for Rust Resistant Sheet Metal
- CRIB 2032—Anti Corrosion Treatment
- CRIB 2038--Adhesives

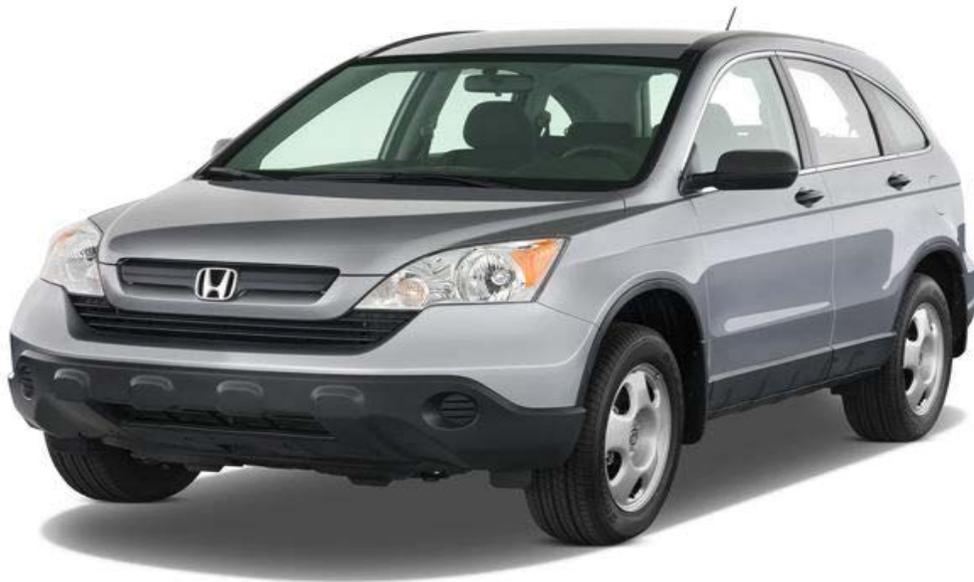
Honda Repair Procedures for 2009 CRV

Roof Panel

Installation

1. Clamp the new roof panel, and tighten the mounting bolts.
 2. Check the body dimensions.
 - Rear pillar gutter and rear panel position (see page 4-6)
 - Windshield/door opening (see page 4-7)
 - Tailgate opening (see page 4-7)
 3. Tack weld the front and rear corner edge of the roof panel.
 4. Temporarily install the roof side trim, windshield, doors, and tailgate, then check for differences in level and clearance. Check the operation of the tailgate.
 5. Do the main welding.
 - From inside the vehicle, weld the roof panel stiffener (A) and rear roof rail (B).
 - Weld the front, rear, and side flange of the roof panel (C).
- The roof area must be free of burrs and/or sharp edges to prevent damage to the side curtain airbag during deployment.

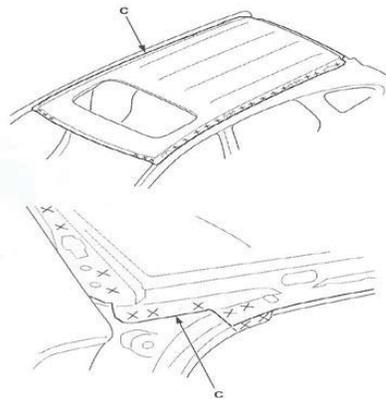
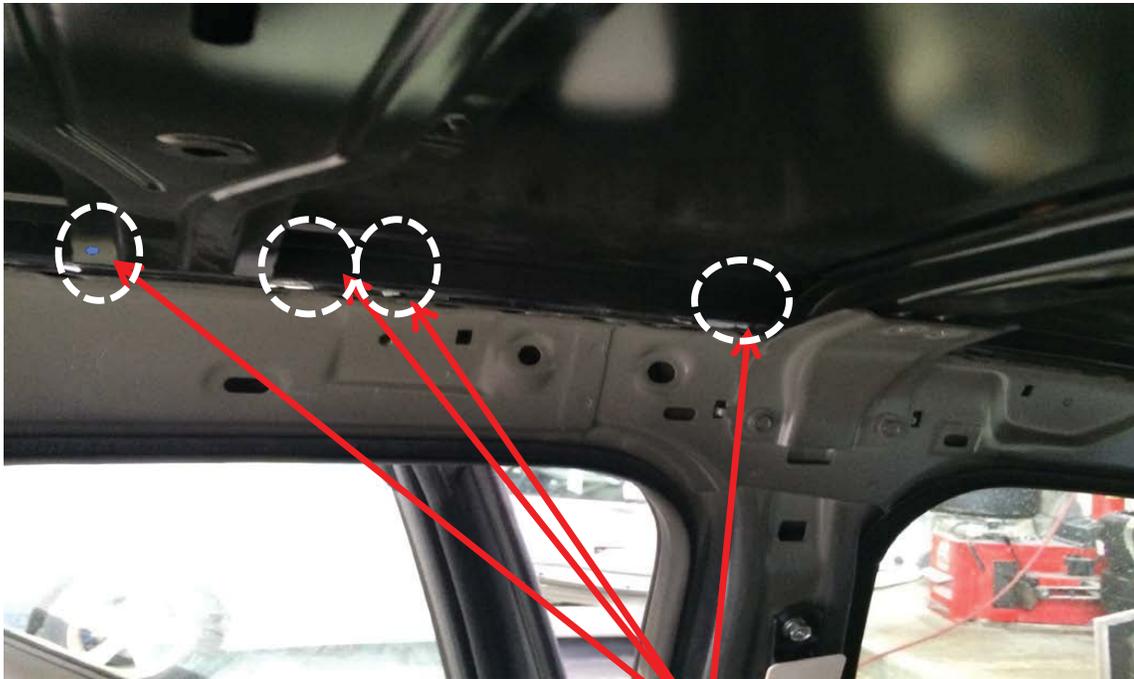
2009 Honda CRV showing separation from only using adhesive for the repair. Roof was not welded as per OEM Instructions.

Light showing where roof has separated from roof rail
